# Ash Corrosion Under Reducing Conditions

D. N. French  
Director  
Corporate Quality Assurance  
RILEY POWER INC.  
a Babcock Power Inc. company  
(formerly Riley Stoker Corporation)

*Presented at*  
National Association of Corrosion Engineers  
Corrosion/80  
Chicago, Illinois  
March 3-7, 1980

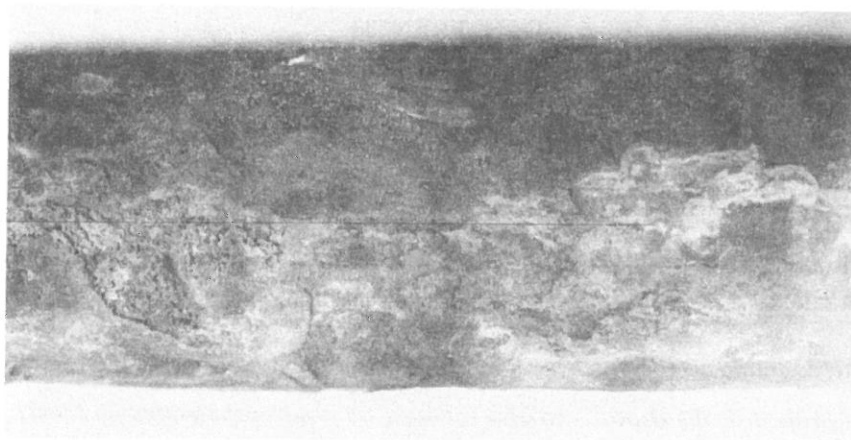
Figure 1 shows a portion of a superheater tube from an oil fired boiler displaying the liquid ash attack and tube wastage. Severe metal loss leads to the failure. Chemical analysis of the scale deposits are given in Table I.

*Figure 1 External Surface Showing of a Superheater Tube From an Oil Fired Boiler Showing Severe Metal Wastage*

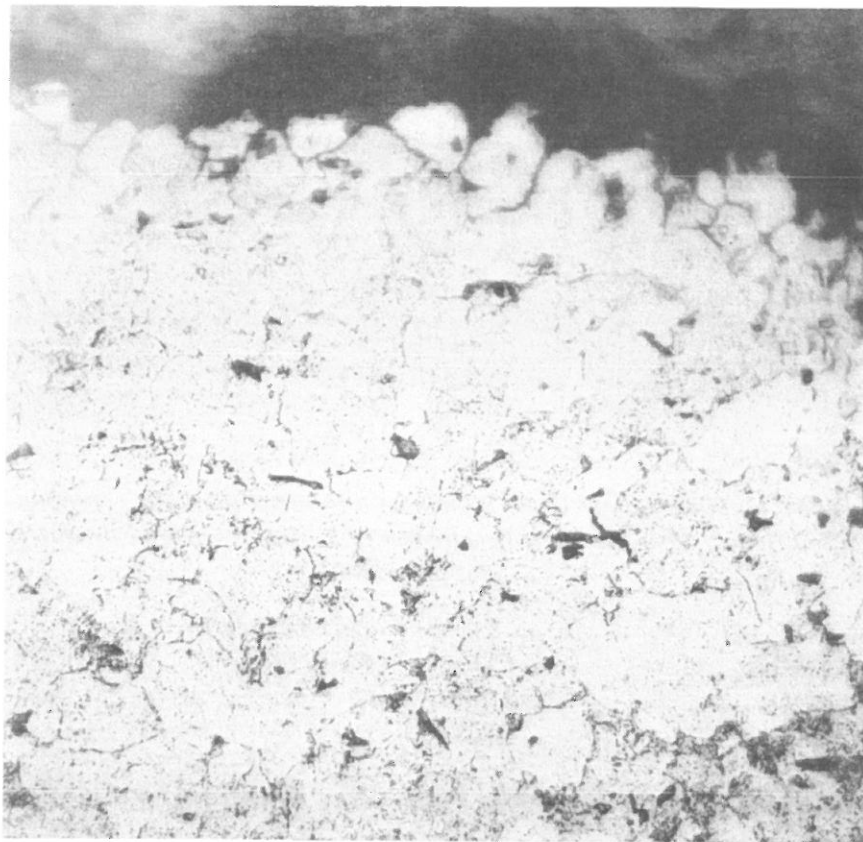
Microstructural analysis shows the penetration of the metal by the corroding species, Figure 2. A sulfur print, Figure 3, of the cross section of the tube showed a high concentration of sulfides at the tube metal-scale deposit interface. [To prepare a sulfur print, dip a piece of photographic paper in 2-3% sulfuric acid solution, drain off the excess acid, press the rough polished (120 grit abrasive) sample surface on to the photographic paper, hold for 2-3 minutes and remove carefully; any sulfides present release  $H_2S$  when reaction occurs with the sulfuric acid.  $H_2S$  turns the silver salts on the photographic paper black to leave an imprint of the sulfide distribution on the specimen surface.] X-ray diffraction analysis confirmed the presence of iron sulfide, FeS, on the superheater tube, Table II.

*Figure 2 Microstructure of the Superheater Tube From Figure 1, Note the Intergranular Penetration of the Sulfide Corrosion Product. 250X*

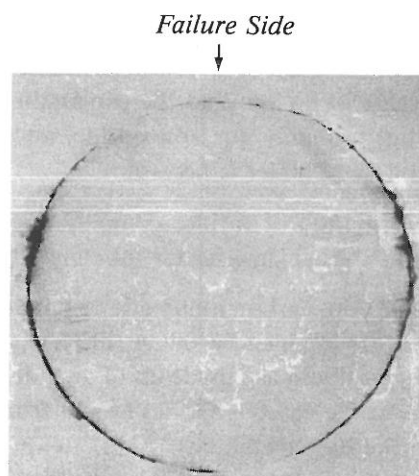
*Figure 3 Sulfur Print of the Cross Section of Superheater Tube From Figure 1. Note the Heavy Concentration of Sulfides Around the Perimeter of the Tube.*

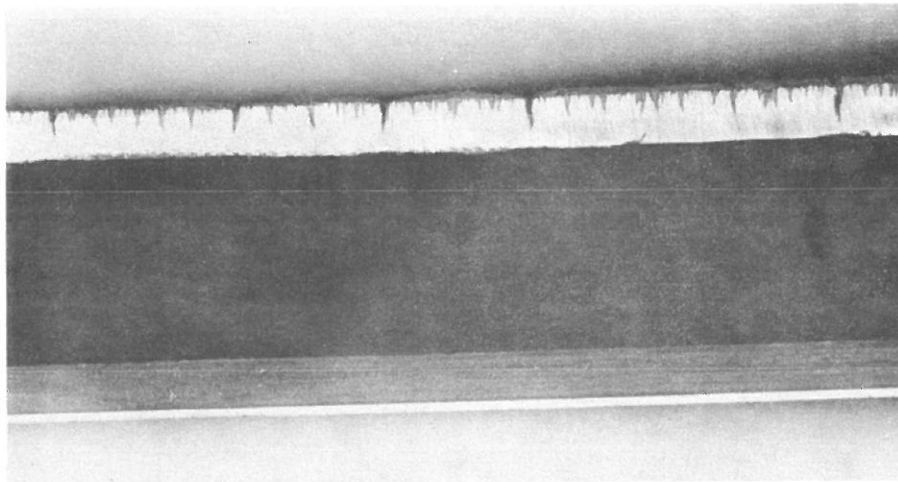
Figure 4 shows a longitudinal section of a failed furnace tube of a coal fired boiler. Table III lists the composition of the scale deposit.

*Figure 4 Longitudinal Cross Section of a Furnace Wall Tube From a Coal Fired Boiler. Note the Deep Penetration of Sulfide Corrosion Products Into the Tube Wall.*
