**BOILER CONDITION ASSESSMENT AND RETROFIT PROGRAM AT  
SIERRA PACIFIC POWER'S TRACY STATION, UNIT NO. 2**

**Brent Higginbotham  
Sierra Pacific Power Co.**

**Daniel P. Hurley  
and  
James P. King  
Riley Stoker Corporation**

**Presented at the  
Power-Gen 90 Conference  
Orlando, Florida  
December 4-6, 1990**

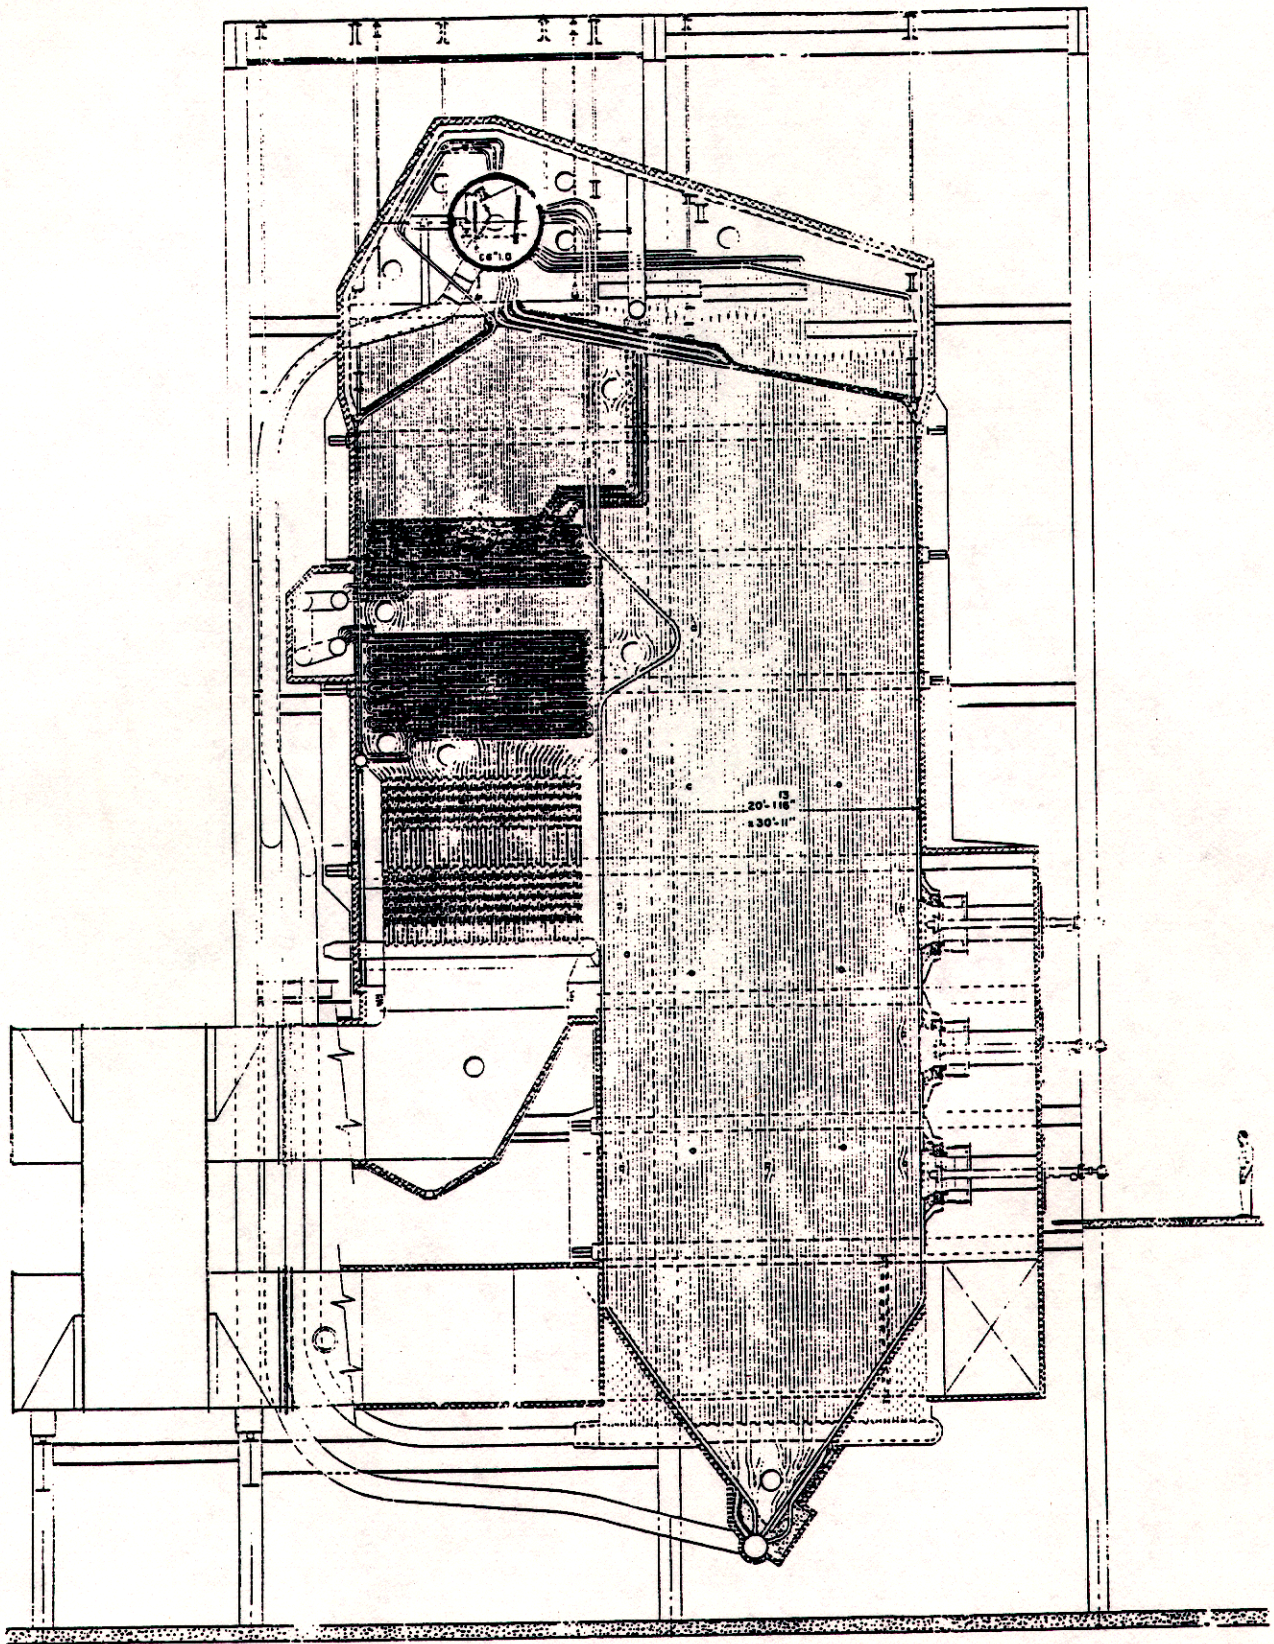
The boiler is a Riley balanced draft, natural circulation unit, 700,000 lb.hr (750,000 lb/hr - 4 hr. peak), capacity and 1400 psig, 950°F design outlet steam conditions. The boiler originally had tangent tube and tile construction with a welded casing. A side view of the original unit is shown in Figure 1.

Fig. 1 — Original Boiler Side View

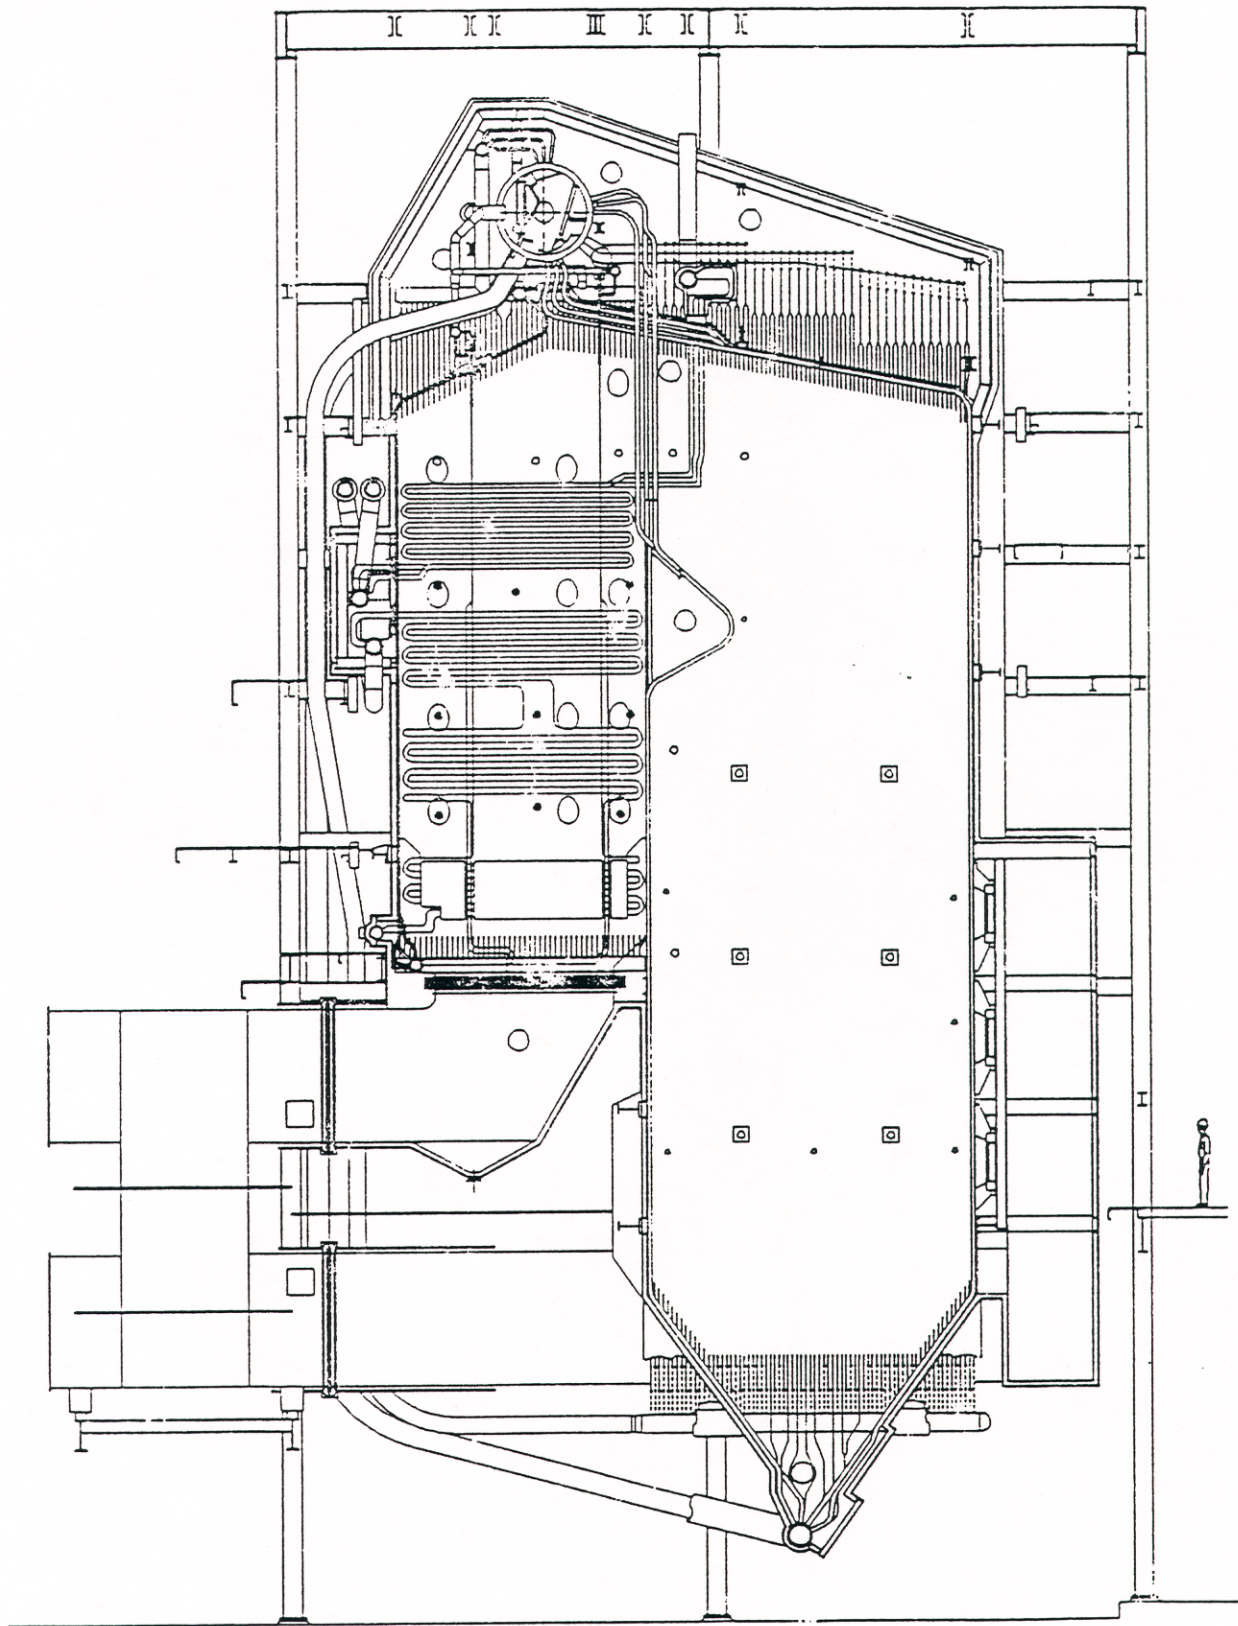
Riley Stoker Corporation was awarded both the design and erection contracts on a competitive bid basis. The table below presents the design changes incorporated in the new economizer and superheater. Figure 2 shows the changes in the design of the restored unit.

Fig. 2 — New Side View

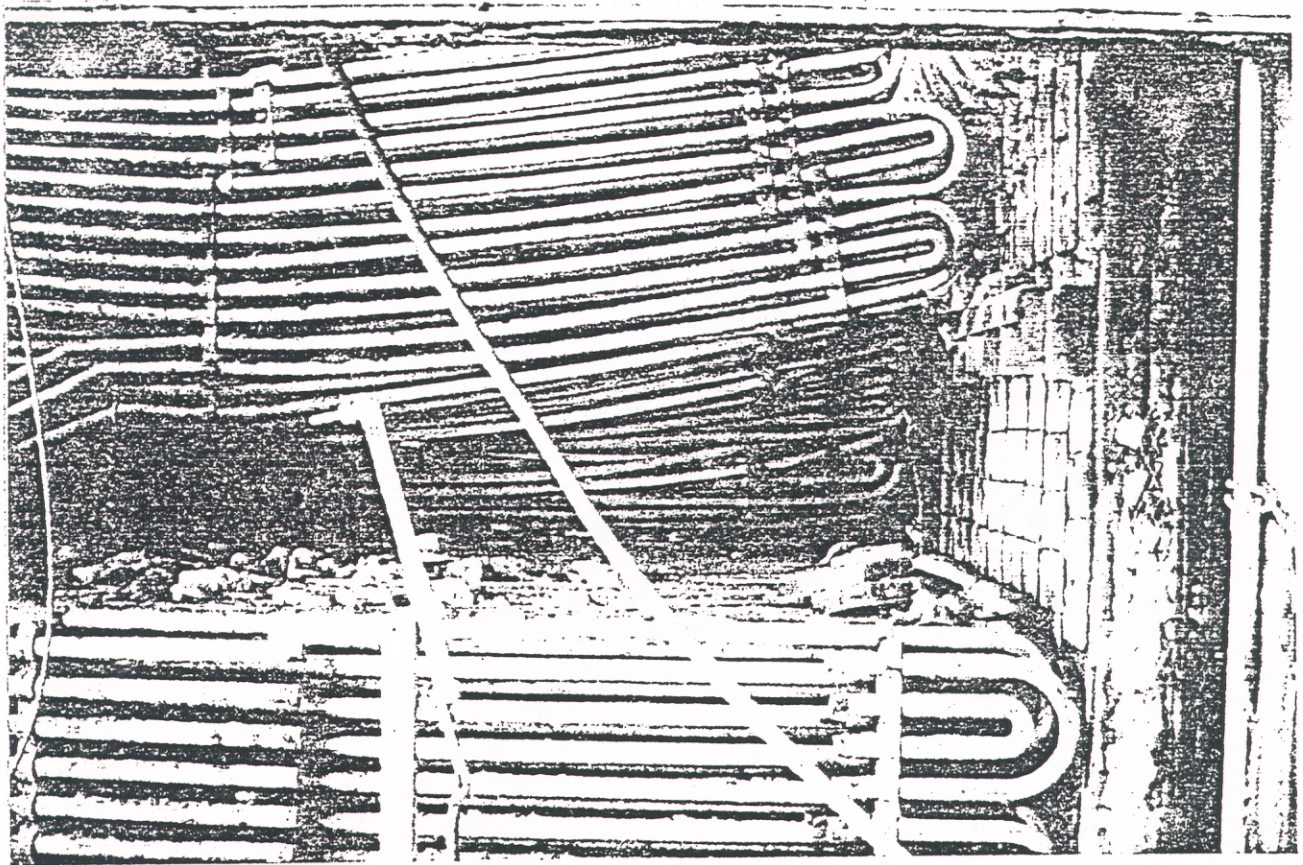
The final report concluded that the Tracy Unit No.2 boiler was in reasonably good condition considering the twenty-two years of essentially cyclic operation. Based on the visual inspection, there were a number of problem areas where the physical condition had deteriorated. These included extensive damage due to overheating of casing and insulation on the side and rear convection walls, sagging of the high temperature super-heater elements, bowing of the economizer elements, internal cracking in the economizer inlet header and cracking of the airheater support members. The metallurgical analysis confirmed that the high temperature super-heater tube sample was completely spheroidized indicating long term exposure to elevated temperatures.

Riley completed boiler demolition early. This work involved removal of all superheater and economizer surface in the convection pass between the economizer feed pipe and the high temperature superheater outlet pipe. Structural steel, suspension level steel, headers, partial roof panels and side and rear wall panels were removed. The Figure 3 photo

graph shows the condition of the secondary superheater just prior to its removal.

Fig. 3 — Side View of Sagged Superheater Tubes

- Replace the convection pass tube and tile walls with membrane wall construction to eliminate the excessive maintenance in this area.
- Replace the high temperature superheater and upgrade to stringer tube supports. Replace the secondary superheater inlet and outlet headers. Upgrade the outlet header to SA335-P22 material.
- Replace the primary superheater and upgrade to stringer tube supports. Upgrade the outlet header to SA335-P11 material. Replace the crossover piping and attemperator.
- Replace the economizer and inlet header. Upgrade the economizer to a stringer tube support for the primary and secondary superheaters. Locate the inlet header outside the convection pass to reduce thermal shocking during hot restarts.
- Design an economizer trickle feed system for supplying flow to the economizer during startup to prevent steaming and reduce thermal shocking.

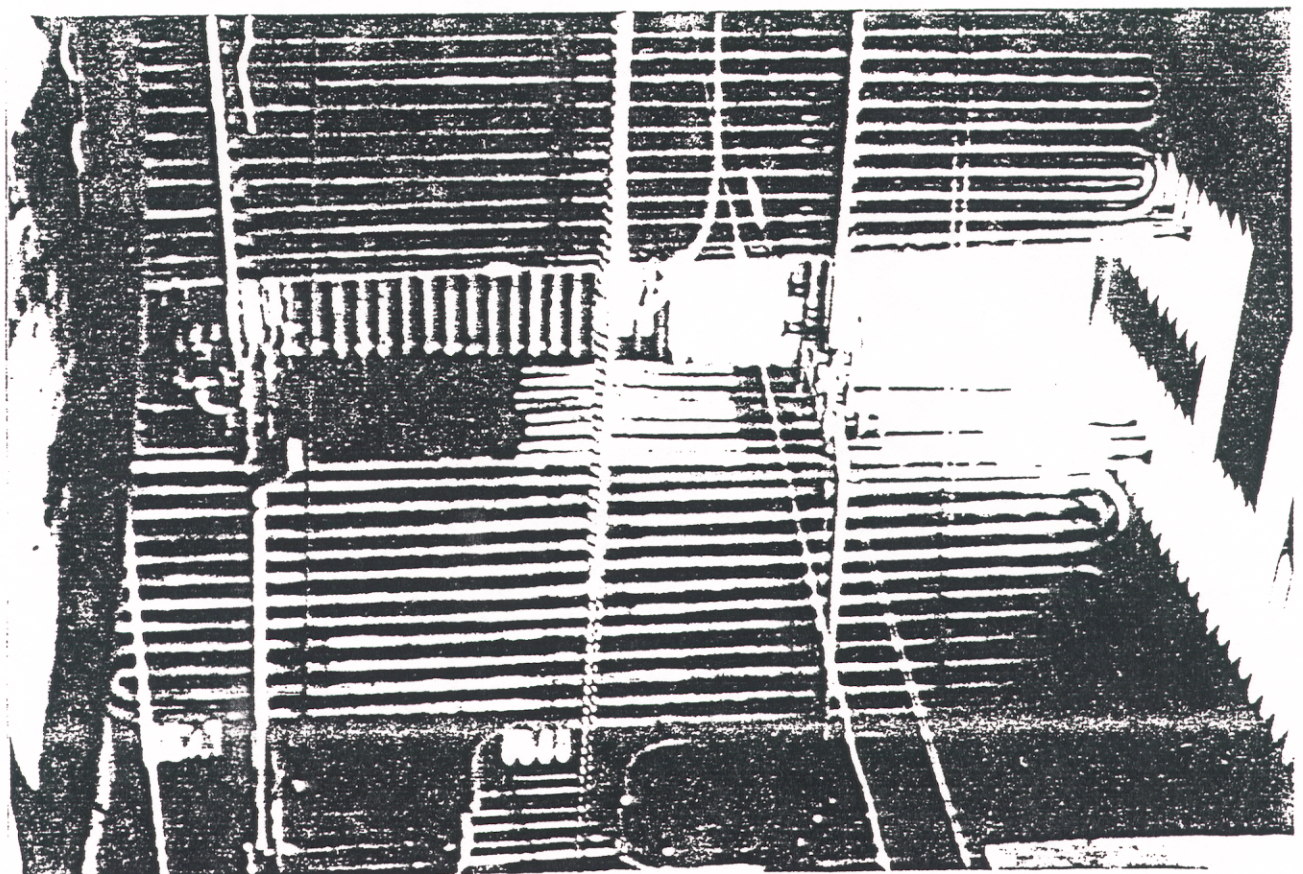
furnace screen work was sequenced before the high and low temperature superheater and economizer elements could be **hung** out in the convection pass cavity. Figure 4 shows the installation of superheater and economizer elements in the convection pass cavity. A window was cut in the new rear wall through which all remaining materials were fed.

Fig. 4 — Front View of Sagged Superheater Tubes
