Characteristics of Water-Side Deposits in Boiler Tubes

David P. Kalmanovitch
RILEY POWER INC.
a Babcock Power Inc. company
(formerly D. B. Riley, Inc.)

Presented at
POWER-GEN '94 Americas
Orlando, Florida
December 8, 1994

RST-136

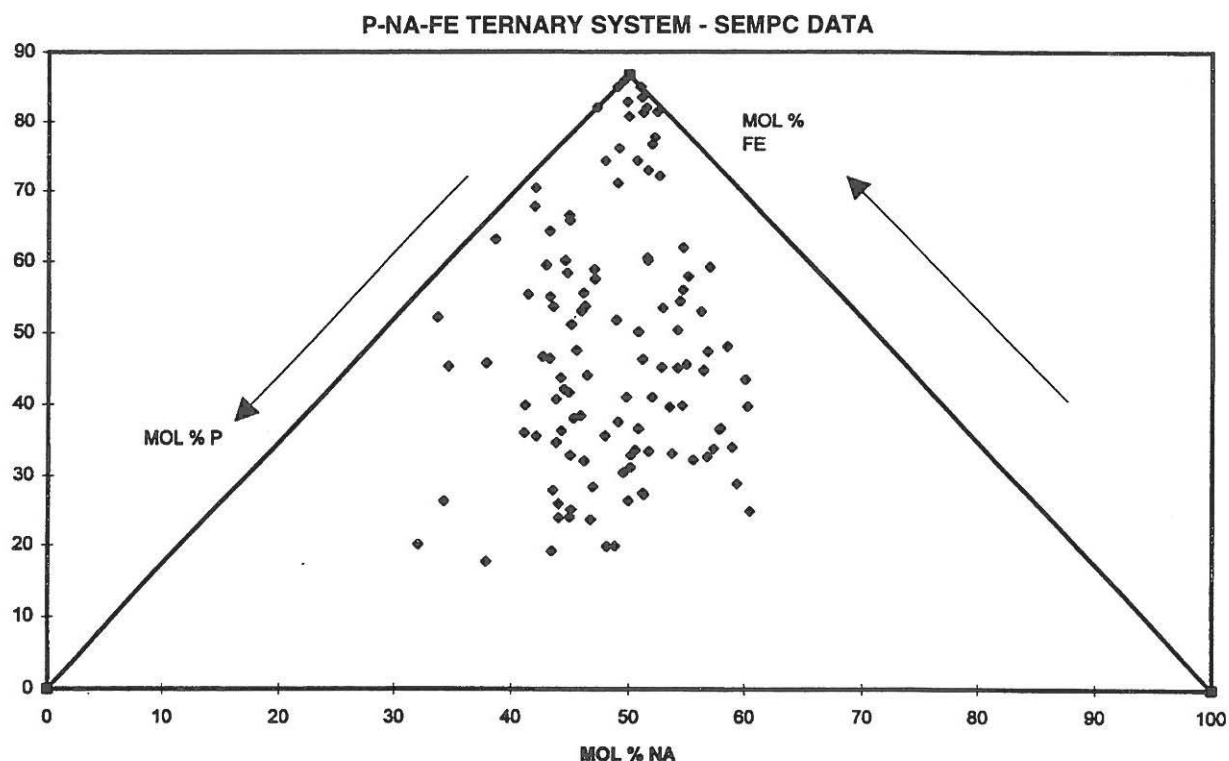
Table 1 lists the phases observed in the deposit as determined by SEMPC. The major phase identified, as expected, was iron-based. The chemical composition of the deposit is listed in Table 2 and is derived from the averaging of all points analyzed. Also listed in Table 2 is the average composition of selected groups of phases including the unclassifieds. Examination of the data shows that the unclassified points were rich in sodium and phosphorus. Indeed, further evaluation revealed that a significant proportion of the points analyzed were predominantly iron, manganese, phosphorus, and sodium. Figure 1 shows a ternary graph of these three components of the points where $\text{Na} + \text{P} + \text{Fe} + \text{Mn} > 85\text{wt.}\%$ (on oxide free basis). These points were then examined to determine if there was a relationship between these components. This was achieved by converting the weight percent values as obtained from the SEMPC data to normalized three components on a molar basis. The use of mole concentrations is necessary in order to establish if there is any type of stoichiometry in the system. Representation of the data can be done in many ways, other graphs could be used to represent the relationship between the $\text{Mn} + \text{Fe}$ versus Na and P . The results show

Figure 1 Ternary diagram representing the molar relationship between Iron - Phosphorous - Sodium in a deposit based on SEMPC data

that there was extensive interaction between the iron, phosphorus and sulfur. Indeed, all the points were rich in iron with on pure sodium phosphate phases observed (these phases would be represented by points along the x axis). The data also shows that the deposits were rich in sodium and may have had the potential to cause caustic attack.

The results of the analysis indicated to the utility the need to assess current water chemical treatment processes and the need to detect and remove areas affected by hydrogen dam-

age. The data showed that while they changed from a phosphate-based treatment process, the deposits were phosphate rich. In many cases where there has been a switch to a different treatment the location, extent, and chemistry of the deposits are changed. Similar analysis of intact tube samples were recommended to determine if the modifications in the treatment program had resulted in improved deposit characteristics.

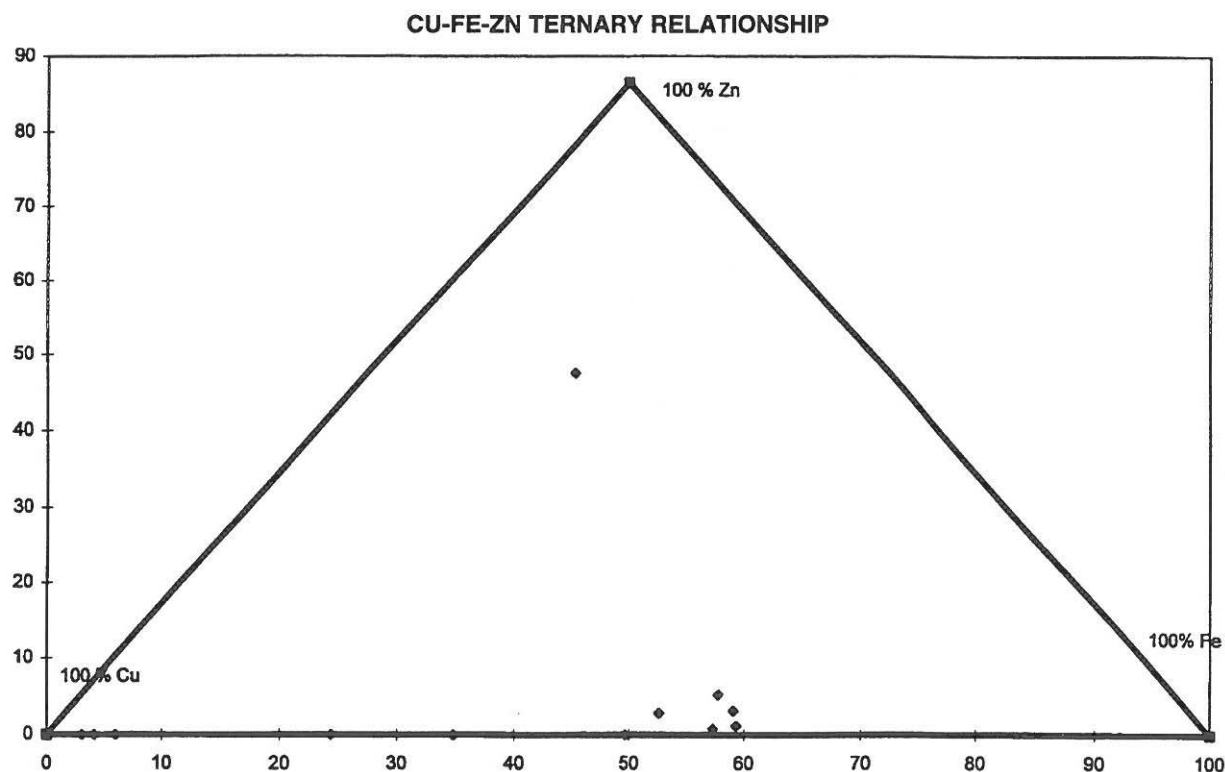
Of interest was the potential effect of the copper and zinc in the deposit on the hydrogen damage. Figure 2 shows the relationship between copper, zinc, and iron for the points containing these components. It can be seen from the ternary diagram that there was extensive interaction between the copper and iron but limited interaction between iron or copper with zinc.

Figure 2 Ternary diagram representing the molar relationship between Iron - Copper - Zinc in a deposit based on SEMPC data

The results of the analysis showed that the deposit present in the region with hydrogen damage was a complex mixture of iron oxide, calcium rich-phases, and iron/copper rich points. Based on the information obtained it was recommended to the utility to chemically clean the boiler, review water chemistry, and continue monitoring tube deposit characteristics.
