**CONDITION ASSESSMENT PROGRAMS FOR
BOILER AND PIPING COMPONENTS AT THE
BIG CAJUN II POWER STATION**

Presented at the
POWER-GEN '97 International Conference
November 9-11, 1997
Dallas, Texas

RST-149

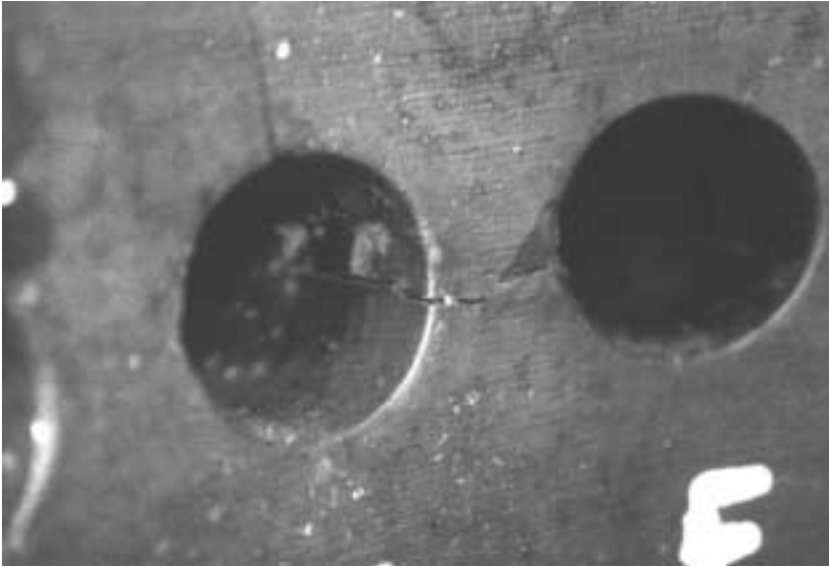
The original cracking in the Unit No. 1 header bore holes and ligament fields was attributed to the combined effects of creep and fatigue. Figure 2 shows the I.D. cracking. This damage had mostly occurred in the early years of operation, due to recorded over temperature conditions and many cold start-ups due to an excessive number of boiler trip events.

Figure 2 Unit No. 1 radiant superheater outlet header ligament cracking

As noted earlier, the first serious problems, internal cracking in a radiant superheater outlet header, were found in the fall of 1992. The two outlet headers on the Unit No. 1 boiler were replaced in the spring of 1993.

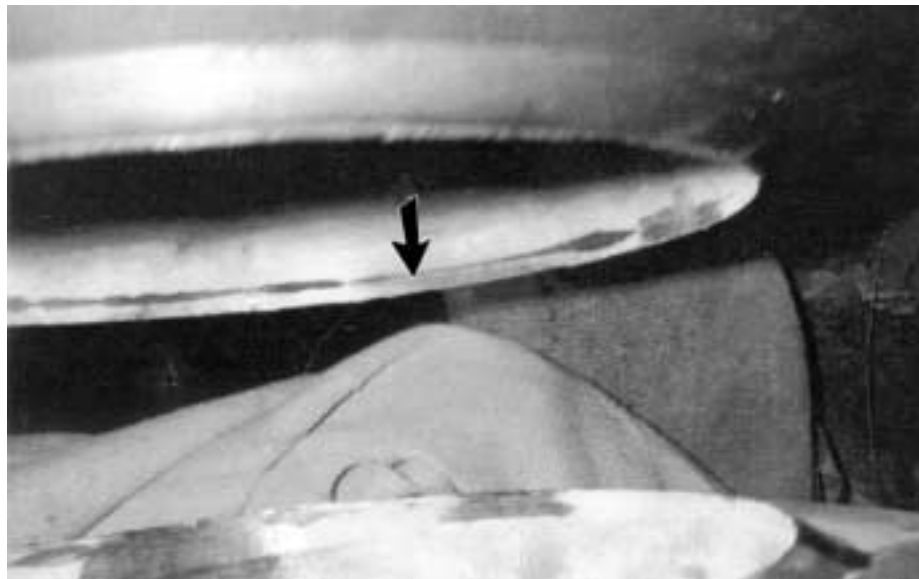
During the spring 1993 condition assessment program on the Unit No. 1 boiler, additional problems were found in the radiant superheater crossover piping components. These included visible crack indications in the existing weld prep regions of the four crossover piping lines at the new radiant superheater outlet header nozzles. In addition, radial crack indications were found in the internal bore holes of the four pipes at threaded locations for radiographic plugs. Figure 3 depicts a plan view of the crossover system, and Figure 4 shows the cracking in a pipe weld.

Figure 4 Photograph of the dye penetrant test indicating the crack in the circumferential weld of the radiant superheater outlet piping

All of these instances of cracking were attributed to thermal fatigue and over temperature conditions experienced by the components early in the life of the boiler. Because of the higher temperatures experienced by the radiant superheater components, spray stations were added to the primary superheater systems soon after the boilers first went into service.

Cracking was also identified in the circumferential welds in elbows between the outlet header nozzles and the downstream attemperators. Cracking was repaired in all of the aforementioned locations. Minor crack indications were also found in the attemperator

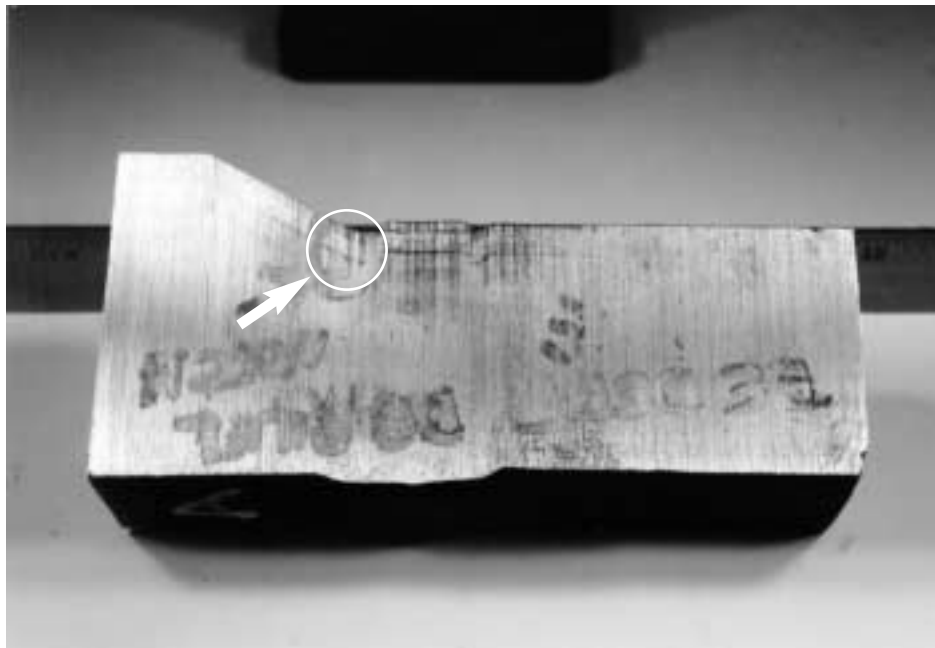
A detailed metallurgical and stress analysis study to more accurately determine the cause of this component cracking was performed by DB Riley for Cajun Electric. The Reference (4) report addresses this study. The ID indications, in the sample weldments, were found to be thermally assisted fatigue cracks. They were located on the inside surface at base metal sites with geometric discontinuities. There was no evidence of creep damage or microstructural overheating in the metal specimens. The depths of the cracks were found to be less than originally estimated by the ultrasonic testing. See Figures 6 and 7. In the laboratory, some weld locations were found to have bands of stringer inclusions, which were present in the original material. These are not detrimental, but may be the cause of false indications in the field ultrasonic testing.

Figure 6 View of the cut cross sectioned surface showing the location of the crack at the taper transition at the ID of the elbow

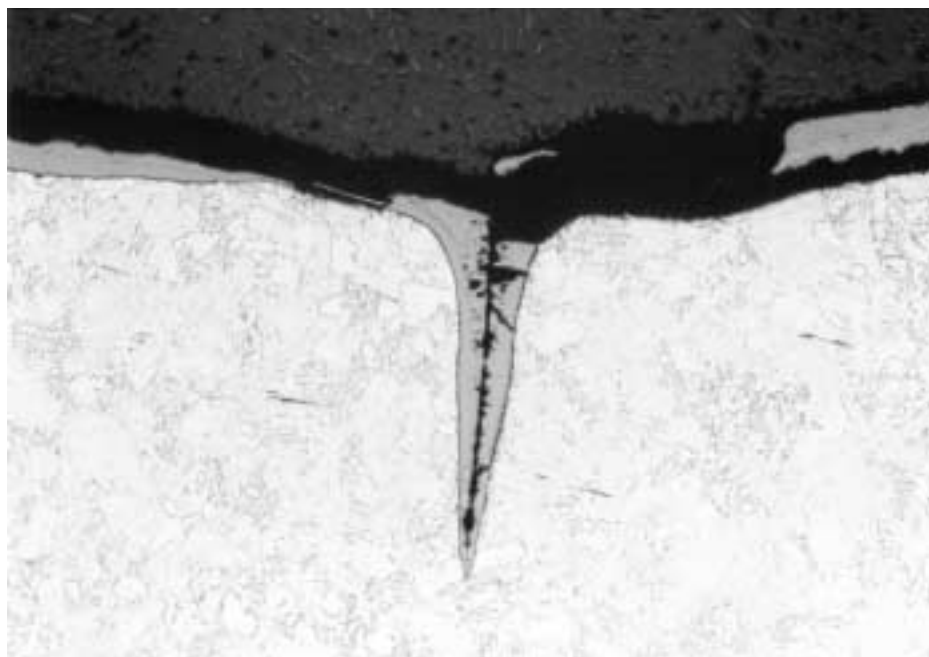
Figure 7 The oxide filled crack at the ID surface. The crack is a thermally-assisted fatigue crack measuring 40 mils deep. Stringer inclusions can also be seen beside the crack

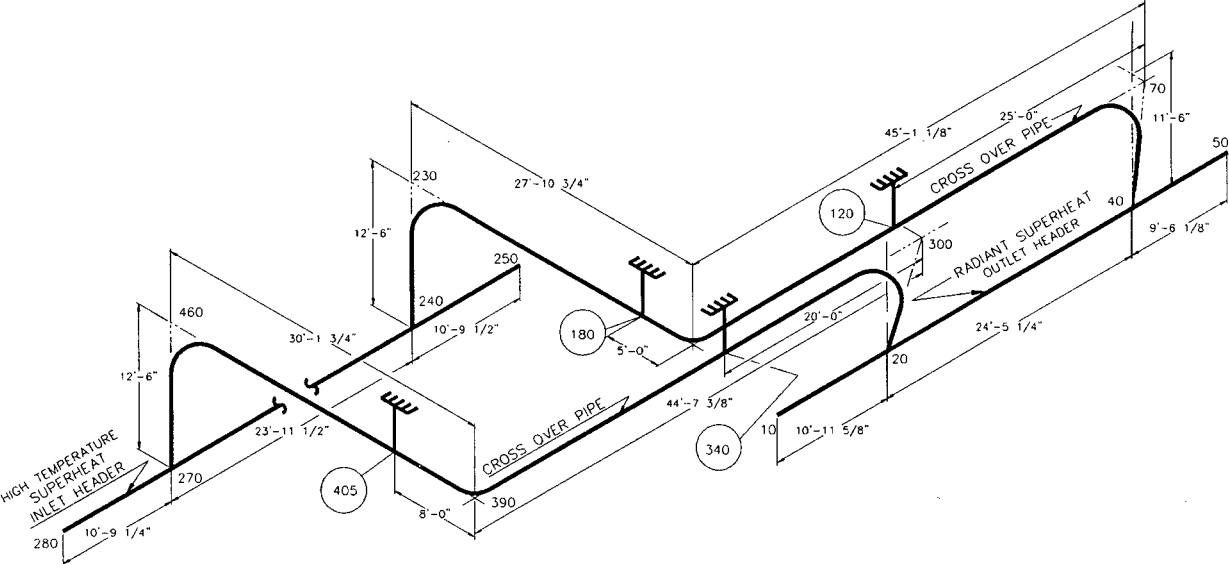
Stress analysis cases were run for a computer model of the crossover piping system, which includes the radiant superheater outlet and high temperature superheater inlet headers. See the Figure 8 schematic drawing of the piping model. The results of the stress analysis cases shows that under normal operating conditions, and even for a higher temperature (upset) condition, the piping system loadings satisfy the requirements of the ASME B31.1 Power Piping Code, Reference (5). However, when the model was run with non-functioning supports, then the maximum stresses exceeded the code allowables.

Figure 8 Piping model developed for the radiant superheater crossover piping analysis

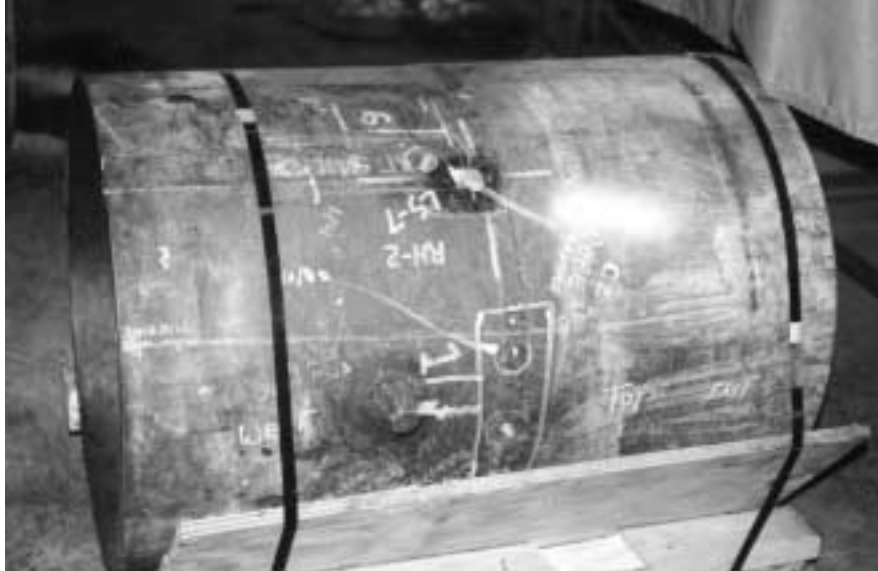
The condition assessment of the steam piping was begun on the Unit 1 lines during the 1993 spring outage. During the Unit No. 1 1995 fall outage, some indications were identified by ultrasonic shear wave testing, and surface creep damage was observed by metallographic replication, in portions of the long seam and girth welds of the hot reheat piping in the turbine building. These findings resulted in the removal of plug samples for metallurgical evaluation. In lieu of performing weld repairs to the piping, a three foot long piece of the hot reheat piping was removed for a comprehensive analytical testing program. The spool piece was cut eighteen inches on each side of a circumferential weld, and contained two offset portions of long seam weld. See Figure 11. The results of this program are presented in detail in the Reference (6) and (7) documents, and are summarized herein, as follows.

Figure 11 Hot reheat piping spool piece removed for testing and analysis.

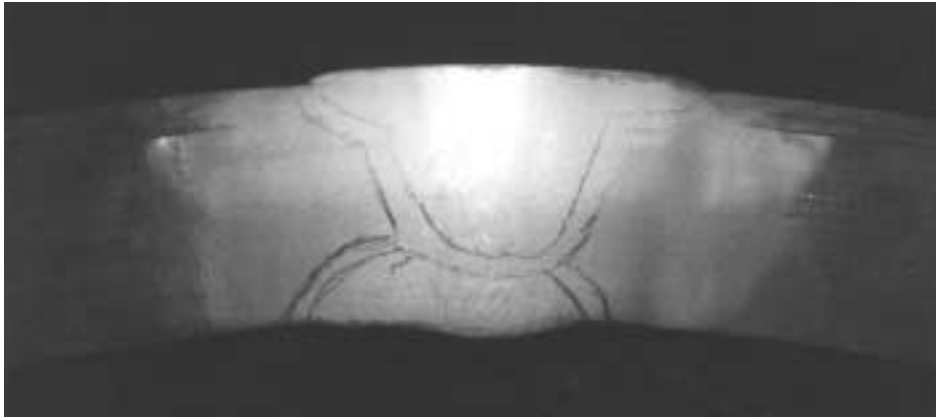
- Visual inspection yielded no evidence of gross defects in the spool piece. Unlike the inherent limitations of *in-situ* inspection of piping, laboratory analysis offered the obvious advantage of being able to examine the internal surface of the spool piece, by visual, nondestructive and destructive techniques. Figure 12 shows a macroetched end view of the spool piece including the longitudinal weld profile. The most significant finding was the presence of a non-uniform counterbore at the I.D. of the girth weld (it does not go completely around the circumference of the pipe). This discontinuity was introduced during joint preparation of the pipe ends prior to welding. This indication was initially identified as a crack indication,

both by ultrasonic testing (UT) and radiography (RT), since the internal surface of the pipe could not be seen in the field.

Figure 12 Image of the macro-etched end of the hot reheat piping spool piece. The etching identifies the asymmetry of the double-V seam weld.

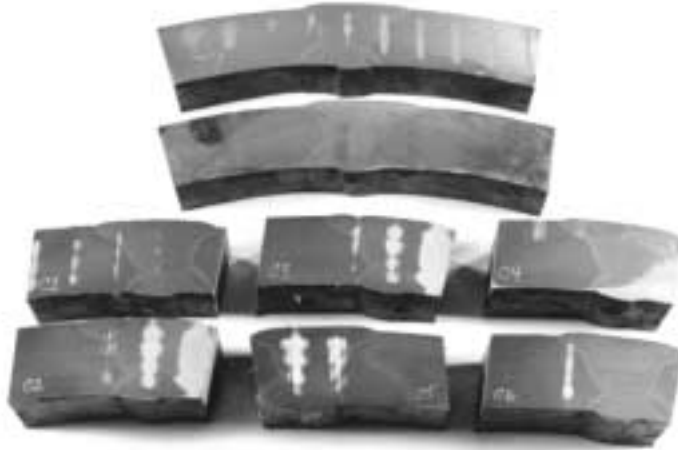
- The creep-crack-growth model shows that the average operating pressure of 509 psig and temperature of 1001°F for this steam piping are reasonable based on the parameters of the specimens tested and operational data reported. The speci-

mens prior to testing are shown in Figure 13. Adequate remaining life is expected under steady-state conditions and in the absence of material flaws or sustained, undue operational loading.

Figure 13 Photograph of the varied spool piece specimens used in testing and analysis
