**CURRENT EXPERIENCE IN  
TYPICAL PROBLEMS AND FAILURES WITH  
BOILER PIPING COMPONENTS AND SUPPORTS**

James P. King, Design Manager  
DB Riley, Inc.

Presented at the  
1998 ASME Pressure Vessels and Piping Conference  
San Diego, California  
July 26-30, 1998

RST-152

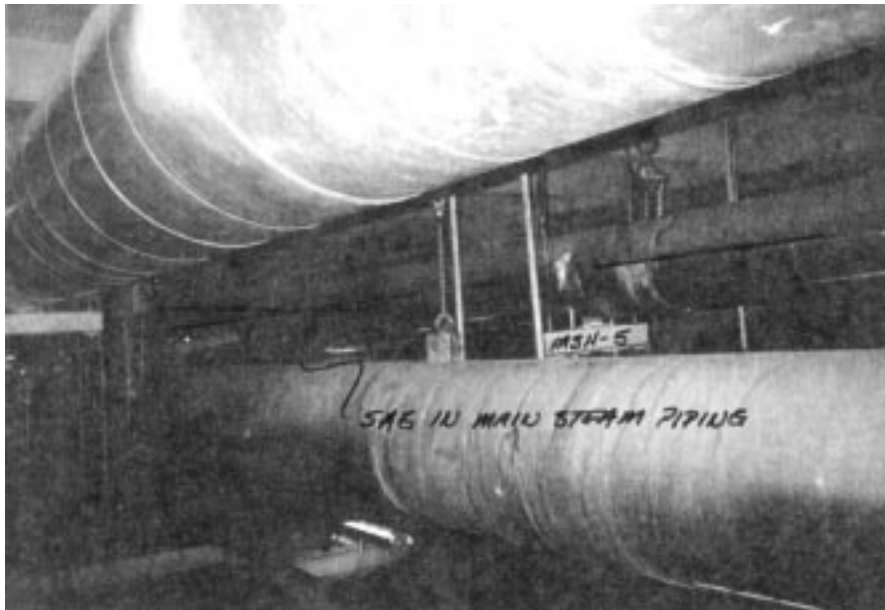
Both hot and cold walkdowns of the piping system were performed. Several anomalies were visually apparent. First, sagging was evident in the lower section of a long horizontal run of piping. The maximum amount of sag was later measured to be seven inches. (See the Figure 1 Photograph). Nondestructive testing tasks, including metallographic replication, were performed on the outside surface of the sagged portion of pipe. They revealed a more advanced stage of spheroidization than at other piping locations. However, there was no evidence of creep damage, loss of hardness, or component thinning. A near term recommendation was given to monitor the condition of the sagged portion of piping, including the taking of a core sample at this location, in order to record the microstructural and surface conditions on the inside of the component.

*Figure 1 Main steam piping general view of sagged horizontal portion.*

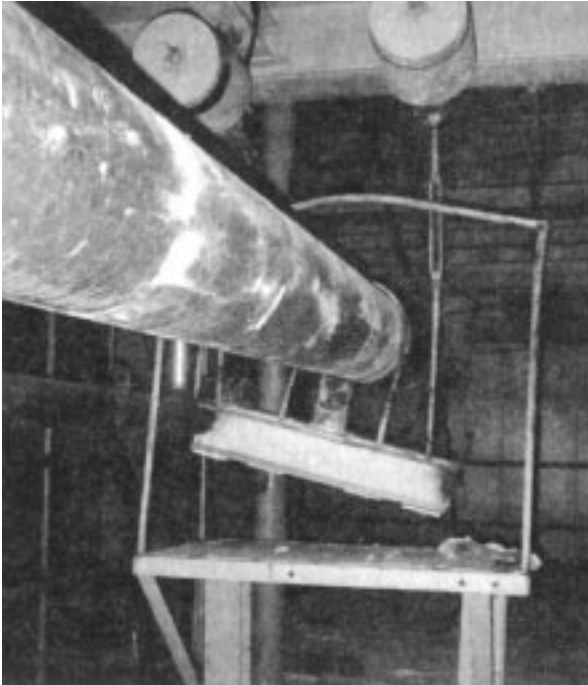
A second finding was the current overall condition of the support system of the main steam piping line. Several hangers were visibly damaged, and others had setting indications which showed the support to be malfunctioning or bottomed out. Of particular concern was the three pairs of dual constant force support assemblies, on the horizontal run of pipe, which were found to be skewed from the normal horizontal and vertical axes, in both the hot

*Figure 2 Main steam hanger in cold condition. View shows the severely skewed support which indicates that the constant supports are not functioning properly.*

and cold conditions. (See Figures 2, 3, and 4 Photographs). Recommendations were given for a re-evaluation of the main steam piping hanger system to ensure its integrity, and for repair or replacement of hangers/supports, as necessary, to assure that they are carrying their design loads.

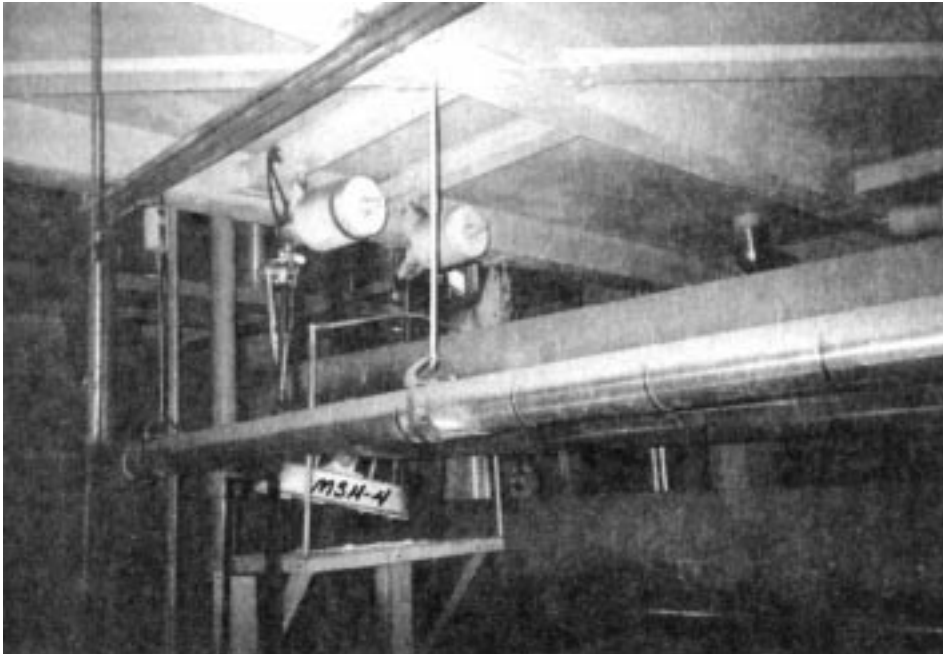
*Figure 3 Main steam line. Constant force supports in hot condition. It can easily be seen as skewed.*

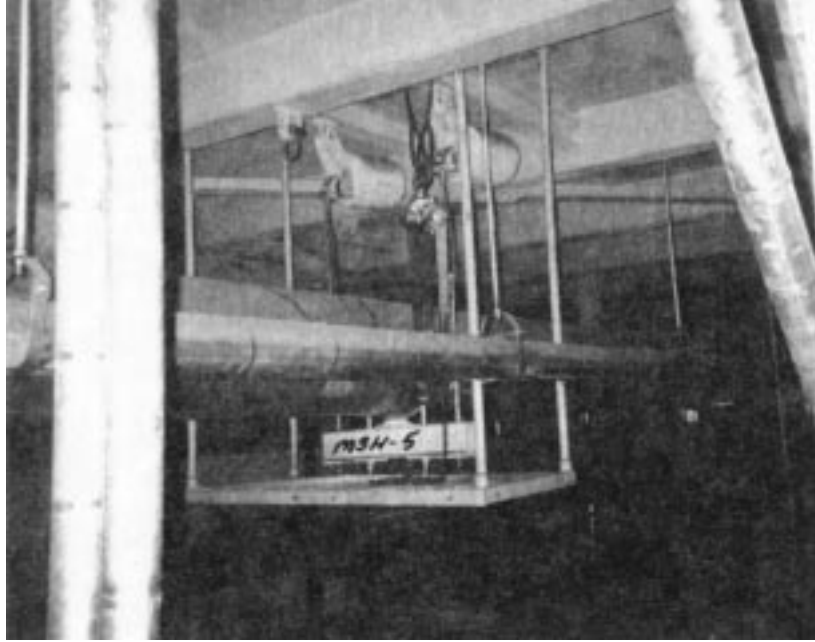
*Figure 4 Main steam constant force support in hot condition. They are also damaged and observed to be skewed.*

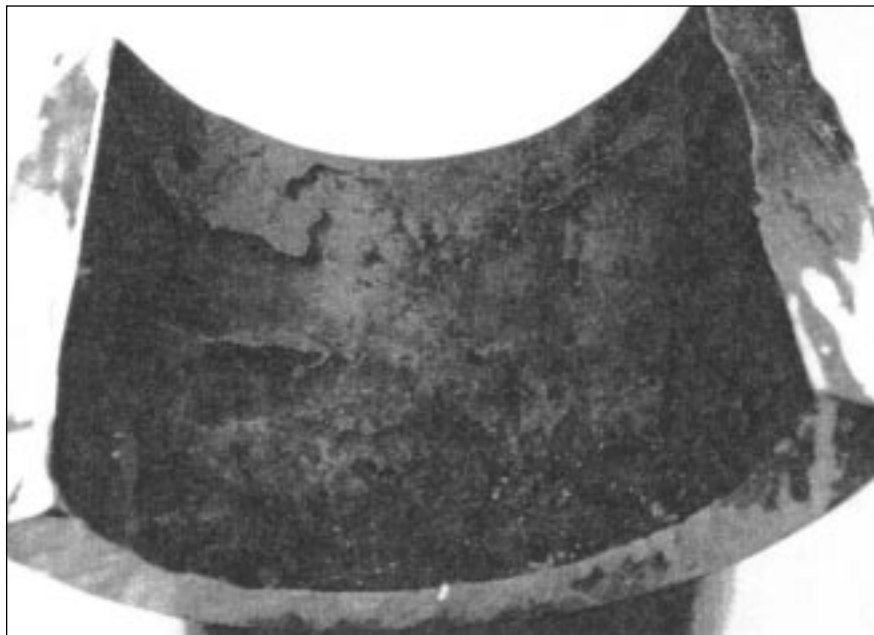
*Figure 6 Typical example of a piping section with evidence of flow accelerated corrosion on the inside surface.*
