**EVALUATION OF  
HOT REHEAT STEAM PIPING,  
INCLUDING A TEST SPOOL PIECE,  
AT THE BIG CAJUN II STATION**

Presented at the  
POWER-GEN'96 International  
December 4-6, 1996  
Orlando, Florida

RST-144

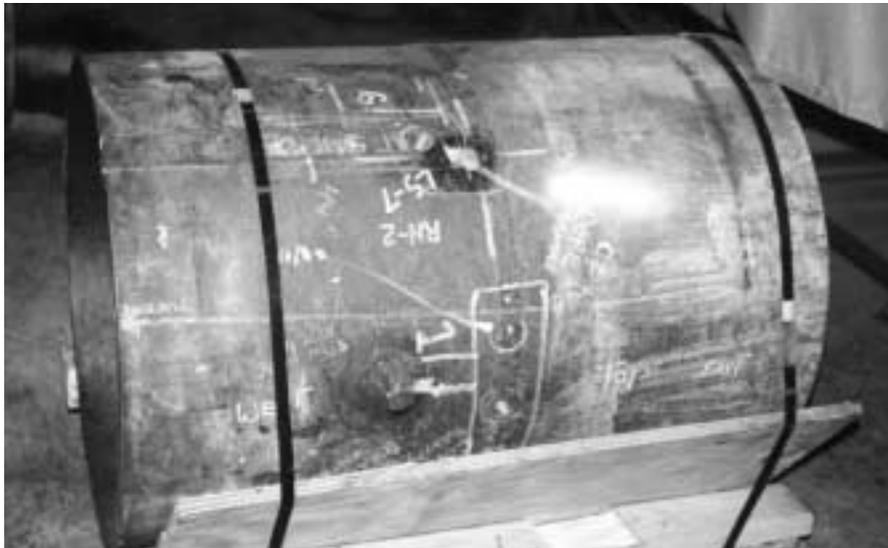
*Figure 1a The Spool Piece As-received From the Hot Reheat Line at Big Cajun II Unit No. 1, Showing the Downstream Portion of the Seam Weld and the Locations of the Plug Samples in the Longitudinal and Circumferential Welds.*

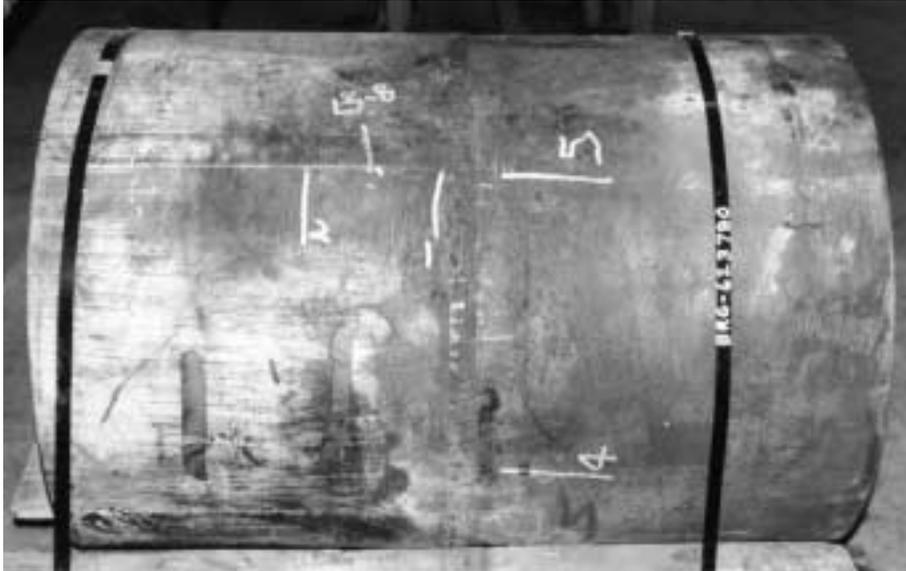
*Figure 1b Photograph of the Spool Piece As-received From the Hot Reheat Line at Big Cajun II Unit No. 1, Showing the Upstream Leg of the Long Seam.*

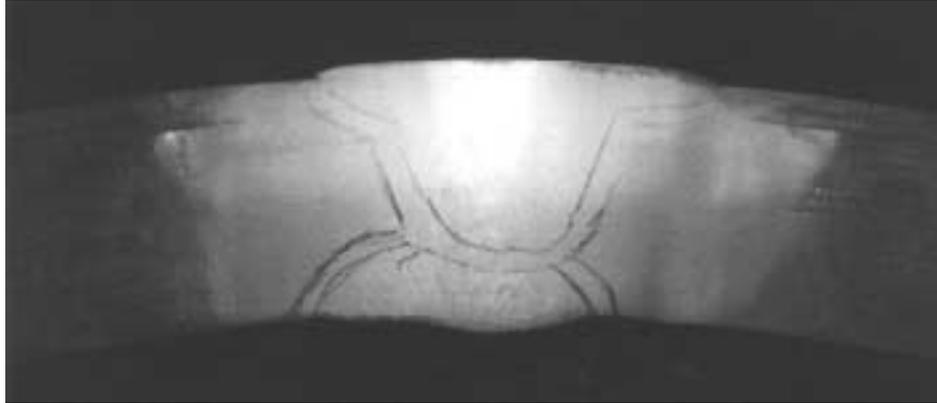
The downstream end of the spool piece was polished and etched to reveal the weld profile of the longitudinal seam weld to facilitate the UT inspection (Figure 3). The double-vee geometry was seen and the cusp located approximately 3/8" from the I.D.

*Figure 3 Macroetched, Cut End of the Downstream End of the Spool Piece, Showing the Asymmetry of the Double-V Seam Weld.*

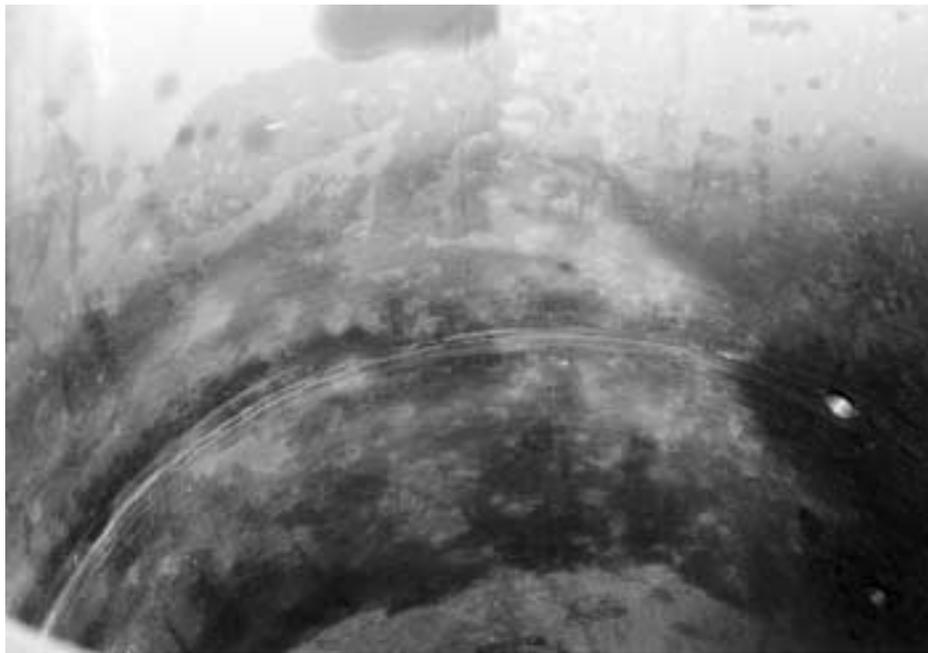
The internal surface of the pipe was covered with a layer of magnetite 7 to 10 mils thick. No visual evidence of unusual corrosion or erosion was found. A discontinuity in the joint preparation of the girth weld was also observed at the I.D. of the pipe. The end preparation shows a non-uniform counterbore on the upstream side of the weld (Figure 4). This observation is significant because an unanticipated geometric discontinuity could provide false indications during UT inspection, particularly since it would not be indicated on the original spool piece drawings.

*Figure 4 Internal Surface of the Spool Piece Showing Nonuniform Counterbore on the Upstream Side at the Girth Weld.*

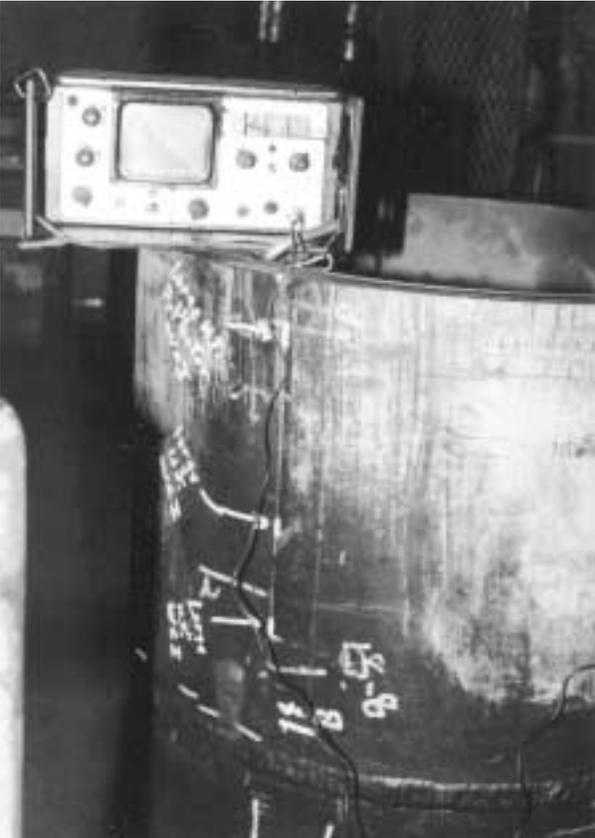
A recurring, linear indication was detected on one side of the upstream longitudinal weld (Figure 5a). The indication was found to be approximately 14" in length, starting at the top cut edge of the spool piece, with the signal trailing approximately 5" from the centerline of the girth weld. The indication was found with the 45° scan from the opposite side of the weld at a sound path of 3-1/2". The signal could not be displaced by repeated damping. Shallow, angled grinding of the weld toe at the top of the pipe resulted in the disappearance of the signal. Subsequent electropolishing and WFMT revealed no visual indications. A similar indication, only 1/4" in length, was found on the same side of the downstream longitudinal seam weld (Figure 5b). These indications were considered to be significant. A metallographic section was taken through the "upstream" indication for further analysis by optical microscopy.

*Figure 5a Upstream Leg of the Seam Weld Where a 14" Long Indication Was Seen on One Side of the Weld as Marked.*

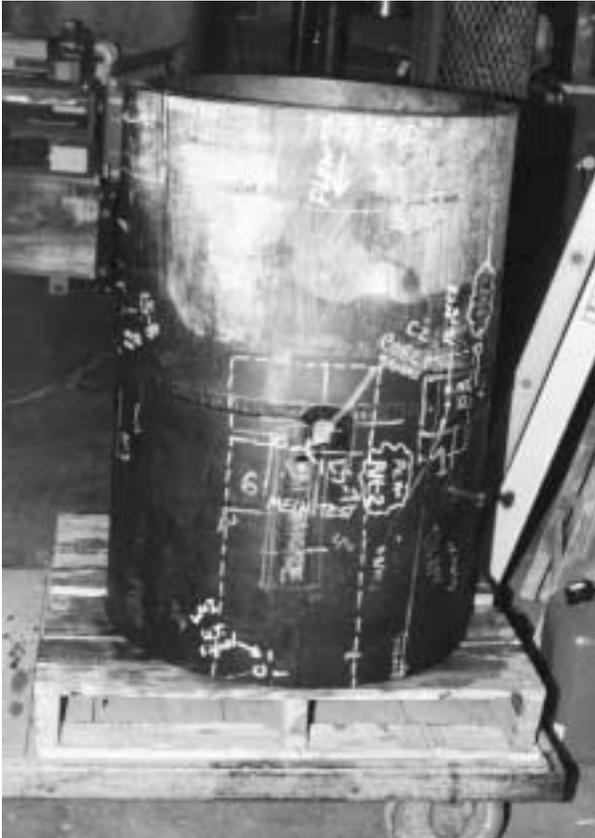
*Figure 5b Overview of the Spool Piece Showing the 1/4" Long Indication on the Downstream Leg of the Long Seam.*

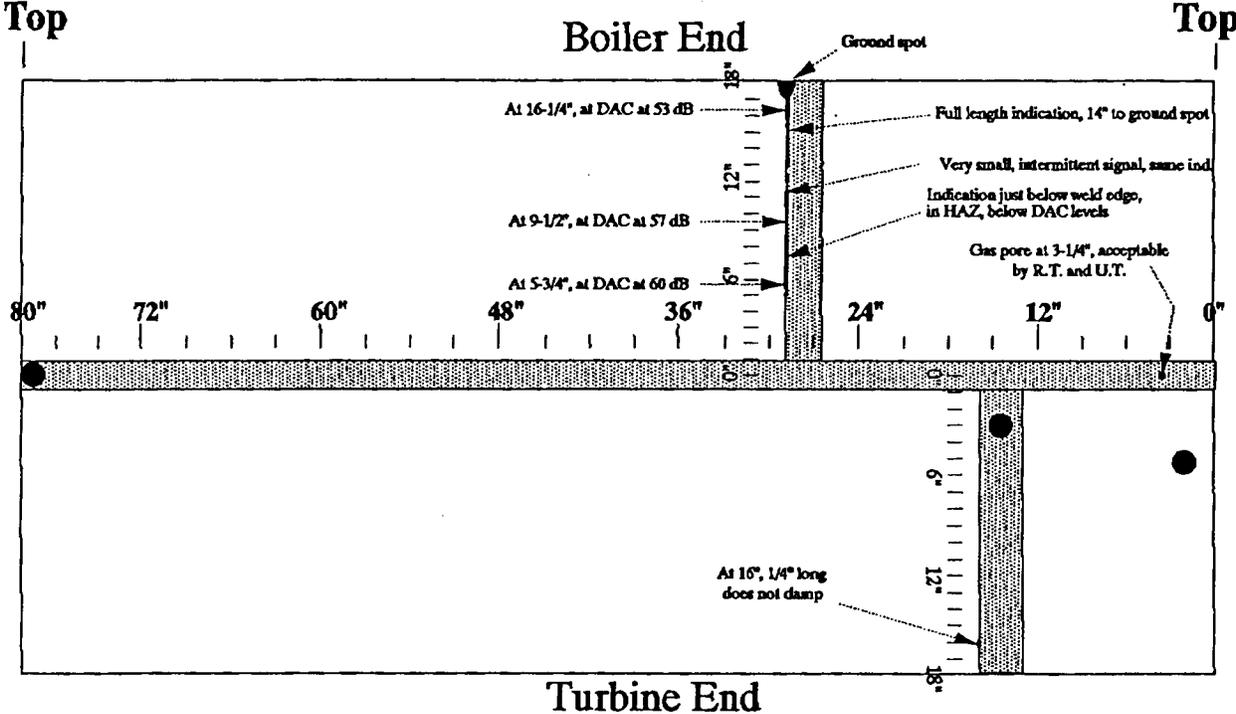
Figure 6 Sketch Showing the Locations of the UT and RT Indications on the Spool Piece.

The ultrasonic inspection of the girth weld showed one indication which was typical of porosity (Figure 6). This indication was found to be acceptable and would warrant no further action, as was also determined by RT. The non-uniform counterbore at the I.D. of the weld produced the appearance of a root signal, which could be clearly identified as an extraneous reflector because the surface distance (the distance from the exit point of the sound wave from the probe to the center of the weld) was too long to be in the weld zone. However,

A sketch which summarizes the results of the UT and RT inspections is shown in Figure 6.

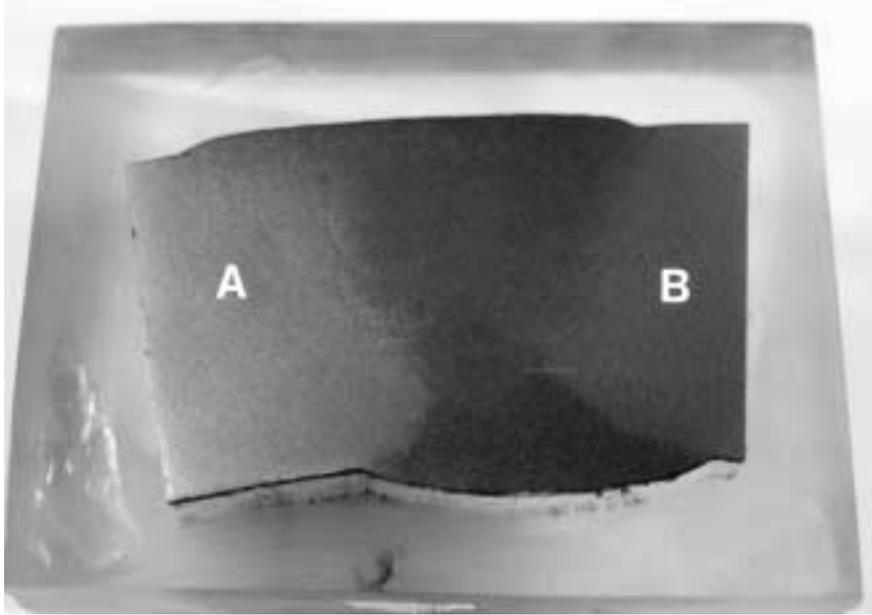
Photomicrographs of the two metallographic samples are shown in Figure 7. No obvious HAZ is seen for the longitudinal seam weld which indicates that it has likely been subject

*Figure 7a Photograph of Macroetched Metallographic Specimen of the Longitudinal Seam Weld*

to a post-weld normalizing heat treatment. In comparison, the HAZ is readily apparent for the circumferential weld which indicates that it has received a subcritical post-weld heat treatment.

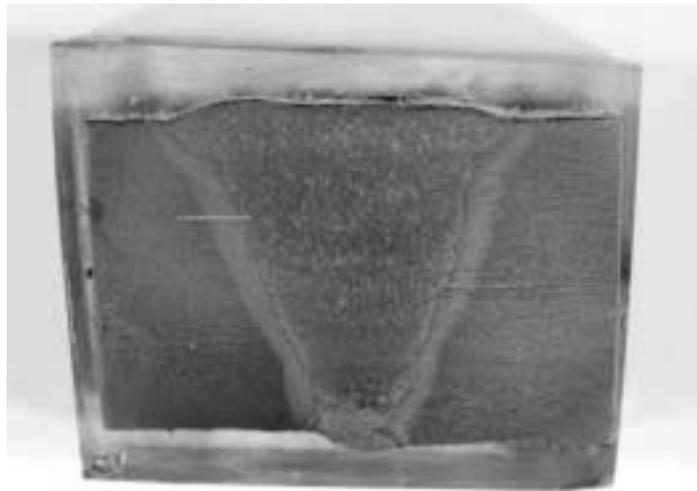
*Figure 7b Photograph of Macroetched Metallographic Specimen of the Circumferential Weld.*

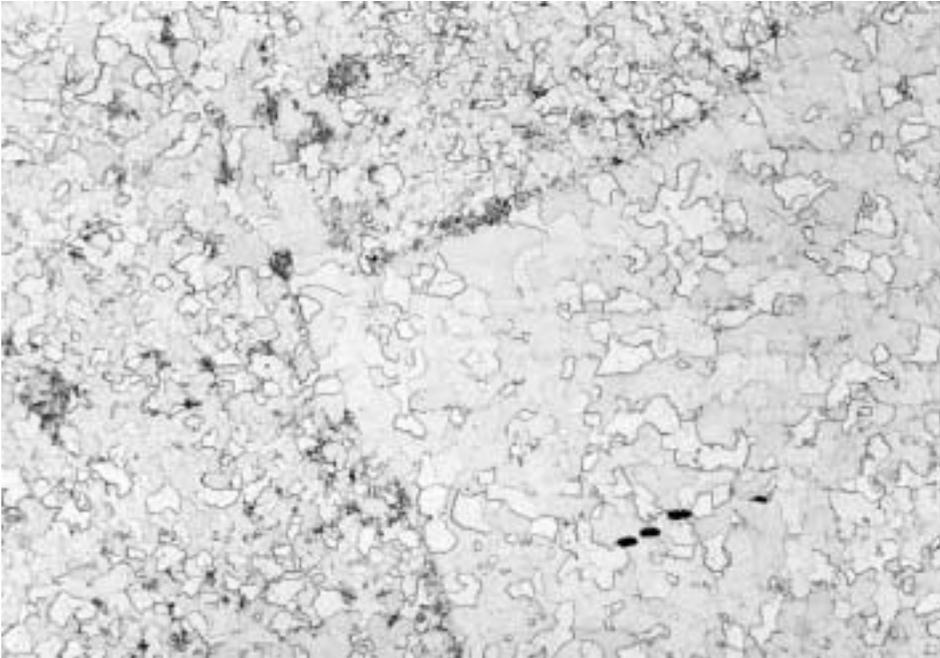
The microstructure of the longitudinal seam weld shows no evidence of creep damage at magnifications up to 1000X. A high density of nonmetallic inclusions was found along the fusion line of the weld, including in the cusp region (Figures 8a and 8b). Mild intergranular oxidation is present at both I.D. and O.D. surfaces. No evidence of gross weld defects was seen. The base metal consists of some lamellar pearlite and a dispersion of fine spheroidized

*Figure 8a Microstructure at the Cusp of the Long Seam Weld (50X)*

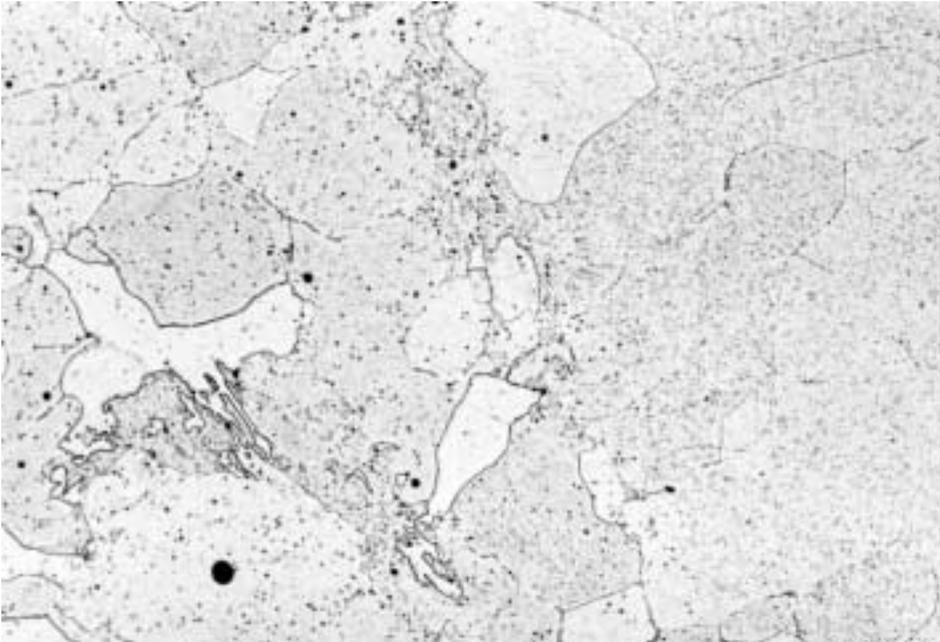
*Figure 8b Detail of the Cusp Microstructure Showing a Higher Density of Nonmetallic Inclusions in the Weld Metal (left) Compared to the Base Metal (right) (400X)*

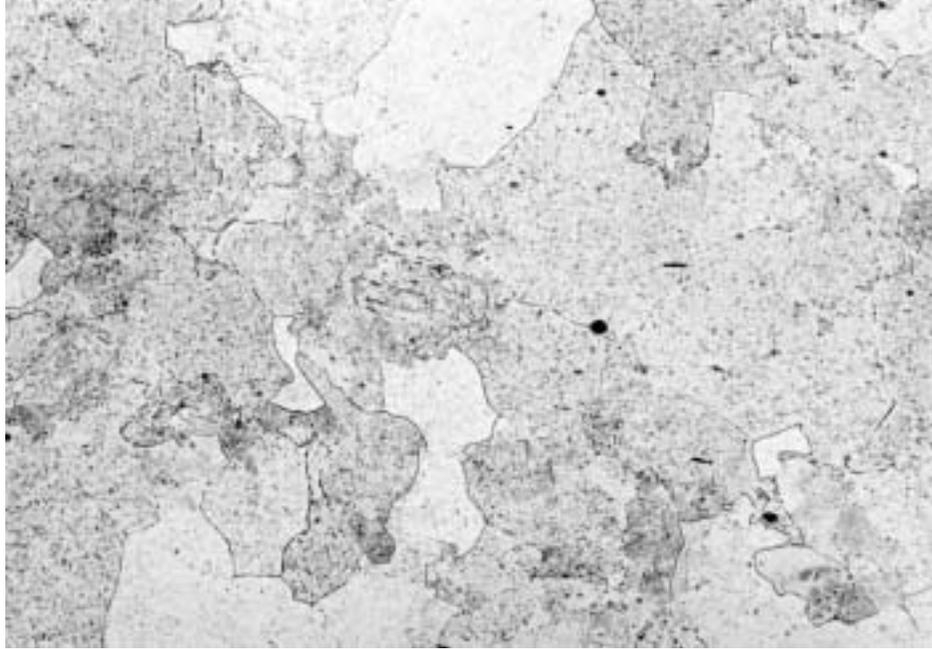
carbides in a ferritic matrix (Figure 8c). The presence of lamellar pearlite in the microstructure, typically seen in new material, indicates that the pipe base metal has not been significantly degraded by service temperatures.

*Figure 8c Detail of the Base Metal Microstructure Showing Some Lamellar Pearlite and Spheroidized Carbides in a Matrix of Ferrite. (400X)*

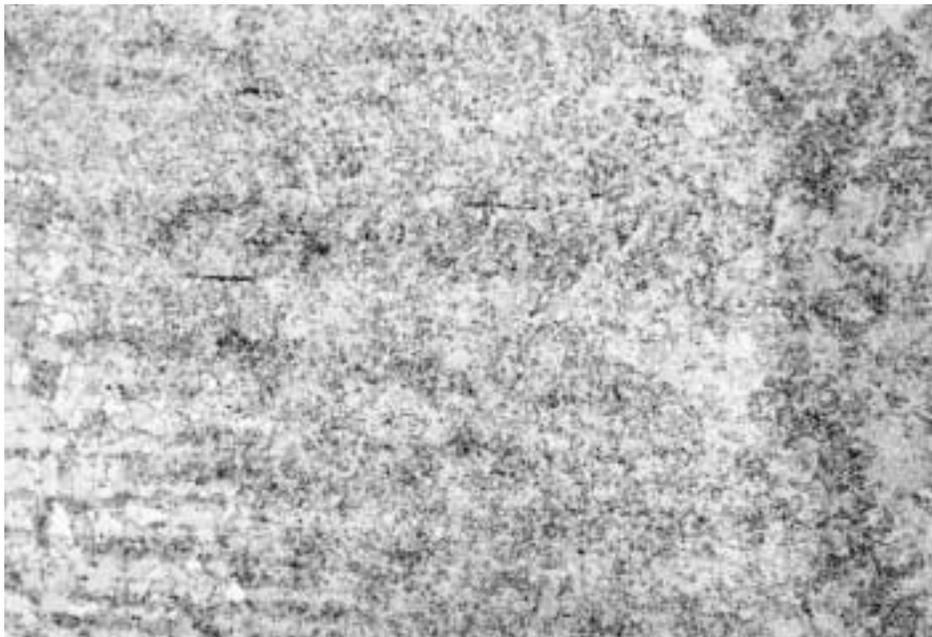
The microstructure of the girth weld showed no evidence of creep damage (Figures 9a and 9b). The indication found by RT and UT suggested to be porosity was found to be lack of root fusion (Figure 9c). No evidence of creep damage was observed in association with this defect. The microstructure of the base metal is similar to that observed near the longitudinal seam weld (Figure 9d).

*Figure 9a Overview of the Base Metal/HAZ/Weld Metal Interface of the Circumferential Weld. (50X)*

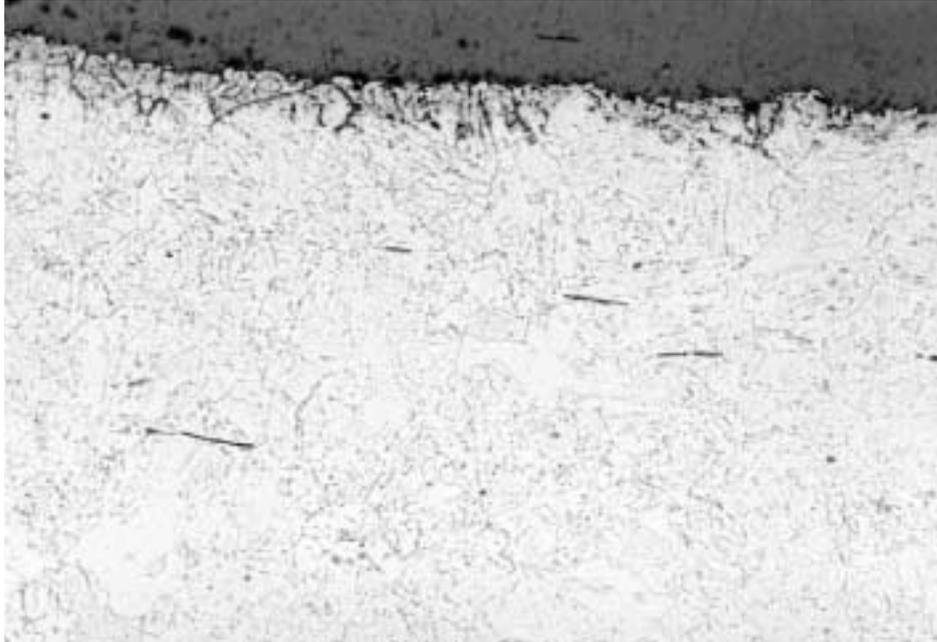
*Figure 9b Detail of the HAZ at the O.D. of the Sample Showing Intergranular Oxidation But No Evidence of Creep Damage. (400X)*

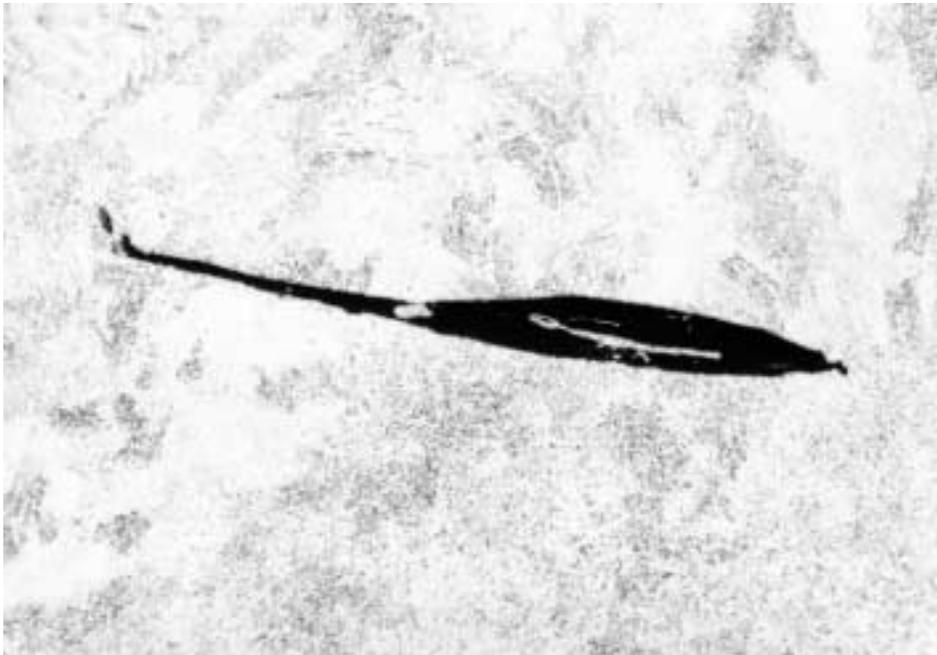
*Figure 9c Overview of the Lack of Fusion Defect in the Circumferential Weld. (50X)*

- Indications were detected in the girth weld by both UT and RT. In the laboratory, the largest indication was identified as a fabrication-induced flaw, namely lack of root fusion, by metallographic examination. No evidence of creep damage was found to be associated with the flaw, when examined by optical microscopy.

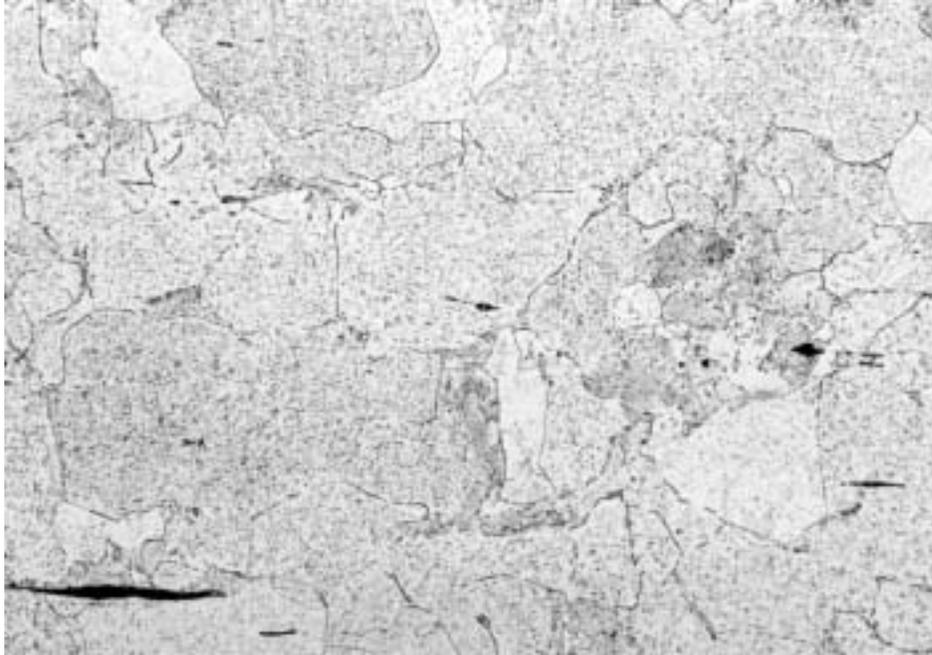
Figure 9d Detail of the Pipe Base Metal Showing Some Lamellar Pearlite and Spheroidized Alloy Carbides in a Matrix of Ferrite. Note Stringer Inclusions. (400X)

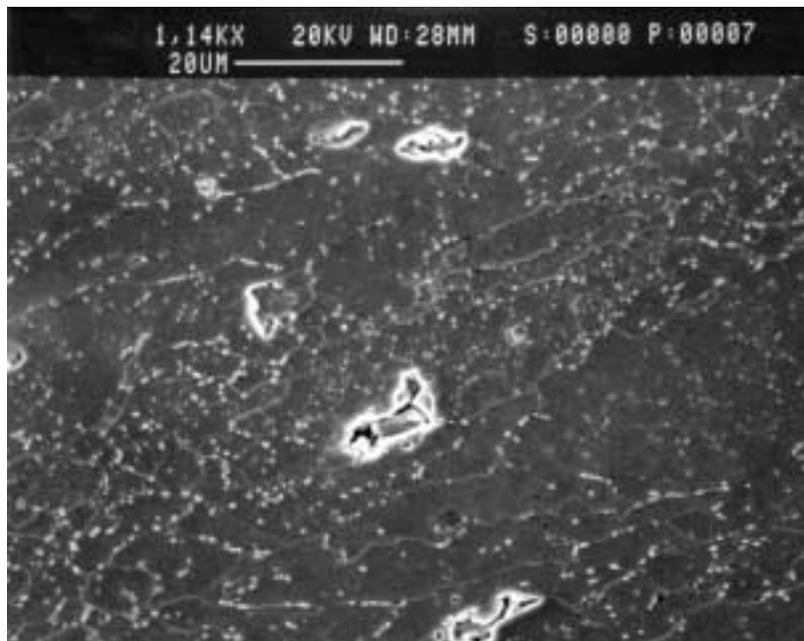
Examination of the stress-rupture specimens showed that cavity nucleation in the HAZ of the longitudinal seam weld was generally associated with an inclusion (Figure 11). EDS analyses of these inclusions showed that they are largely manganese and sulfur-rich (Figure 12).

Figure 12a SEM Micrograph of Stress-Rupture Sample T2 Showing Cavity Nucleation at Nonmetallic Inclusions in the HAZ.

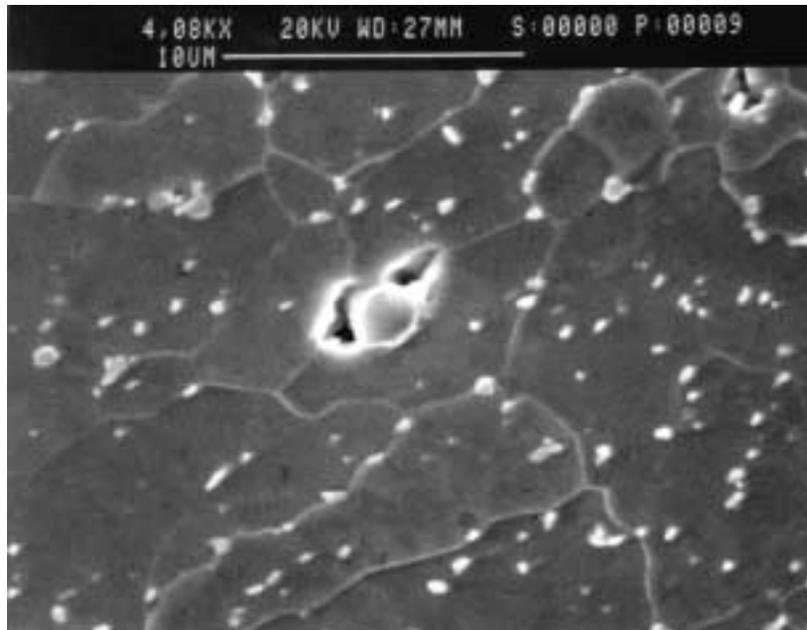
Figure 12b SEM Micrograph of Stress-Rupture Sample T2 Showing Cavity Nucleation at Nonmetallic Inclusions in the HAZ.

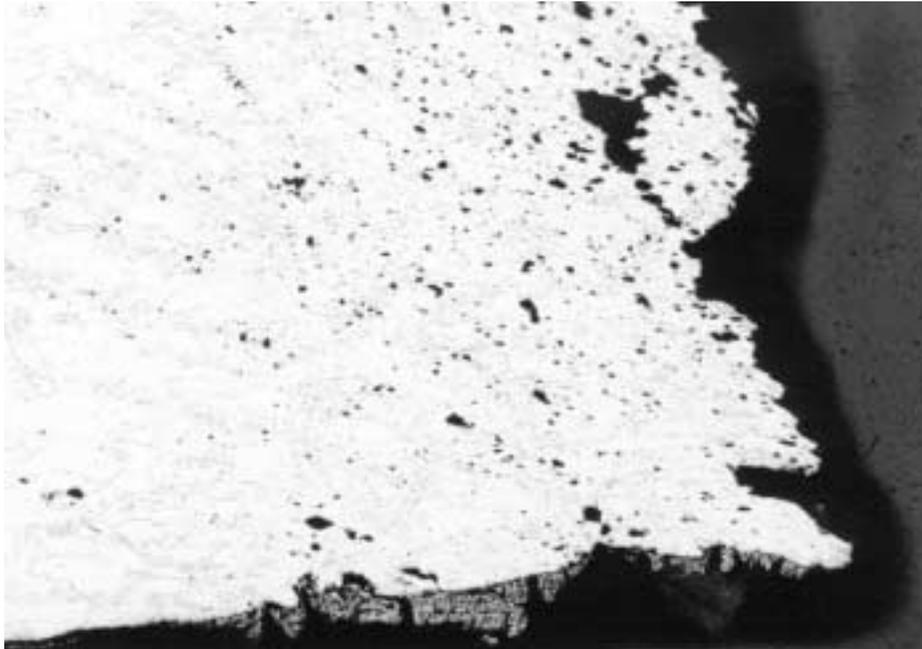
Sample T1 failed after 213.9 hours at 1250°F and Sample T2 failed after 409.0 hours at 1225F. The calculated Larson-Miller parameters are given in Table 2. A substantial amount of ductility is seen in both samples. Optical metallography of the stress rupture test specimens showed that the fracture occurred through the HAZ (Figure 15). In addition, aligned cavities were observed in the weld metal at prior austenite grain boundaries.

*Figure 15a Micrographs of the Stress-Rupture Specimen, T1, Showing That Failure Occurred Through the HAZ of the Long Seam Weld. (50X)*

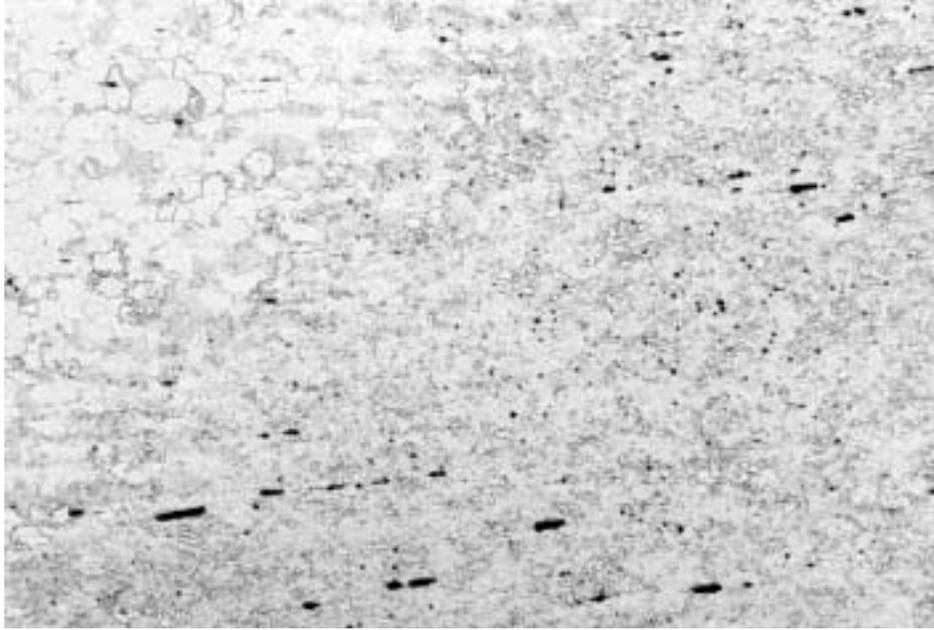
*Figure 15a Micrographs of the Stress-Rupture Specimen, T1, Showing That Failure Occurred Through the HAZ of the Long Seam Weld. (50X)*
