Failure Analysis Study of a Cracked Superheater Outlet Header

Robert L. Roland
CAJUN ELECTRIC POWER COOPERATIVE, INC.
Baton Rouge, Louisiana

Presented at
City Public Service San Antonio
January 18-20, 1994
San Antonio, Texas

FAILURE ANALYSIS STUDY OF A CRACKED SUPERHEATER OUTLET HEADER

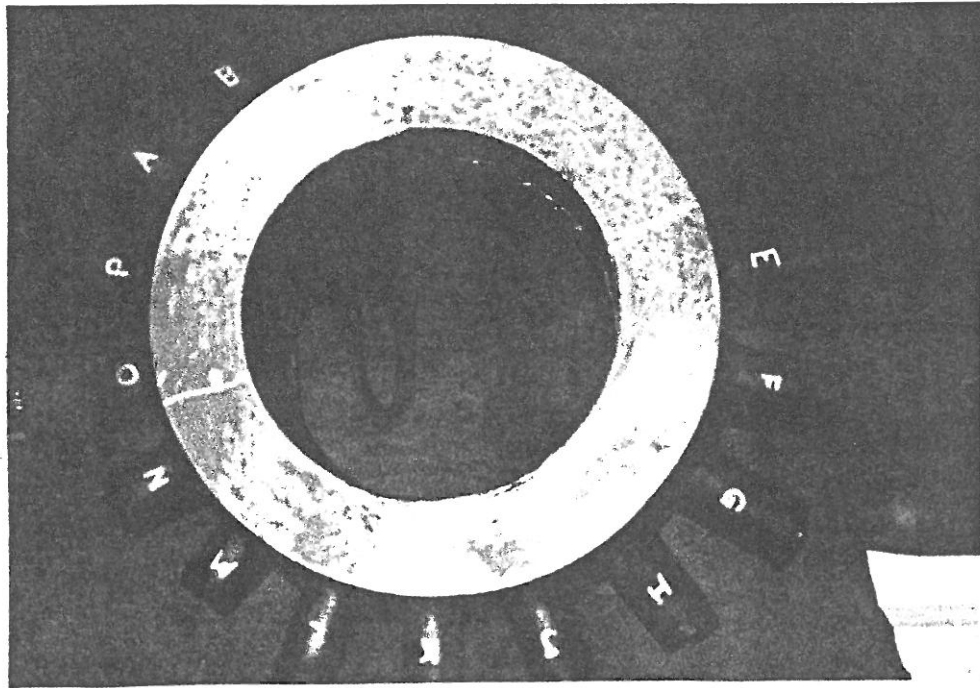
From the sample piece of radiant superheater outlet header, sections were cut from the region with indications of cracks. The section of interest was at the inboard region of the header (centerline of boiler). Figure 2 shows the ring section of

FIGURE 2
Section of East Header removed for evaluation.
Note designation of nipples/bore holes.

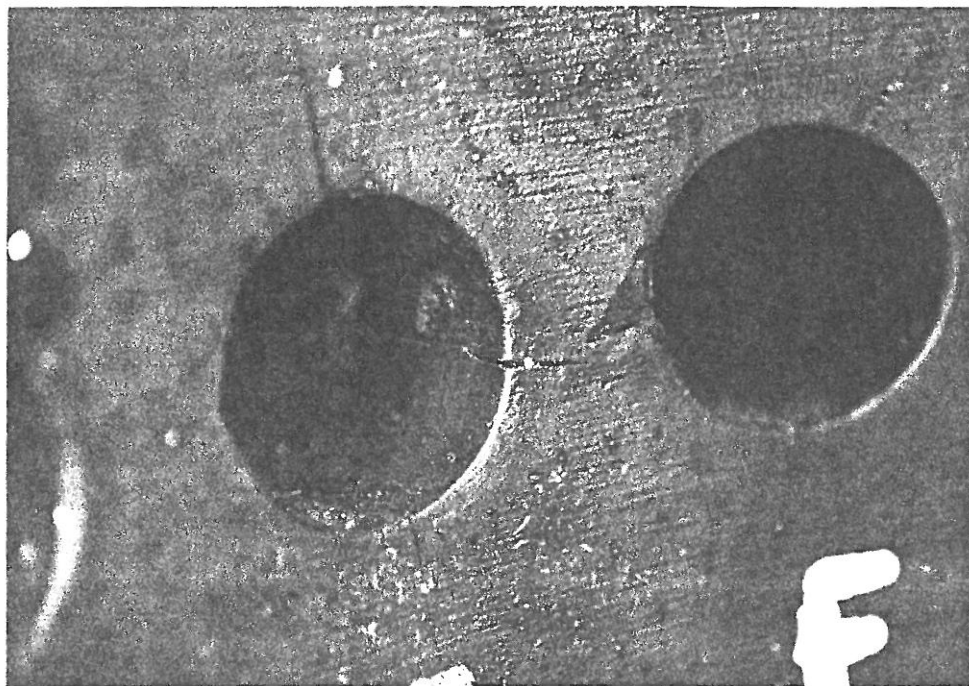
All the major cracks observed in the header section were measured for length using calibrated calipers. The results are shown in Figure 5. The longest cracks were associated with bore holes E and F. These bore holes are at the front of the header and were connected to tubes which formed the leading edge of the radiant superheater header assembly, and therefore would have been at the highest temperature. Limited or little evidence of cracking was observed for bore holes N through J which correspond to the central section of the superheater assembly. The connected tubes would be at lower temperatures than tubes connected to bore

FIGURE 3
Macro photograph of crack present between bore holes E & F.
Note deep crack in bore hole E.

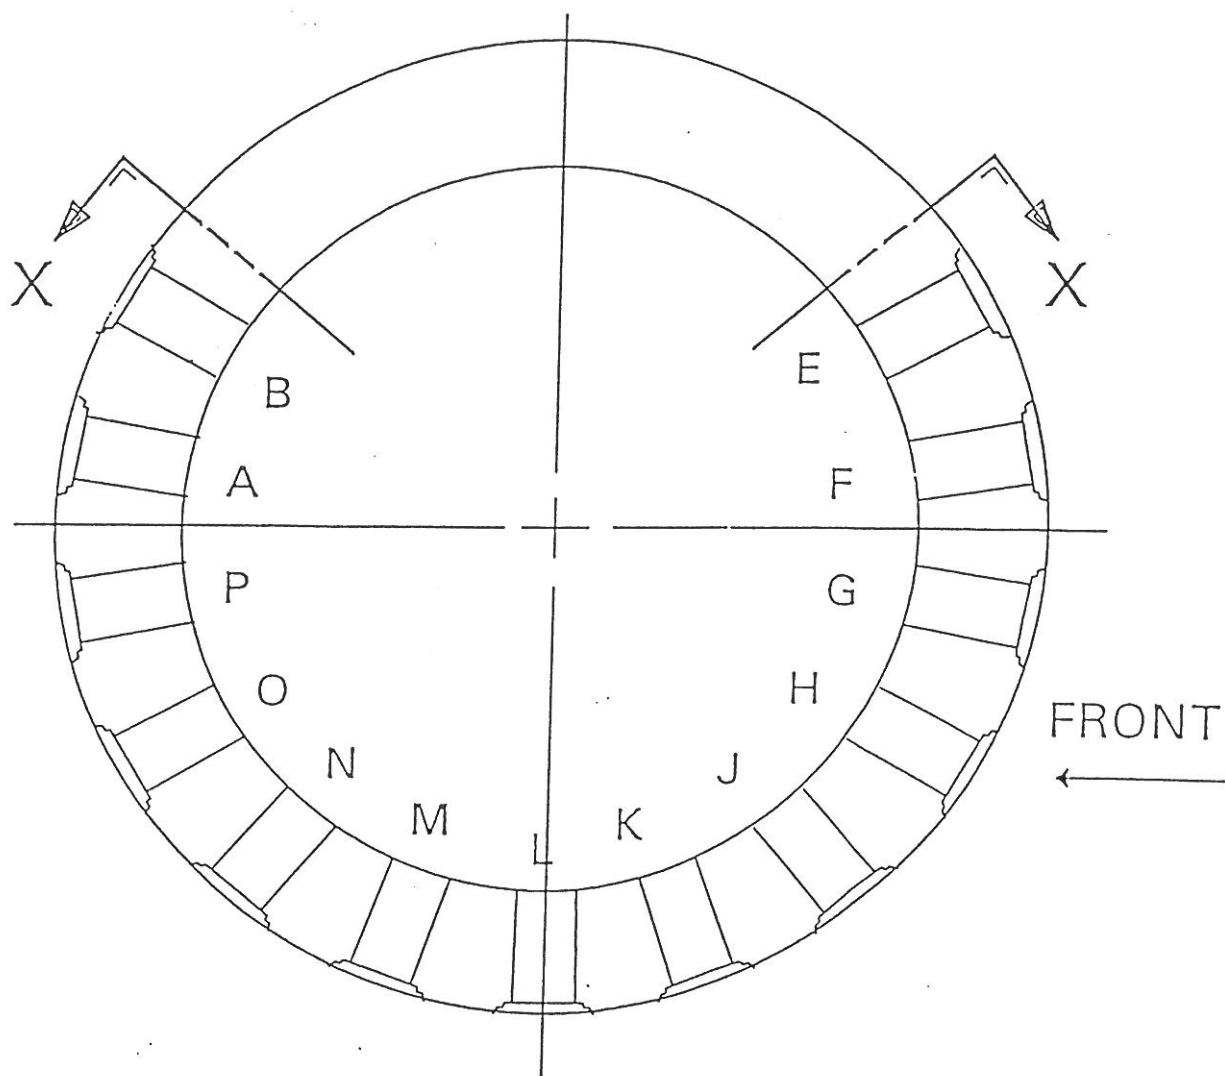
Figure 4 shows the designation of the tube nipple connections. These nipples were labeled A through P according to the original drawing. Indications of cracks were noted at the edge of the bore holes in the region bounded by tubes E through H, and B through P. These cracks were longer in the circumferential direction than the longitudinal direction. Figure 3 shows detail of the cracks observed at bore hole F. Further inspection showed radial superficial cracks at the I.D. surface adjacent to the bore hole. More detailed visual inspection within the bore hole revealed longitudinal cracks which did not originate or end at the I.D. surface of the header.

FIGURE 4
SCHEMATIC OF EAST HEADER SHOWING DESIGNATION OF
BORE HOLES. SEE FIGURE 5 FOR SECTION X-X.

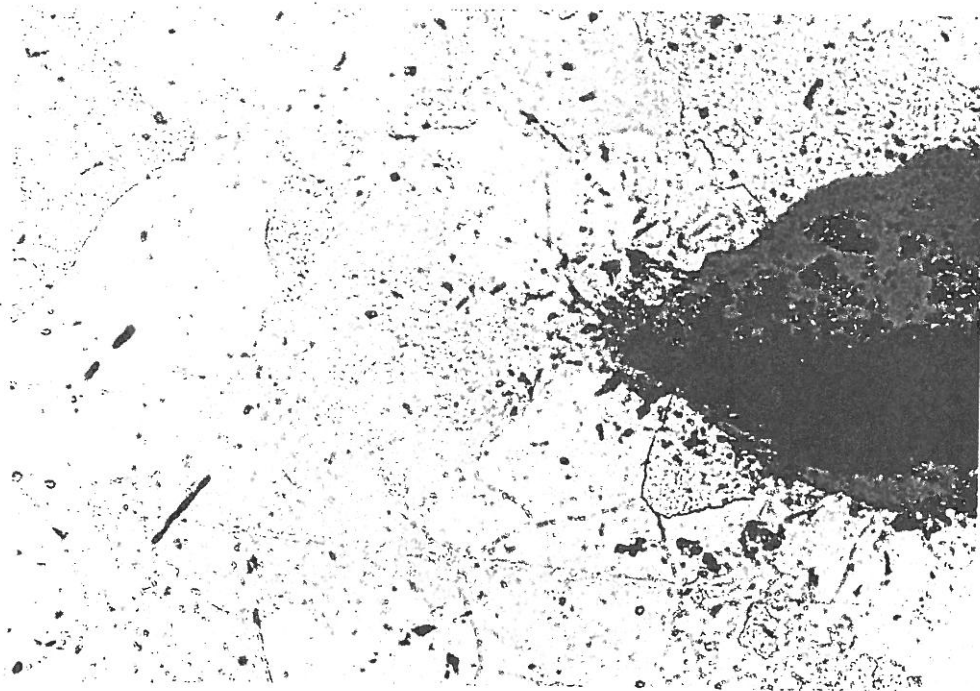
FIGURE 6

Figure 6 shows the microstructure at the I.D. including the morphology associated with a typical crack. The structure has been fully spheroidized, presumably during service. Some creep damage was observed. Investigation of the crack morphology shows a thick oxide-filled crevice. The crack tip shows the propagation was transgranular, which is typical of thermal fatigue. There was some evidence of creep damage at the crack tip along with some oxidation at the interface between the oxide wedge and the base metal.

It should be noted that the extent of creep damage, while measurable, would be considered to be Wedel-Neubauer (5) Type A. That is, the I.D. region of the header in the location of the circumferential cracks was at the initial stages of creep.

Microstructure at tip of crack present at I.D. (bore hole G).
Note transgranular propagation and spheroidized carbides. Some
isolated creep voids are present 400X

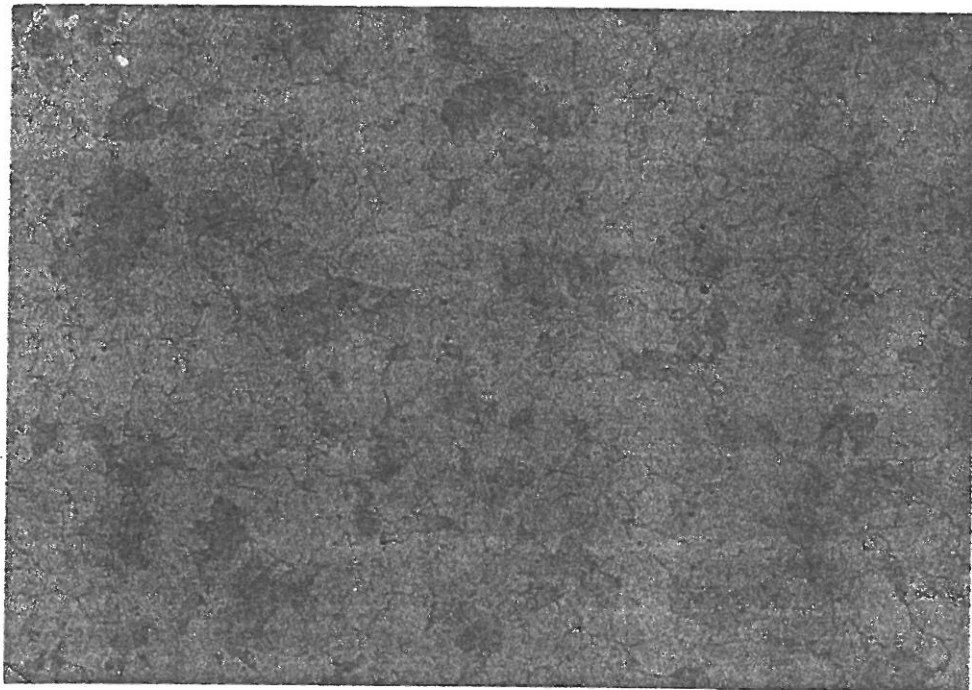
FIGURE 7

The microstructure at the O.D. is shown in Figure 7. The structure is similar to that observed at the I.D. (Figure 6), that is a spheroidized microstructure with some evidence of creep.

Microstructure at O.D. of section adjacent to bore hole G.
Some creep voids are present 400X

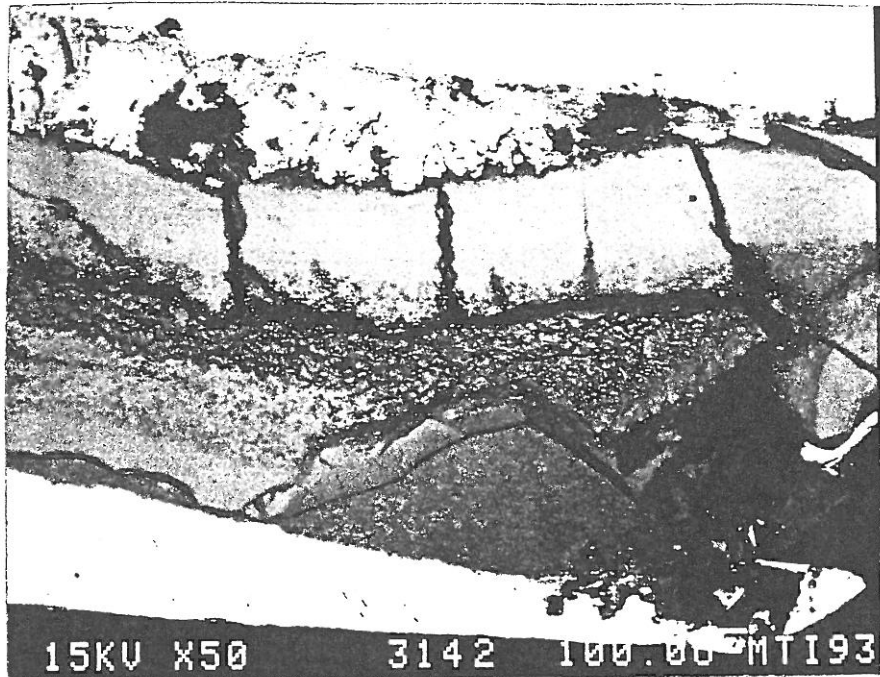
The metallurgical mounts were also examined using scanning electron microscopy in the backscattered imaging mode. The advantage to the use of SEM is the high magnifications possible combined with the chemistry sensitive contrast achieved with backscattered imaging. With this technique, holes or voids will appear black compared with the bright background of the base metal. Furthermore, oxidized or corroded metal will have a different contrast than intact material. Comparison of the SEM micrographs of the I.D. and O.D. sections showed that the I.D. had more voids than the O.D. Figures 8 and 9 show details of the crack observed at the I.D. of bore hole G, using backscattered imaging. The layered structure of the scale is clearly evident. Also, there is a distinct corrosion interface between the scale and the base metal.

FIGURE 8
SEM (BEI) image of oxide-filled crack in bore hole G.
Note different layers and the partially oxidized interface
between dense scale and base metal. 50X

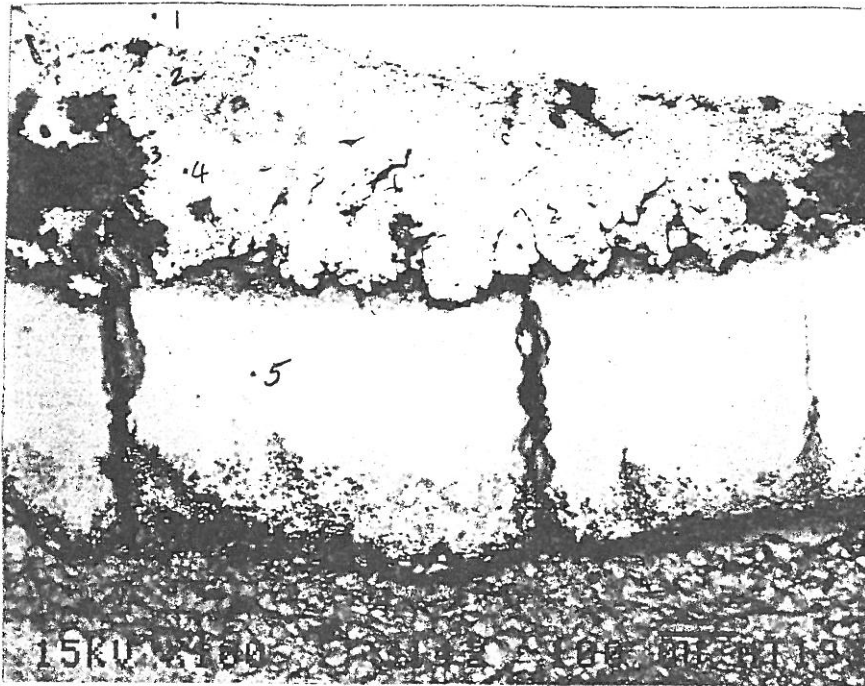
FIGURE 9
SEM (BEI) detail of Figure 8 showing interface
region between scale and base metal. 100X

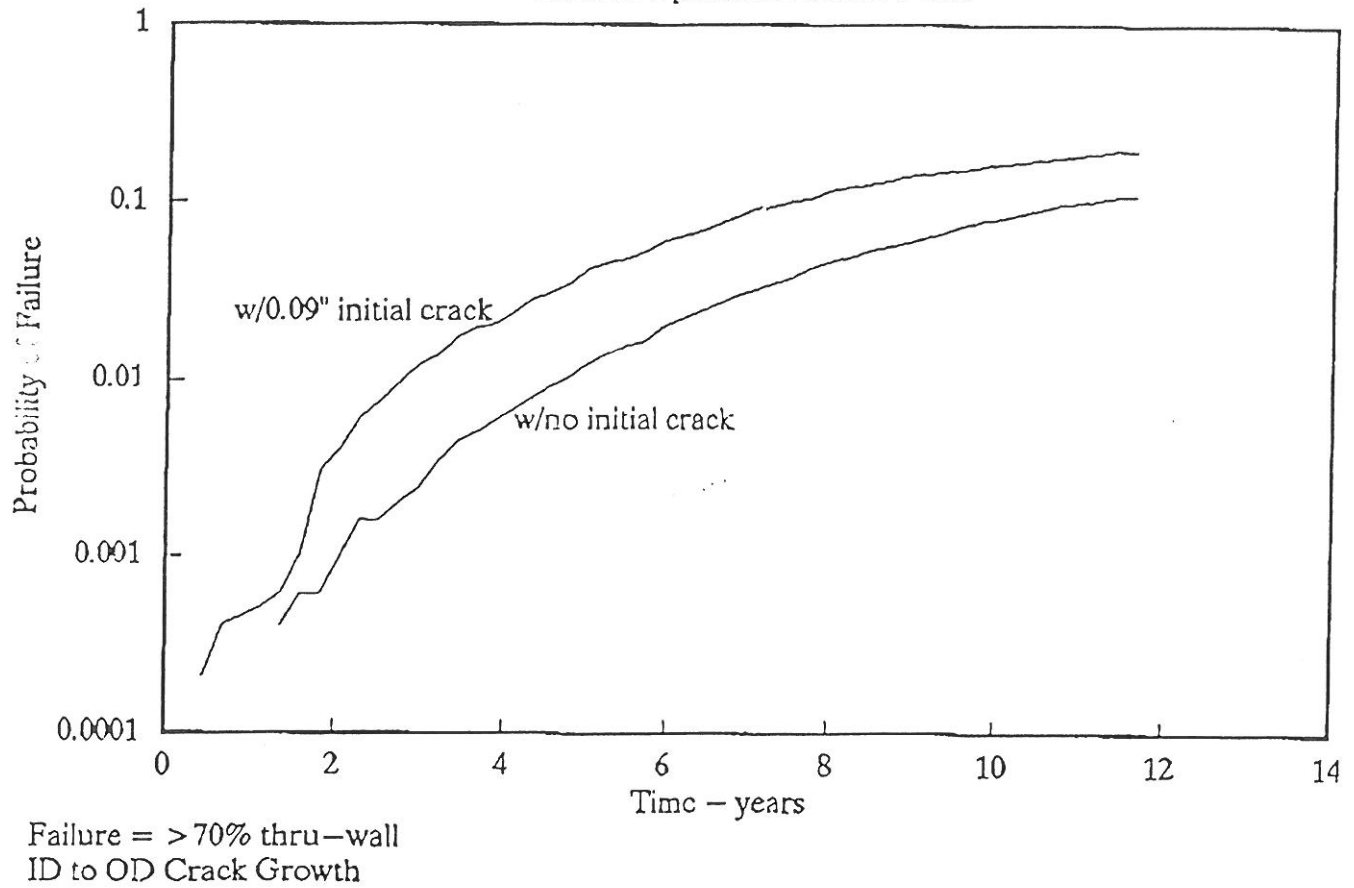
Obviously, this value is much lower than the 1.51" measured crack depth. It is most probable that the median property values were not appropriate, or that some number of unknown but significant load cases have not been input to the program. Quite possibly these unaccounted for load cycles, occurred during the early years of operation for which accurate records were not found. The probabilistic results for this case confirm some of the uncertainties in the analysis. For the probability analysis, 5000 simulations were run, and the first ten results reported. These results indicate failure or crack depth equal to 1.7 inches, for three of the simulations. The results also show that after 85,000 hours of operation there is a 16% probability of failure.

Figure 10 shows the probability of failure versus time for two cases, namely with and without the initial 0.09" deep crack.

FIGURE 10
Probabilities of failure after fourteen years
(85,000 hours) of operation.

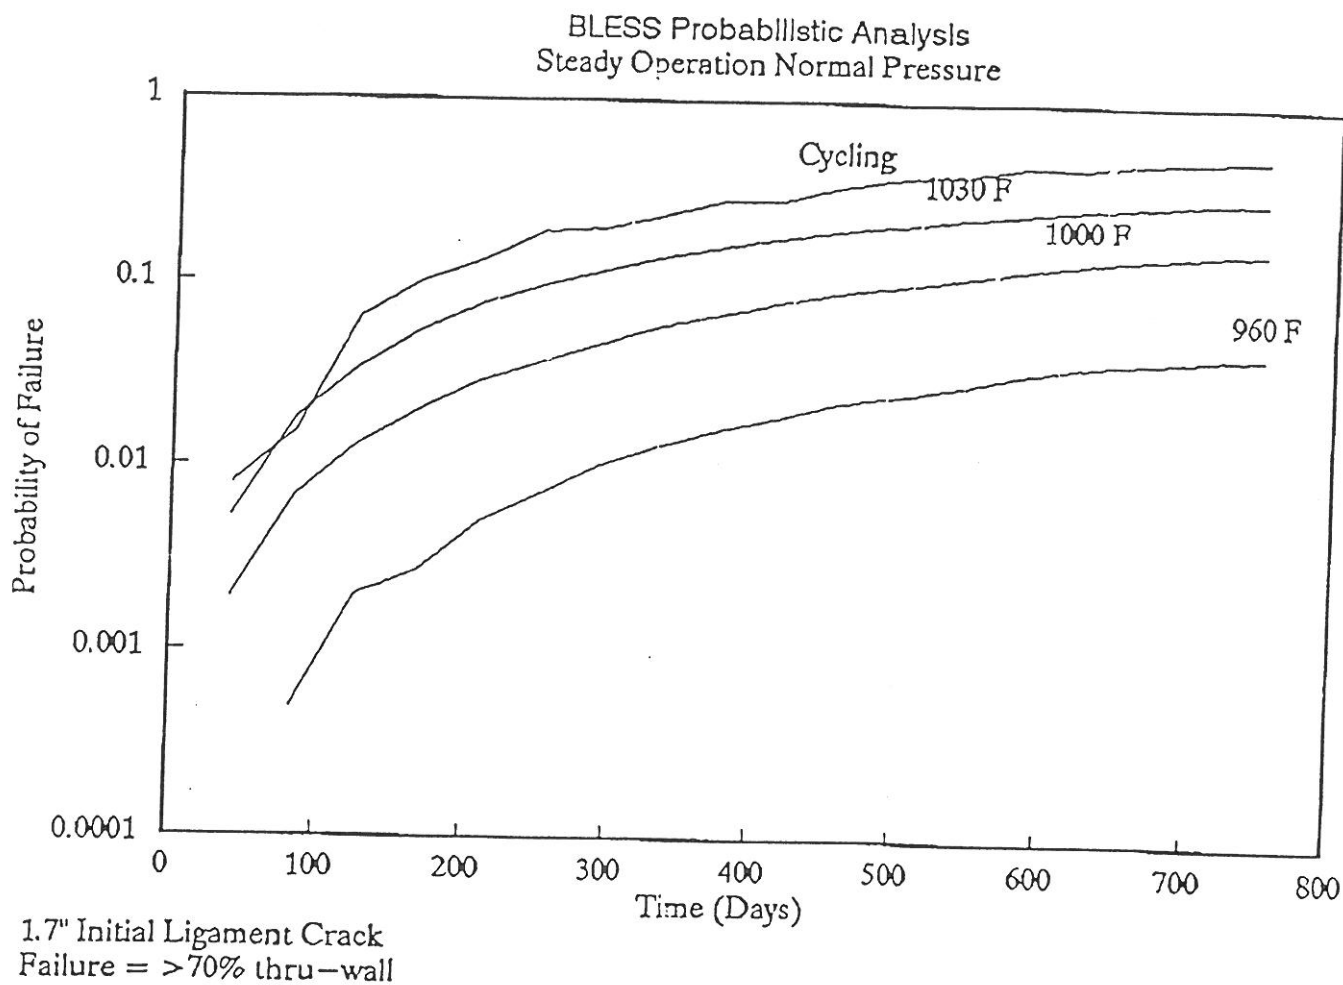
The results are shown graphically in Figure 11, as probabilities of failure over a

future two years of operation. For the cyclic operation case, failure is postulated to occur after further 17,048 hours at a crack depth of 2.36 inches, which is 70% of the wall thickness value. For the steady state case at 1030°F, failure is postulated to occur at 33,027 hours, at the crack depth of 2.36 inches.

FIGURE 11
Probabilities of failure for additional two years of
operation, after crack discovery.
