### **FAILURES IN E- AND EL-TYPE PULVERIZER MILL MAIN DRIVE SHAFTS**

**Gary R. Wood  
Senior Metallurgical Engineer  
American Electric Power Service Corporation**

**Joyce M. Hare  
Senior Metallurgical Engineer  
Riley Stoker Corporation**

**Presented at  
Power-Gen '94 Americas  
Orlando, Florida  
December 7-9, 1994**

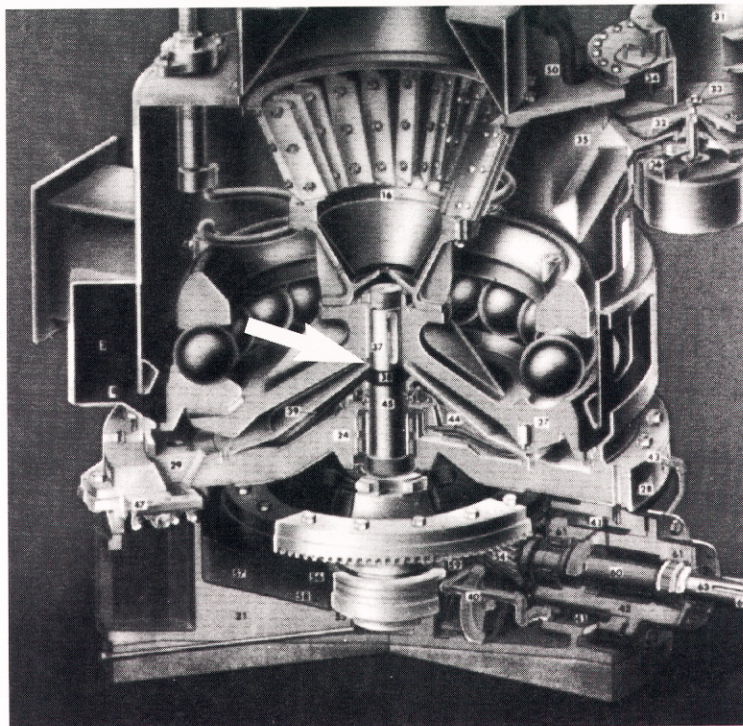
American Electric Power's Philip E. Sporn plant has experienced a series of ten pulverizer shaft failures. Some of these failures have occurred after rebuilding a failed shaft. The shafts have failed in the tapered section near the lower edge of the yoke bushing contact point. Although shaft failures have occurred at other AEP plants, the frequency of failure is markedly less at these plants than that experienced at Sporn Plant. Four additional shafts had been removed from service, three due to cracking in the keyway in the tapered section and one due to incipient cracking in the same area where all previous failures had occurred. This latter shaft, which had not failed, was submitted for metallurgical analysis to shed light on the initiation mechanism. Figure 1 shows a schematic of an E- type mill and the approximate location of the failures.

*Figure 1 Schematic of an E-type Pulverizer and the Approximate Location of the Failures on the Main Drive Shaft*

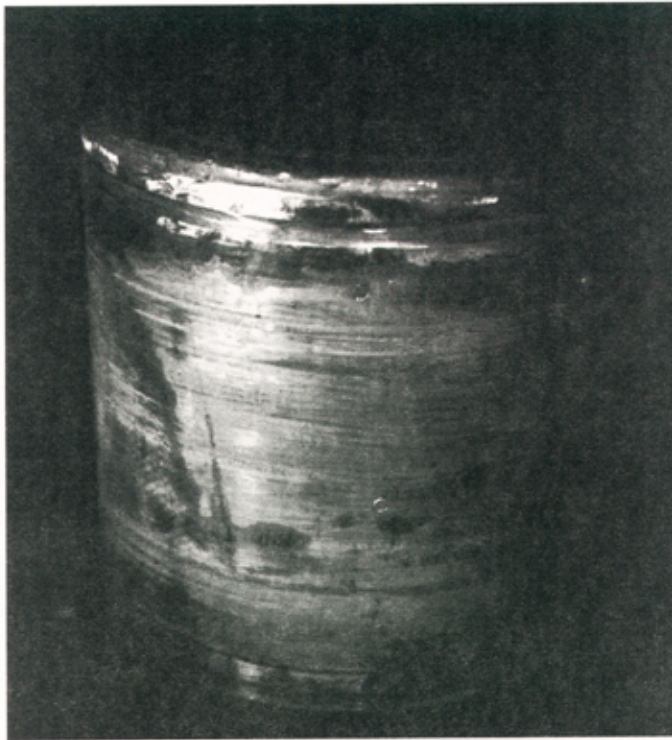
In response to the premature failures of several pulverizer shafts at Sporn Unit No. 1, failure analysis programs were conducted to learn the cause of the fracture. In all cases, the shaft fractured in the yoke bushing-to-shaft contact zone in the vicinity of the relief groove. The fractures were perpendicular to the axis of the shaft, but every fracture surface had been mechanically damaged by the continued rotation of the shaft following fracture (See Figure 2) and could not be used for fractographic analysis. AEP decided to check the replacement shafts nondestructively for any signs of cracking. After one of these shafts had been in service for approximately three weeks, the yoke was dismantled and the contact zone was examined by Wet Fluorescent Magnetic Particle Testing (WFMT). Several circumferentially-oriented indications were detected on the tapered portion of the shaft above the relief groove, well within the contact zone. The shaft was removed from service for metallurgical evaluation which included scanning electron microscope (SEM) analysis and optical microscopy.

*Figure 2 Fractured Shaft in the Pulverizer Mill*

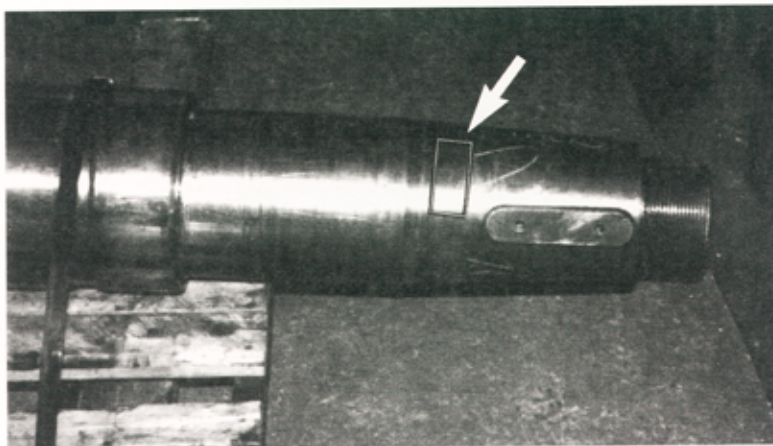
Figure 3 shows the tapered end of the replacement shaft and the location of the circumferential indications. Sample No. 1 was removed from this area and included some of the WFMT crack indications. This sample was examined in the SEM, the cracks were then mechanically opened, and the resulting fracture surfaces also examined in the SEM. A longitudinal metallographic section (parallel to the axis of the shaft and perpendicular to the crack indications) was prepared from Sample No. 1. Sample No. 2 was removed from the tapered portion of the shaft but away from the cracked area. Sample No. 3 was removed from the core of the shaft. Longitudinal sections were metallographically prepared from the latter two samples for optical microscopy.

*Figure 3 Replacement Shaft Recently Removed from the Mill with WFMT Indications inside the boxed area*

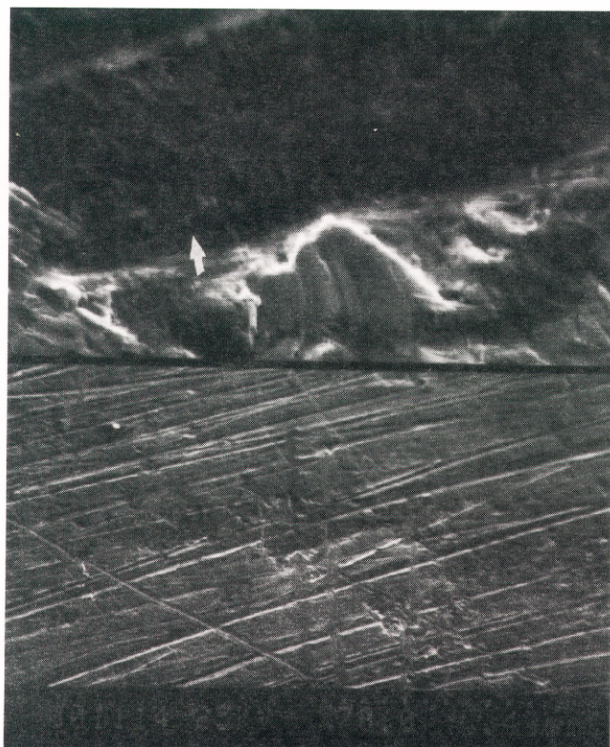
SEM examination of the outside surface of the shaft contained in Sample No. 1 showed a locally roughened surface around the WFMT indications which clearly could be identified as cracks (See Figure 4). The roughness ranged from pit-like features to shallow abraded areas, typical of fretting damage. This type of damage results from the relative motion between two surfaces in contact, here the bushing and the shaft.

*Figure 4 SEM Split Image Showing the WFMT Indication at 70X (Bottom) and 700X (Top)*

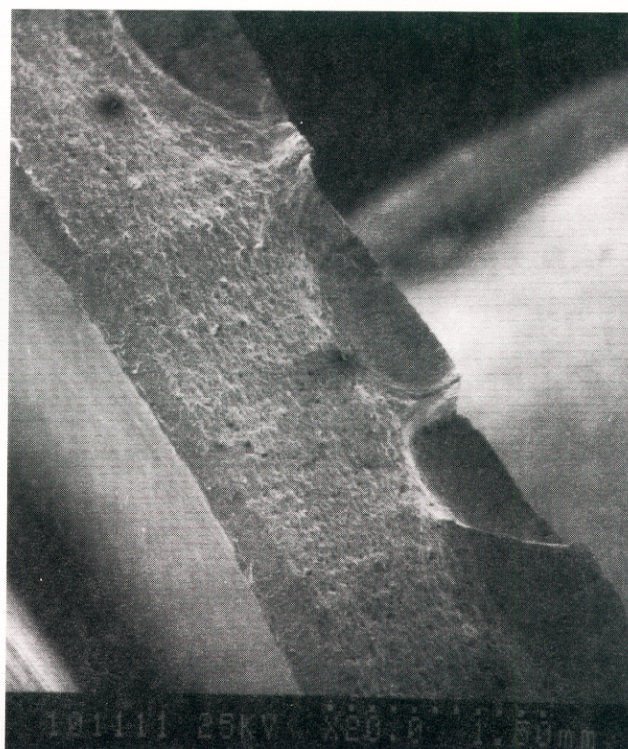
The fracture surfaces of the WFMT cracks are shown in Figure 5. The four dark thumbnail-shaped cracks, ranging from 17 to 29 mils in depth, originate at the outside surface of the shaft, are flat, and exhibit beach marks typical of fatigue.

*Figure 5 Overview of the Fracture Surface Produced by Mechanically Opening a WFMT Indication. Four Fatigue Cracks (Thumbnail Features) Have Initiated at the Fretted Surface of the Shaft.*

The incipient cracks detected by WFMT are concluded to be fine fatigue cracks which have initiated at surface-fretted regions on the tapered portion of the replacement shaft. This indicates that there has been relative motion between the bushing and the shaft which has induced, at localized points of contact, stresses of sufficient magnitude to initiate fatigue cracking. Within three weeks of service, the cracks had grown to a depth of 20 to 30 mils. The microstructure of the shaft is considered to be typical of quenched and tempered 4340 alloy steel. No evidence of material or fabrication defects were observed which could be linked to the cracking.

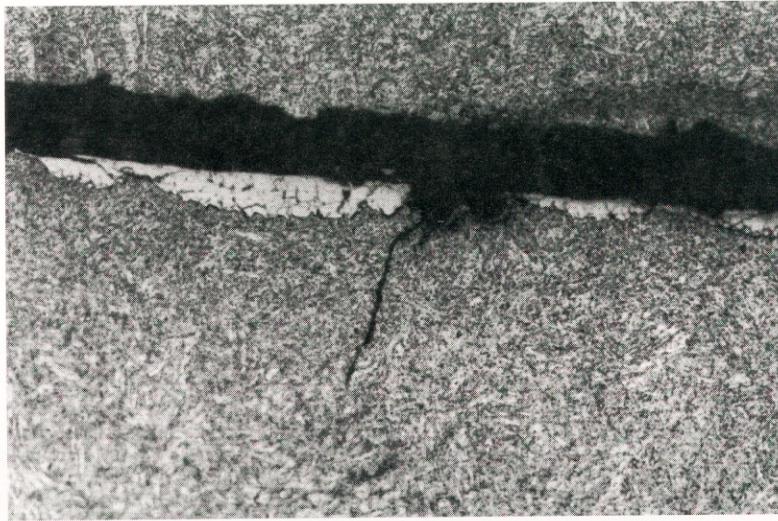
Examination of Sample No. 1 revealed several shallow transgranular cracks that had initiated at the surface of the shaft, an example of which is shown in Figure 6. Since no surface decarburization was observed in either Samples No. 1 or No. 2 indicating cracking before heat treatment of the shaft, it could be concluded that the cracks had initiated during the three-week service period. The initial crack propagation direction is oblique to the surface, typical of fretting cracks that initially follow the deformed grain structure at the surface. Once the crack has grown beyond the influence of any fretting action, it propagates as a fatigue crack in a direction perpendicular to the principal alternating stress<sup>1</sup>. A discontinuous white layer was observed on the surface of the shaft which was found to be unique to the fretted area and associated with cracking (See Figure 6). Microhardness test measurements indicated

that the white phase was harder than the matrix. It was concluded that the phase is untempered “white” martensite which is typically produced by fretting<sup>2</sup>.

*Figure 6 Typical Fatigue Crack Originating at White Layer of Martensite on the Fretted Surface of the Replacement Shaft*

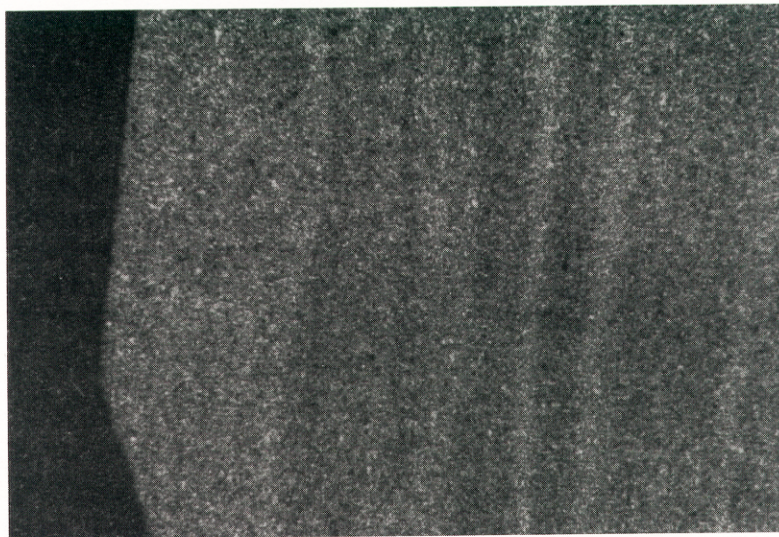
The general microstructure of Sample No. 1 in the cracked region is tempered martensite. Sample No. 2 exhibits a banded microstructure of tempered martensite dispersed with carbide particles (See Figure 7). Banding is the result of compositional segregation in the original cast ingot and is considered to be normal. The core microstructure of Sample No. 3 (Figure 8) is more highly banded and consists of spheroidized carbide dispersed in tempered martensite with some tempered bainite and ferrite.

*Figure 7 Banded Structure Near the Relief Groove of the Shaft. Note Absence of Surface Decarburization.*

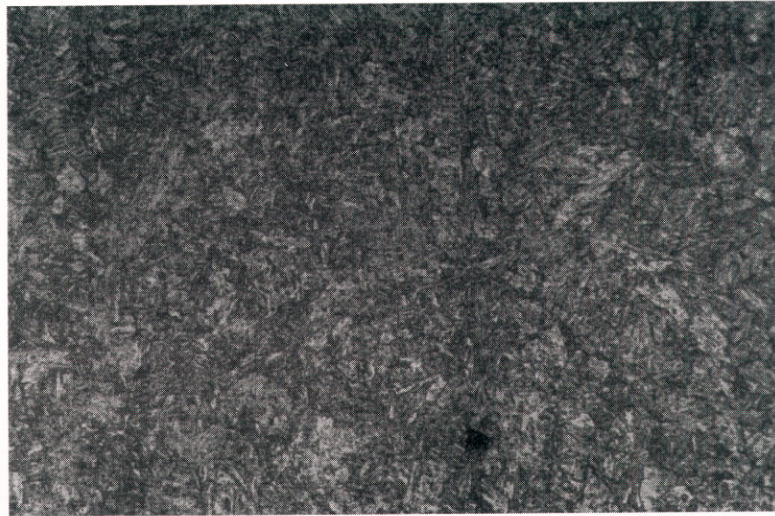
*Figure 8 Detail of the Core Microstructure*
