Furnace Wall Corrosion Problems in Coal Fired Boilers

D. N. French

RILEY POWER INC.

Presented at

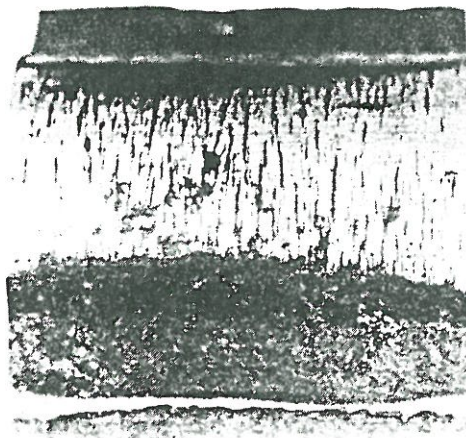
- 1) The circumferential penetration of the corrosion products on the fireside of the furnace tube is displayed. Figure 1 shows the tube fireside surface with the ash deposit and scale removed, Figures 2 and 3 show longitudinal cross sections. Note, the deep fingerlike penetrations into the tube surface.
- 2) Sulfur prints show the corrosion deposits within the tube wall penetrations and on the tube surface to contain sulfides. Figure 4 shows a circumferential and longitudinal sulfur print.
- 3) The O.D. ash deposit appears to be in two layers, a reddish brown outer layer and a dark black glassy appearing inner layer.
- 4) The ash deposits contain carbon as well as the usual oxides associated with coal ash, see Table I.

Figure 1 Surface of a Furnace Wall Tube That Shows the Circumferential Sulfide Wall Penetrations, About 4x.

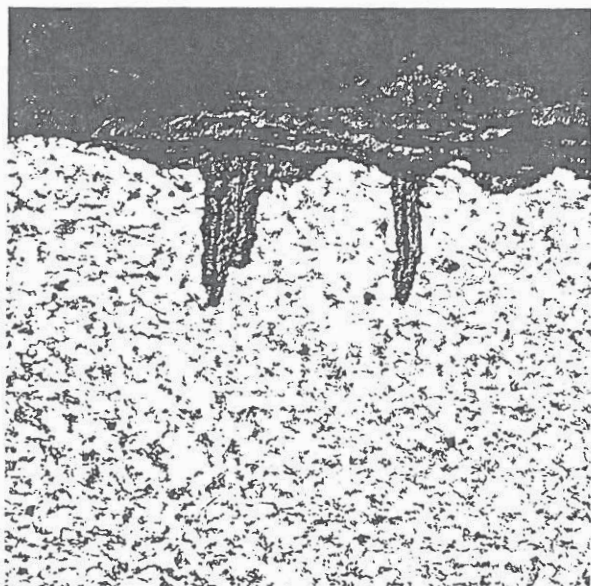
Figure 2 Longitudinal Cross Section of the Tube in Figure 1, 2% Nital Etch 100x.

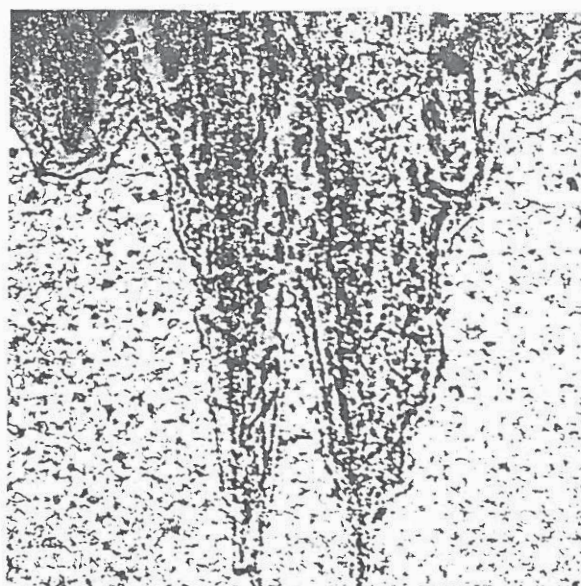
Figure 3 Another Example of the Deep, Finger-like Penetrations Into the Tube Surface, 2% Nital Etch, 100x.

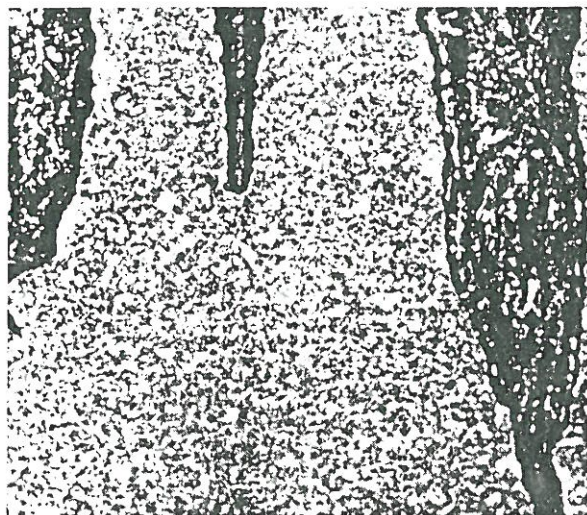
Several samples were submitted for detailed examination of the corrosion deposits attacking the tube surface. The analyses were performed by Energy Dispersive X-Ray (EDX) Spectroscopy in conjunction with a scanning electron microscope (SEM). Figure 5 shows the corrosion penetration area scanned and Figure 6 shows the x-ray map for sulfur. The only other elements detected were silicon, chromium and iron. No sodium, potassium, or chlorine was observed. The amounts of sodium and potassium are below the limits of detectability, from Table I, 0.29%Na and 1.3% and 0.33%K. Even though none of these elements was found, the presence of both in the ash suggests that pyrosulfates are possible.

Figure 5 The Corrosion Penetration Scanned by EDX for S, 52x.

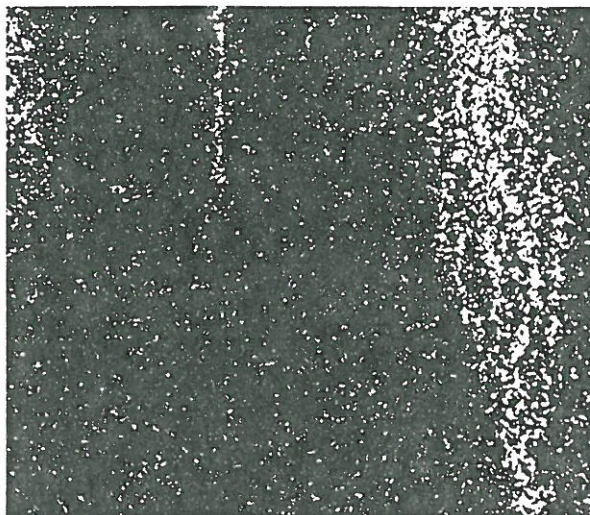
Figure 6 EDX Scan for Sulfur, Note the Concentration of Sulfur in the Corrosion Products, 52x.
