Hydrogen Damage in Utility Boilers

Dr. David P. Kalmanovitch
Consultant, Materials Engineering
RILEY POWER INC.
a Babcock Power Inc. company
(formerly DB Riley, Inc.)

Presented at
International Conference
on Boiler Tube Failures in Fossil Plants
San Diego, California
November 5-7, 1991

RST-108

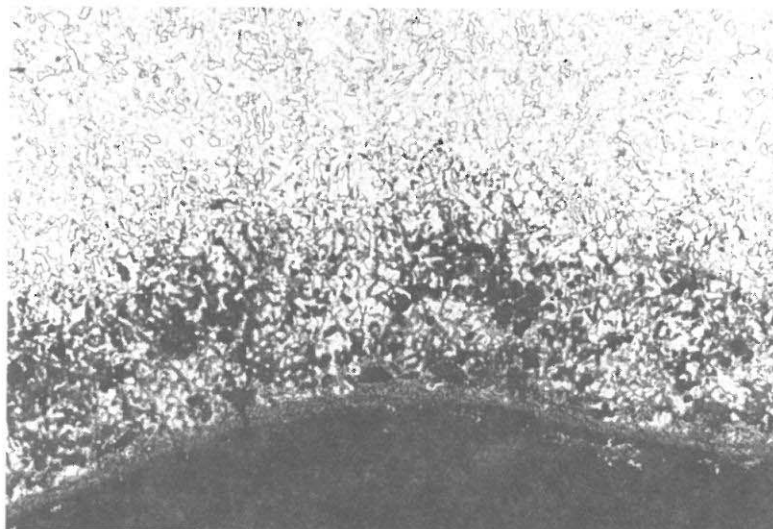
Figure 1 Waterwall Sample — Case Study No. 1

Note the I.D. voids, microcracks, and copper deposits typical of hydrogen damage (50X)

The results of this case study show that the ultrasound techniques are effective only when used in conjunction with systematic metallurgical analysis. Post-mortem analysis of the boiler survey showed that the hydrogen damage was not as extensive as indicated by the UT survey. The hydrogen damage in the roof tube was quite surprising and indicated a problem with boiler lay-up procedures. Certainly, the heavy I.D. deposits suggested a high propensity for I.D. corrosion and localized overheating of the tube. The lessons learned from this study have been used to develop a more systematic method of evaluating hydrogen damage in boilers.

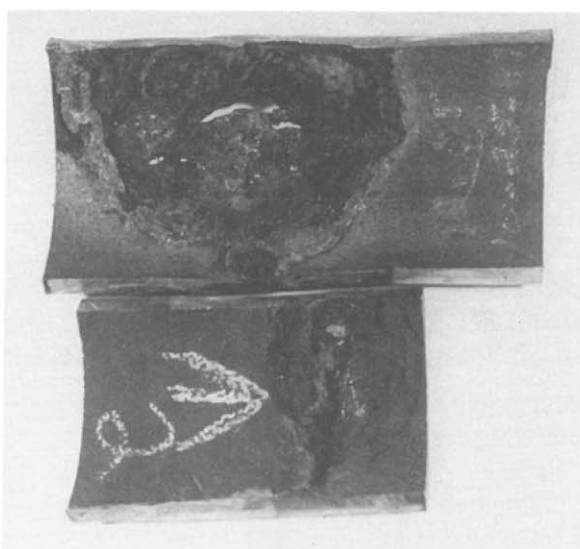
This boiler is a pulverized coal-fired unit operated at a pressure of 1575 psig. The unit was commissioned in 1967. Extensive water-wall failures were observed in the rear wall of the furnace at the burner elevations. Furthermore in all cases the hydrogen damage was present at flash weld locations. Metallographic examination of failures showed that there was slight misalignment of the tube ends at the flash welds. The misalignment combined with excess weld splatter at the I.D. formed a flow disrupter. This led to heavy localized I.D. deposits and subsequent hydrogen damage, see Figures 2 and 3. The samples showed severe gouging and hydrogen damage in the weld metal. A survey of the condition of the water walls was undertaken using the longitudinal wave velocity reduction technique. The UT survey indicated possible hydrogen damage in the rear and side walls at the burner elevations. This corresponded very well with the failure history of the unit. Based on the survey the locations which showed positive or possible damage were replaced. The unit has not reported any water wall failures since repairs were made.

*Figure 2 I.D. of As-Received Failed Tubes — Case Study No. 2
Note the Localized Deposits and Gouging at Welds*

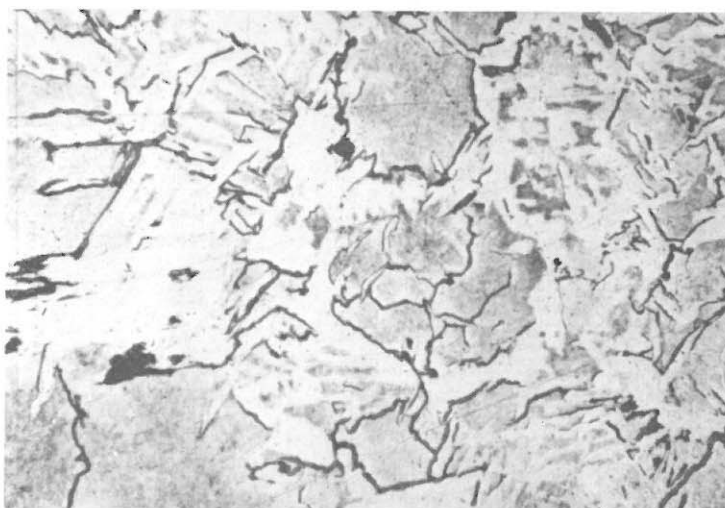
Figure 3 Hydrogen Damage Manifested as Cracks in Weld — Case Study No. 2 (500X)

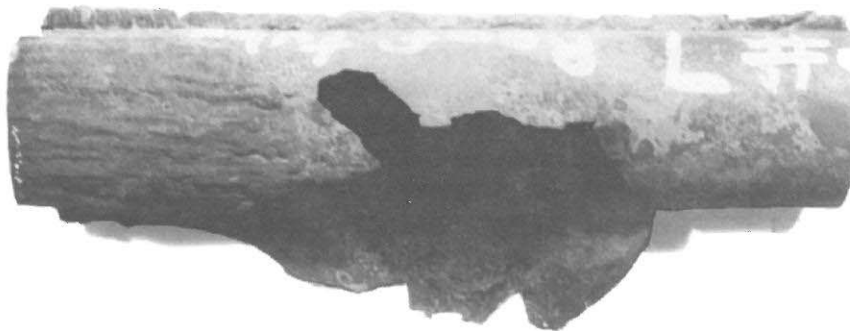
This unit was commissioned in 1965 and is rated to operate at 1260 psig. The boiler is designed for gas and oil. Multiple outages due to water-wall tube failures had been noted over recent years. A detailed inspection of the furnace was performed by DB Riley. The hydrogen damage was associated with welds and severe I.D. gouging (presumably by caustic attack). The location of the failures was at the west side wall and the roof. Significant thinning of the tubes had occurred. Field repairs had been made to the tubes and the ruptures had occurred at these repairs. The repairs were pad welds. Detailed analysis showed that the pad welds were made over damaged base material. The high localized heat input during welding may have increased the damage to the original tube. The result is interesting as it shows the effect of welding repairs of damaged base metal and the importance of determining the failure mechanism prior to adopting a repair procedure (see Figures 4 and 5).

Figure 4 As Received, Failed Roof Tube Sample — Case Study No. 3

Based on the failure mechanism the examination involved a UT survey for wall thinning only. This survey confirmed the presence of thinned tubes in the areas where failures due to hydrogen damage had occurred. The results lead to extensive replacement of affected areas. There have been no reports of failure from the unit since it re-entered service.

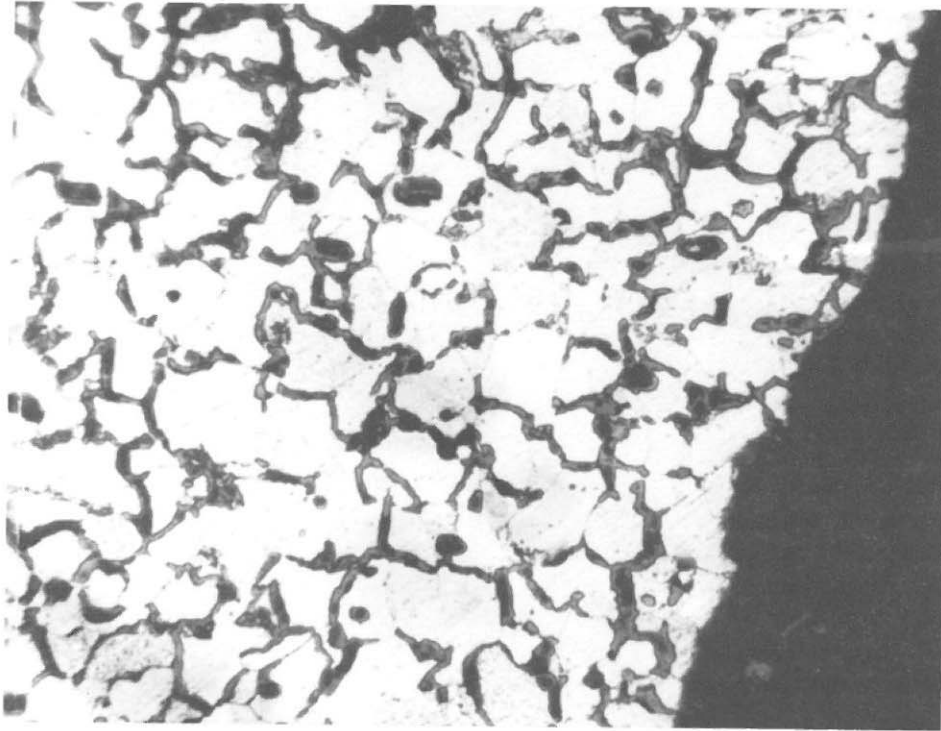
*Figure 5 I.D. of Roof Tube Failure Edge — Case Study No. 3 (500X)
Note the Oxide-Filled Hydrogen Damage Cracks*
