Investigation of Radiant Superheater Crossover Pipe Weld Cracking at Big Cajun II Station

Presented at
ASME Pressure Vessels and Piping Conference
Vancouver, B.C., Canada
August 4-8, 2000

**INVESTIGATION OF RADIANT SUPERHEATER
CROSSOVER PIPE WELD CRACKING AT
BIG CAJUN II STATION**

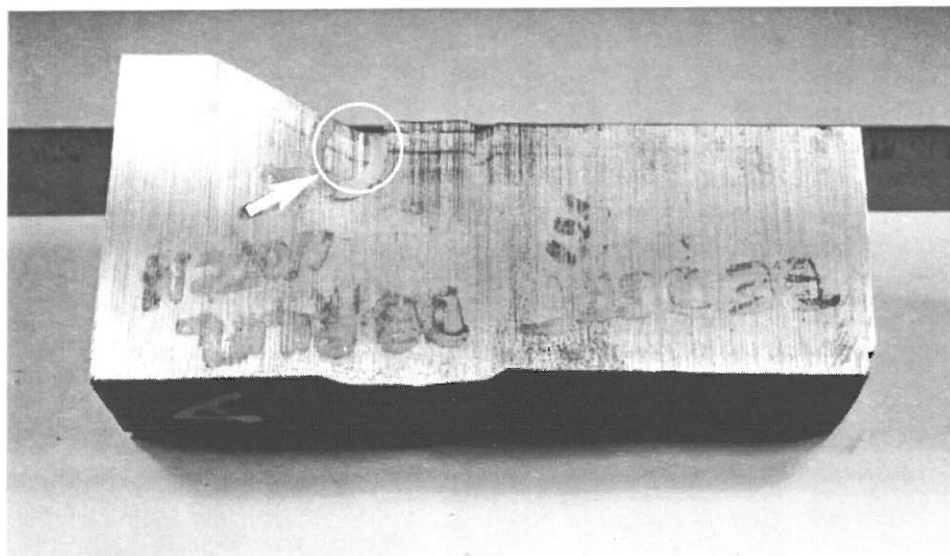
Ultrasonic shear wave testing revealed indications in the pipe to elbow weld area. The metallurgical investigation of the weldment identified and confirmed the presence of cracking, as noted during the nondestructive testing. The results revealed the presence of circumferential cracks up to 50 mils in depth. The cracks were attributed to thermally assisted fatigue. There was no evidence of creep damage or microstructural overheating in the metal specimens. The depths of the cracks in the sample were found to be less than originally estimated by the ultrasonic testing. In the laboratory, some locations on the weld were found to have bands of stringer inclusions, which were present in the original material. These are not detrimental, but could have been the cause of false indications in the field ultrasonic testing. Figure 1 gives a view of the cut cross sectioned surface of the weldment, showing the location of a crack at the taper transition at the inside of the elbow. Figure 2 shows an enlarged view of the oxide filled, circumferential crack at the inside surface.

Figure 1 The cut cross-sectioned surface of the sample weldment, showing the location of a circumferential crack at the taper transition at the inside of the elbow to pipe junction.

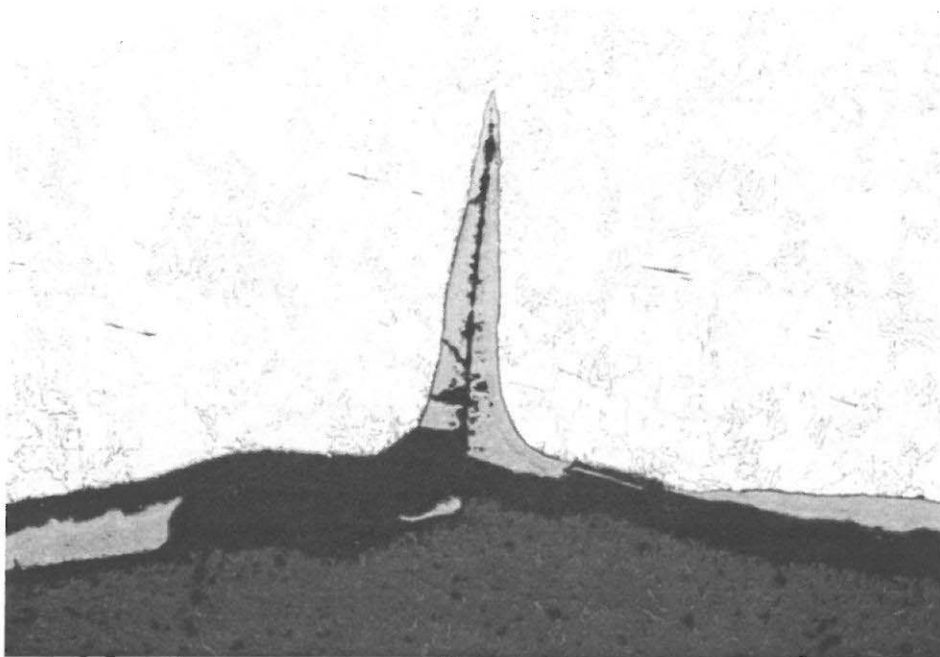
Figure 2 An enlarged view of the oxide filled crack at the inside surface of the taper transition junction. Stringer inclusions can also be seen adjacent to the crack.

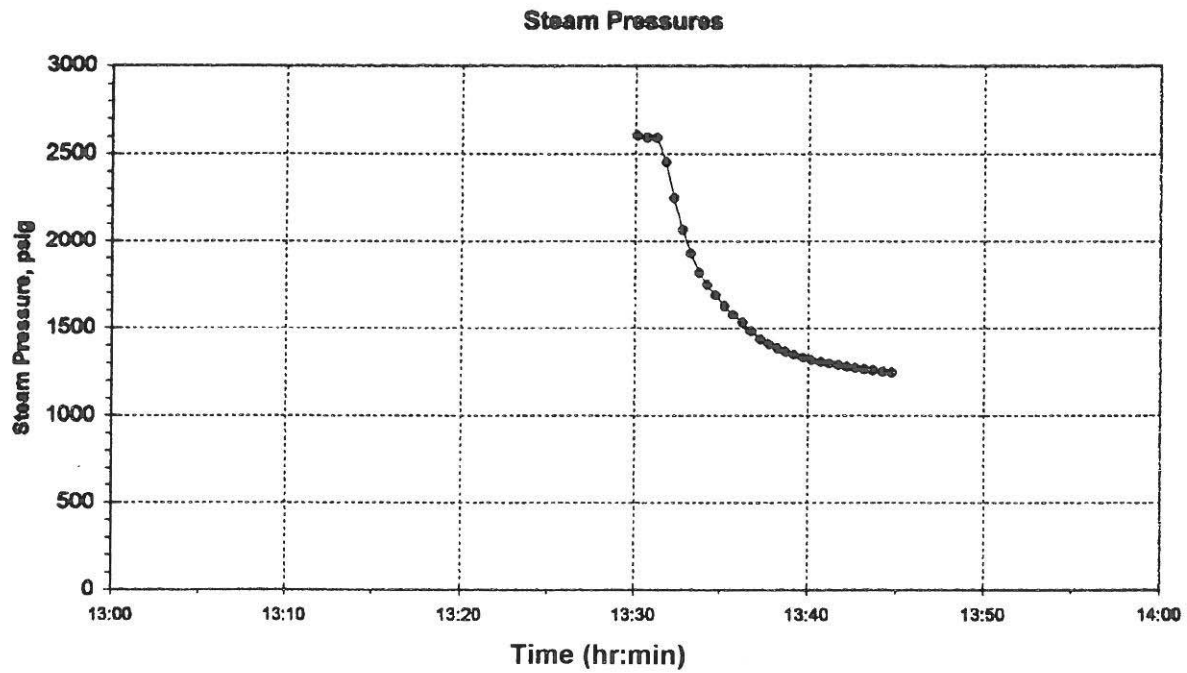
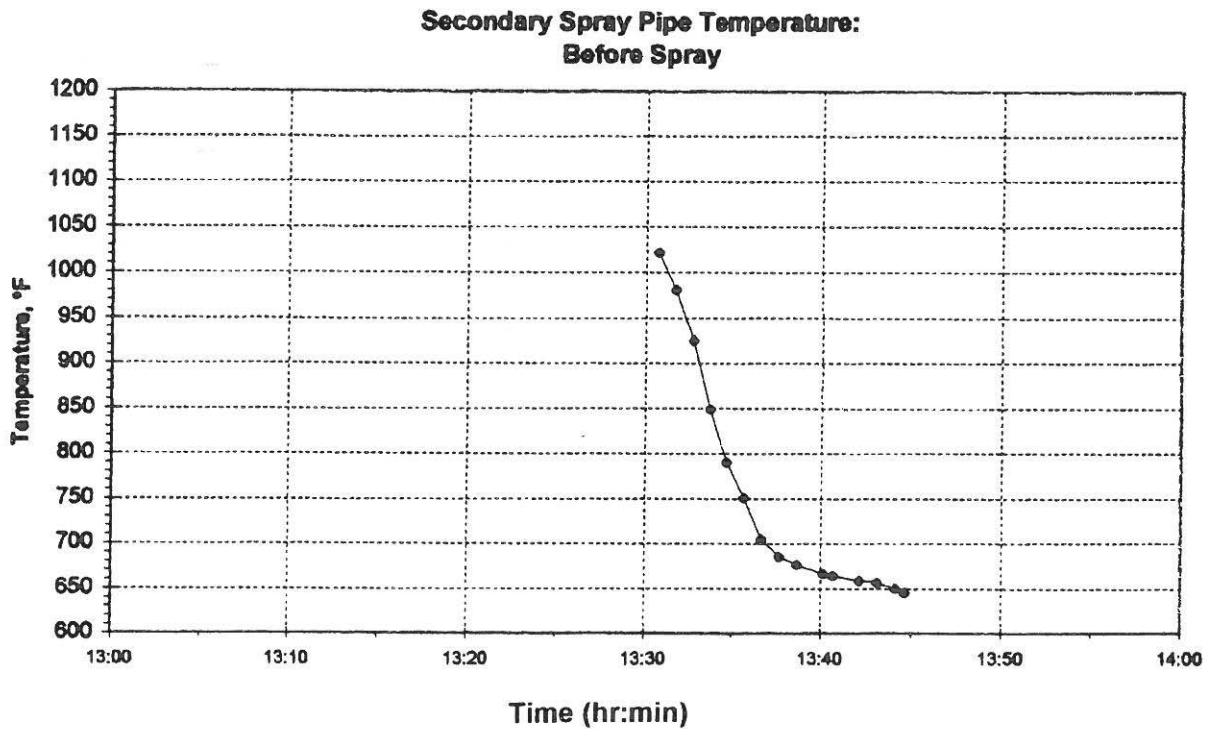
In addition to the thermal stresses imposed on the crossover piping by the changes in steam temperature, corresponding changes in pressure also contribute to the stresses in the crossover piping. Because of this, pressure gradients were also evaluated for the transient tests and trips. The temperature and pressure transient profiles for the July 14, 2000, boiler only trip event are shown on Figures 3 and 4.

Figures 3 and 4 Temperature and pressure plots versus time from the Transient No. 3, boiler only trip event of July 14, 2000.

Due to the severe temperature gradient effects from the boiler only trip events, it has been recommended that the operational practice of keeping the turbine on line after a boiler trip be discontinued.

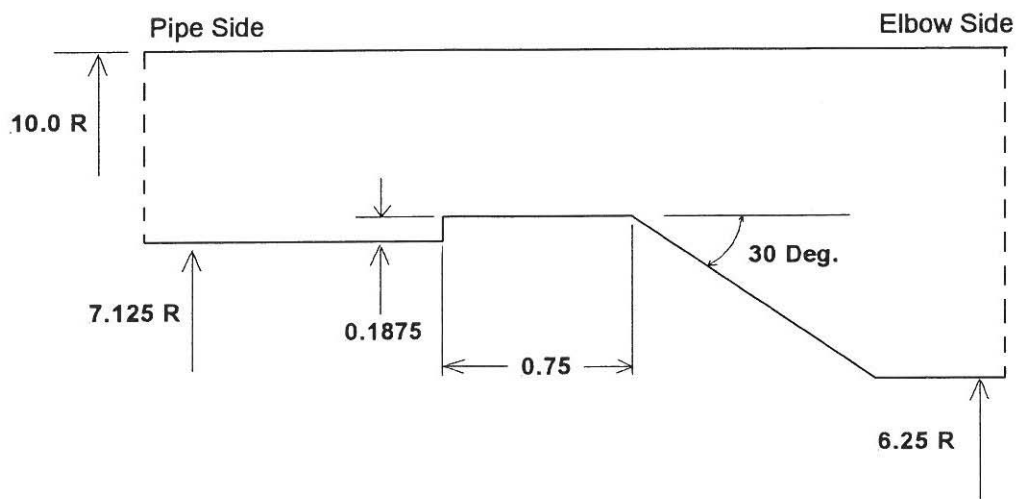
Figure 6 Geometric sketch of the "repaired" pipe to elbow girth butt weld junction.

In addition to the transient effects of temperature and pressure, the ongoing repairs to the welded joints within the crossover system have effectively shortened the individual segments of the piping. The shortened sections have resulted in a reduction in piping flexibility, with a significant increase in the thermal bending stress levels from the originally installed piping. This secondary effect further aggravates the previously described transient effects.

It has also been recommended that for future weld repairs, new pipe spool pieces be utilized in the process in order to avoid the "shortening" effects at the pipe weld joints that have occurred during past repairs.

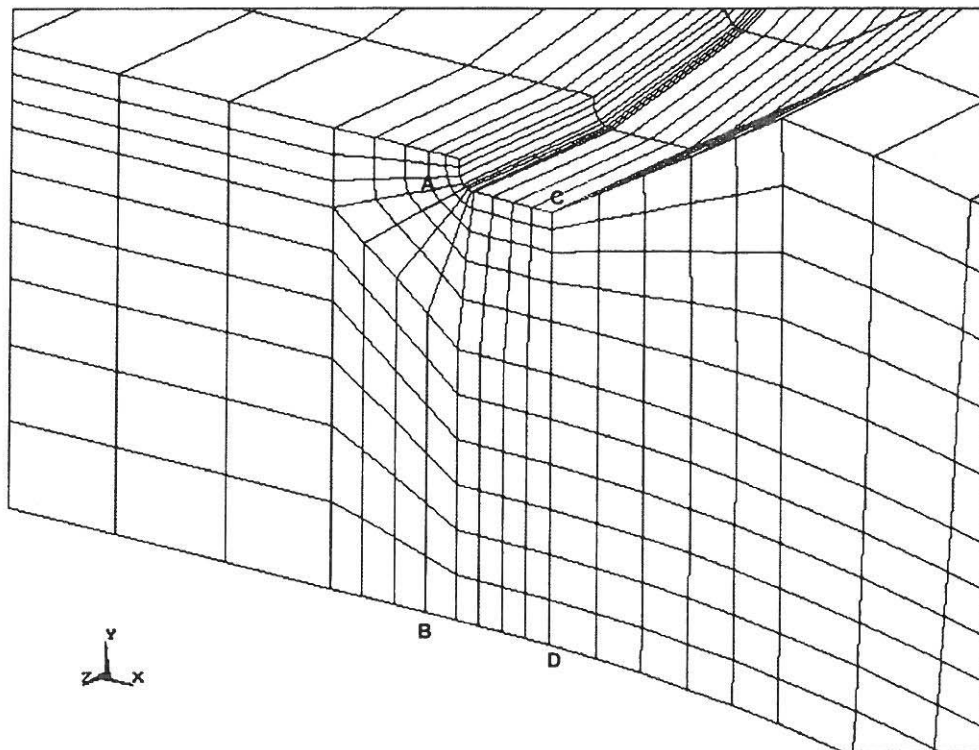
Figure 8 Close-up of the weld region in the repaired configuration at the 180-degree position, indicating the potential crack planes AB and CD.

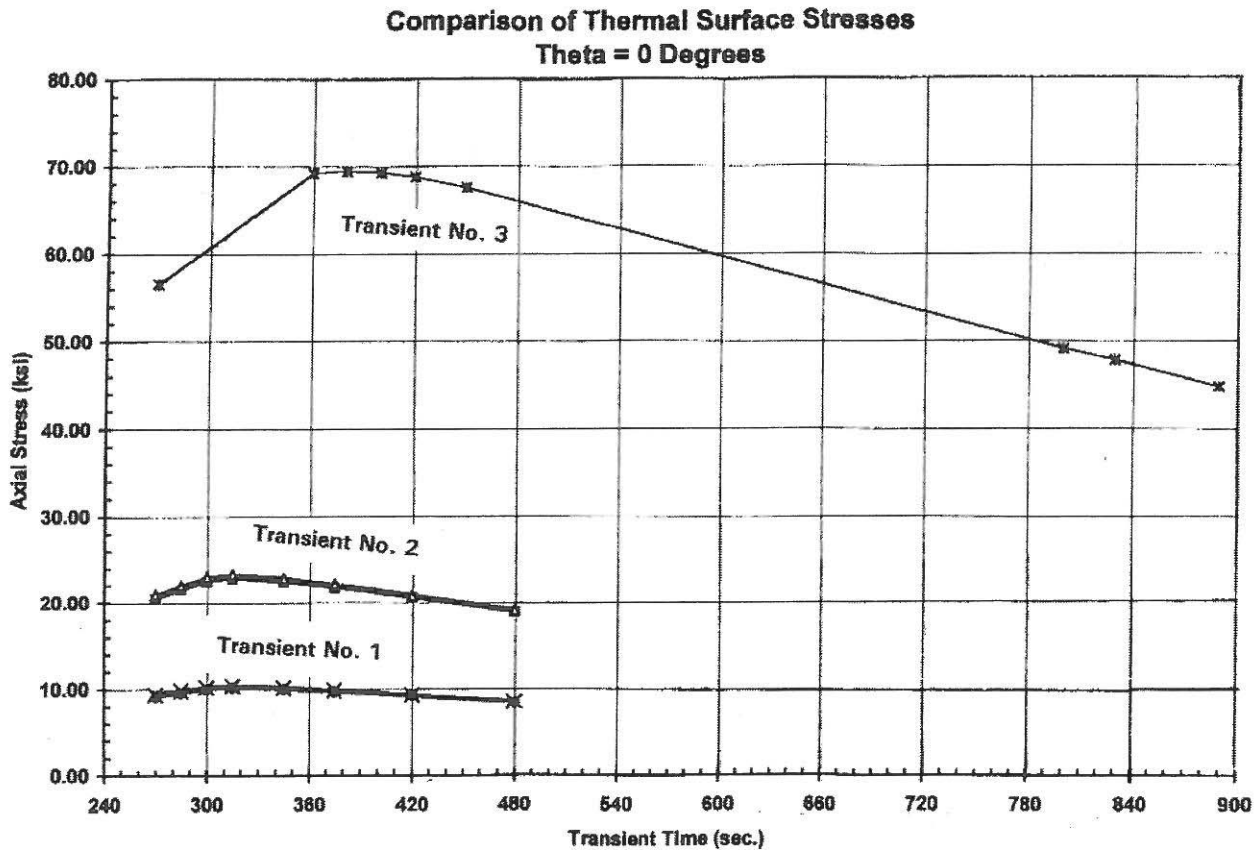
The maximum axial thermal stress predicted during the simulated transients was 72.2 ksi, located in the pipe side of the repair weld model, for Transient No. 3. For Transient No. 1, the maximum stress predicted was 10.6 ksi, and for Transient No. 2 the maximum stress predicted was 24 ksi. The thermal transient stresses are shown in the Figure 9 plots.

Figure 9 Plots of the predicated axial thermal surface (elastically equivalent) stresses resulting from the three defined temperature transients.

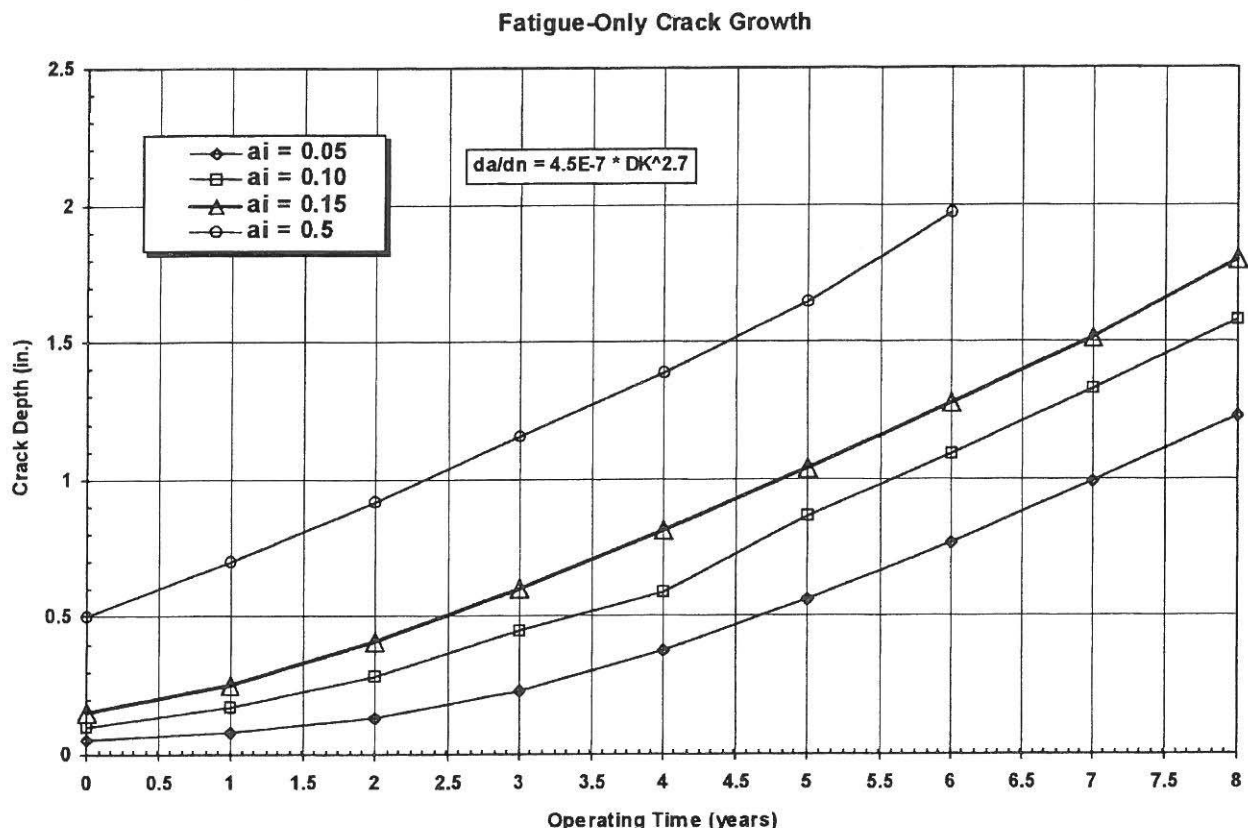
Based on the results of the calculations, crack propagation values are depicted on the curves shown in Figure 10. The resulting crack growth curve values show good correlation with the recorded ultrasonic testing measured depths at typical upstream weld locations. Also, these curves can conservatively be applied to the downstream (of spray) weld components, which are normally exposed to lesser temperature effects. It should be noted that the total combined axial stresses from all the load cases are greater on the upstream (pipe) side, rather than the downstream (tapered elbow) side of the representative repaired weld junction.

Figure 10 Curves showing the predicated crack depths versus operating time as a function of initial crack size, considering fatigue crack propagation.

A significant result of the comprehensive investigation of the cracking is represented by the fatigue crack growth curves, depicted on Figure 10. The crack depths from the curves show good correlation with the recorded ultrasonic testing measured values.

The fatigue crack growth curves, together with current crack depth measurements and ASME Code⁴ minimum wall thickness values, can be used in any component repair and/or replacement decisions. The curves were established based on data from a representative boiler only trip transient, and the reported number of boiler/turbine trips experienced by the crossover piping. Some conservative methods were employed in the evaluations, but assumptions were also made as to the severity of the boiler followed by turbine trip thermal transients.
