# Radiant Superheater Outlet Header Crack Assessment and Replacement

Robert L. Roland  
Engineering Supervisor - Maintenance  
CAJUN ELECTRIC POWER COOPERATIVE, INC.

John W. Scott  
Project Manager  
RILEY POWER INC.  
a Babcock Power Inc. company  
(formerly Riley Stoker Corporation)

*Presented at*  
Power Generation '93 Conference  
Dallas, Texas  
November 17-19, 1993

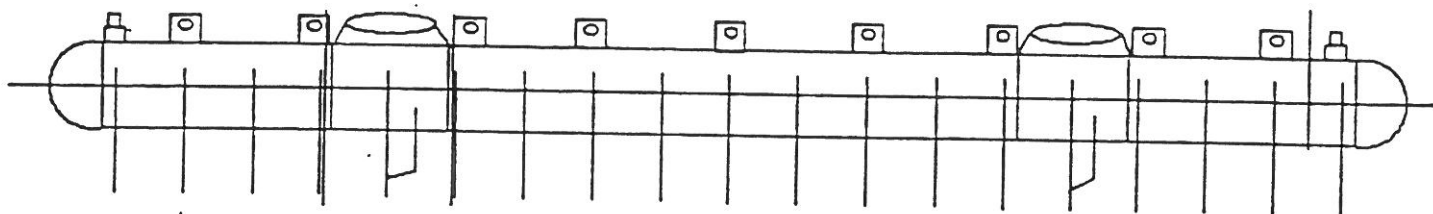
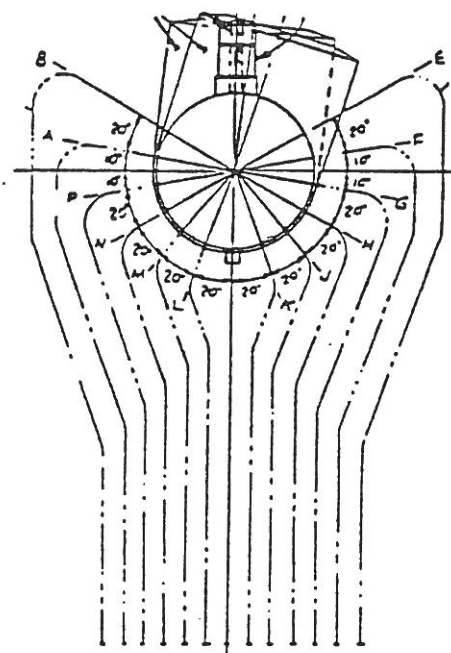
FIGURE 2

In September of 1992, Unit I was forced out of service due to a failed terminal tube on the East RSHO header. This was the first known creep-related RSHO terminal tube failure on Unit 1. During this forced outage, more bulged and swollen tubes were discovered similar to the ones found previously on Unit 2. In addition, several minor cracks in the tube-to-header welds were found. When the tube which had failed in service was cut away from the header, severe cracking was discovered in the tube bore holes at that section. The cracks originated at the ID surface of the header and ran in a circumferential path through the ligament field between the bore holes. Less severe cracks ran longitudinally along the axis of the header.

Based on the preliminary video data, the worst cracking appeared to be in the tube bundles adjacent to one of the header outlet nozzles. Less-serious cracking was seen in the ligament fields of at least five other tube bundles. Ultrasonic shear-wave testing was used to determine the depth of the cracks in the worst areas. The deepest ligament crack as measured from the ID of the header towards the OD was 1.7 inches. The header nominal thickness at this point was 3.5 inches, leaving 1.8 inches of sound ligament wall (see Figure 2). The data available at the time was not sufficient for B&W to make recommendations regarding the fitness for service.
