Recent Experience in Boiler Header Tube Nipple Failures

Presented at
Conference on Boiler Tube Failures in Fossil Plants
Sponsored by
Electric Power Research Institute
November 10-12, 1987
Atlanta, Georgia

RST-72

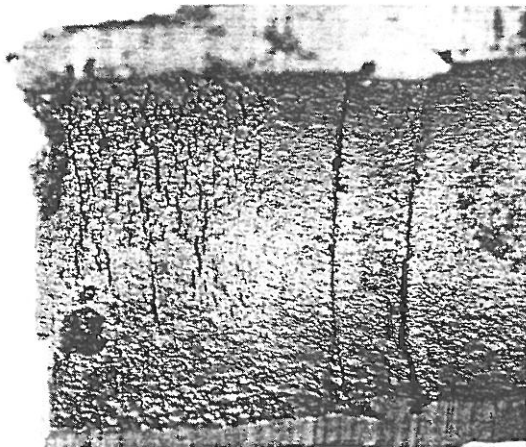
This case involves internal circumferential cracking found in tube nipples attached to an economizer inlet header. In addition to the cracking, extensive internal pitting and corrosion were present, as depicted in Figure 2. The nipples and tubes are specified as, 2" O.D. by 0.200" wall, SA-210 Grade A-1, carbon steel material.

Figure 2. Internal circumferential cracking in a tube connector attached to an economizer inlet header

The massive internal pitting and circumferential cracking, observed for this case study are attributed to a corrosion fatigue process. The cause was determined to be thermal stresses, induced by many cycles of sudden component cooling, in a corrosive environment. The fracture surface of a corrosion fatigue crack is typically thick-edged, and is oriented perpendicular to the direction of the maximum tensile stress.

9. Alleviate thermal shocking to components such as economizer inlet header tube connectors during boiler startups, by such methods as trickle feed operation or installation of an economizer recirculation system.

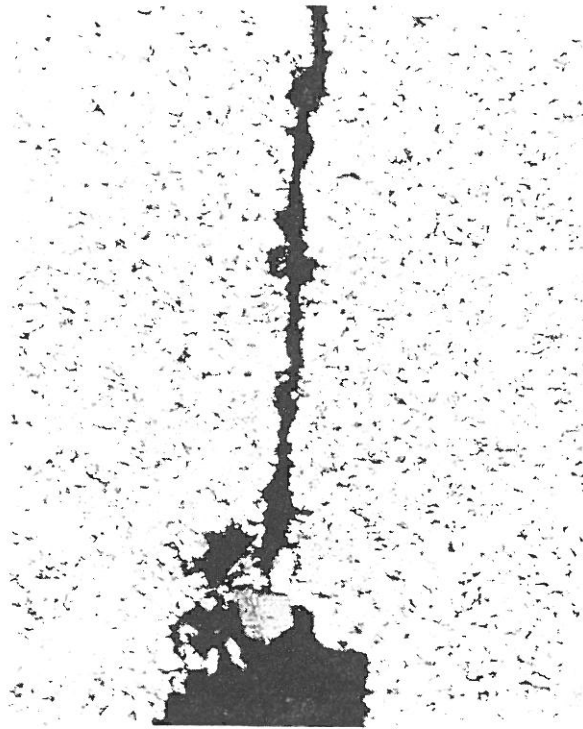
Metallurgical examination of a stub sample revealed that the cracks were nearly straight, transgranular in nature and deposit filled. Figure 3 shows one of the many cracks originating at pits on the inside surface. Some of the cracks were found to have nearly penetrated through to the outside surface of the nipple. The material structure was found to be normal lamellar pearlite in ferrite, indicating no exposure to excessive or long-term over-temperatures.

Figure 3. Photomicrograph of a crack from the Figure 2 sample, originating at a corrosion filled internal pit (100X)

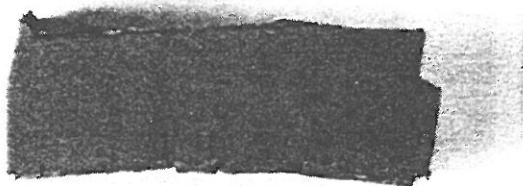
Visual examination of the tube connector samples confirmed the cracking, as shown in Figure 4. Also, both the inside and outside surfaces were thickly coated with a blue-black scale.

Figure 4. Internal circumferential cracking in a tube connector specimen at a superheater outlet header (2×)

The internal circumferential cracking described for this example is typical of a thermal fatigue condition, caused by many cycles of heating and cooling temperature excursions. This condition was enhanced by the presence of a weakened structure, due to long-term overheating, leading to the interaction of creep and fatigue.

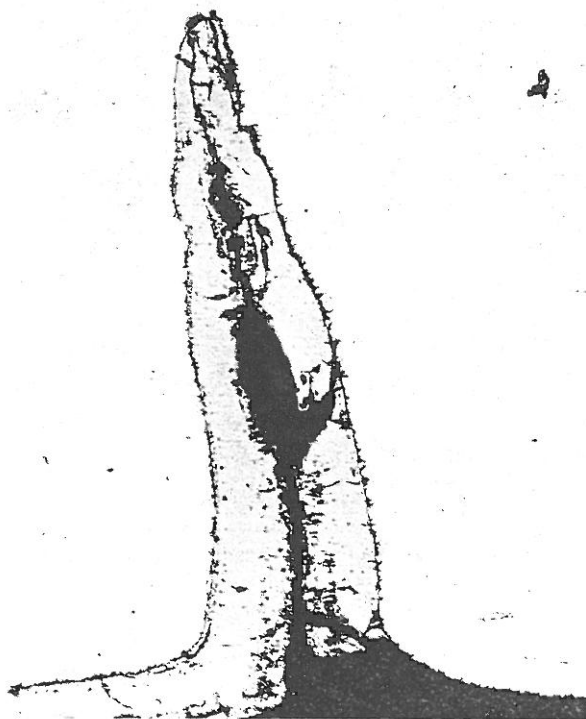
Figure 5. Photomicrograph of a typical transgranular crack from the Figure 4 sample, showing thick oxide deposits (100×)

Metallurgical evaluation of the samples showed many transgranular, oxide filled cracks, up to 0.120" deep. A photomicrograph of a typical crack is shown on Figure 5. The structure was found to be completely spheroidized, with evidence of a slight temperature gradient through the wall. This indicates that the metal has been exposed to high

temperatures for an extended period of time. This condition has been aggravated by the presence of the thick (0.020") internal scale.

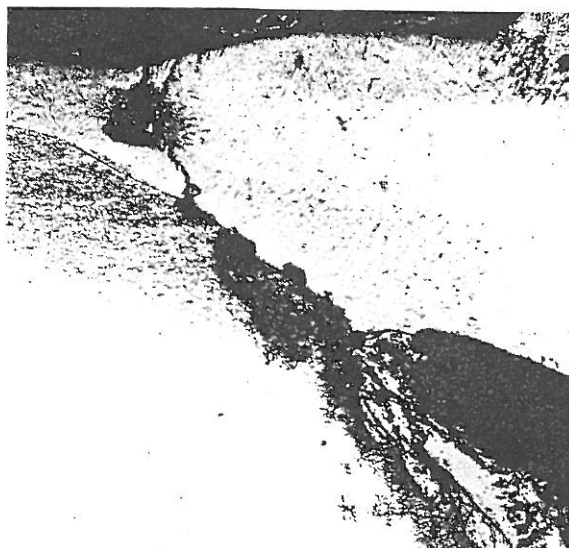
Specimens were cut from the tube sample, transverse to the crack, in preparation for microscopical examination. The results of the investigation showed that the crack had originated at a slag inclusion near the toe of the weld. It had propagated outward, and inward through the weld and into the tube along the weld interface, and through the tube wall. Figure 6 shows part of the crack, together with the heavy oxide scale built up between the crack and the large void existing between the tube and the weld metal.

Figure 6. Close-up of an external circumferential crack originating in a void near the toe of the attachment weld at a superheater header (75×)

The failure is attributed to thermal fatigue, induced by thermal expansion cycling, with the crack initiating at a stress raiser. The crack had existed for some time as evidenced by the thick oxide scale. The oxide deposit assists in the crack propagation because the volume occupied by the oxide is greater than the volume of the metal from which it is formed. The oxide product prevents the crack from closing during the compression portion of the stress cycle, and increases the stress at the crack tip. The crack then propagates faster due to the formation of the wedge.

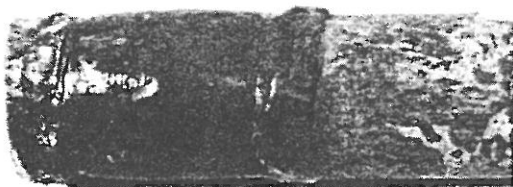
This example concerns a radiant superheater outlet header inlet tube connector, that contained a circumferential crack at the toe of the attachment weld. Also, the tube connector portion was found to be swollen. Refer to Figure 7. The tube material is specified as 1 3/4" O.D. by 0.240" wall, SA-213 Grade T-22.

Figure 7. As received superheater tube connector sample with an external circumferential crack and swollen diameter

A visual and dimensional examination showed the crack starting at the toe of the weld and extending well towards the inside surface. Much internal and external blue-black scale was noted. The stub portion was found to be swollen to 1.844" O.D. compared to the normal 1.750". This portion also showed minor thinning (0.220") on one side.

The conclusion for this case, is that the cracks at the toe of the weld are indicative of fatigue by thermal expansion. An earlier modification to the boiler roof seals had shortened the length of the inlet superheater tubes, thus increasing thermal expansion stresses. In addition, the swollen stub, the spheroidized structure and the thick blue-black scale all confirm high metal temperature exposure, leading to the interaction of creep and fatigue.

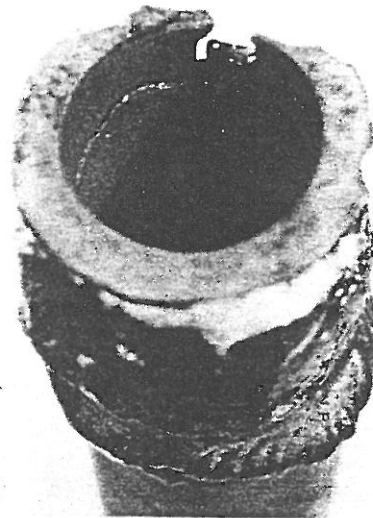
Figure 8. Superheater tube nipple sample with circumferential and longitudinal cracking

This example involves both externally originating circumferential cracking and internal longitudinal cracking, in tube connectors attached to a high temperature superheater outlet header. See Figure 8. For this particular case, the longitudinal cracking was found to exist in the tube nipple, the header bore hole and the header ligament field. The header cracking was located by fiberoptics and confirmed by ultrasonic techniques. The tube material is specified as, 1 3/4" O.D. by 0.250" wall, SA-213 Grade TP321H stainless steel.

The circumferential crack in the attachment weld was obviously due to thermal expansion fatigue, as described for several other cases. The cracks had originated on the outside surface and propagated through to the inside surface.
