**RECENT EXPERIENCE IN  
CONDITION ASSESSMENTS OF  
BOILER HEADER COMPONENTS  
AND SUPPORTS**

James P. King  
DB Riley, Inc.  
Worcester, Massachusetts

Presented at the  
1996 ASME Pressure Vessels and Piping Conference  
July 21-26, 1996  
Montreal, Quebec, Canada

RST-143

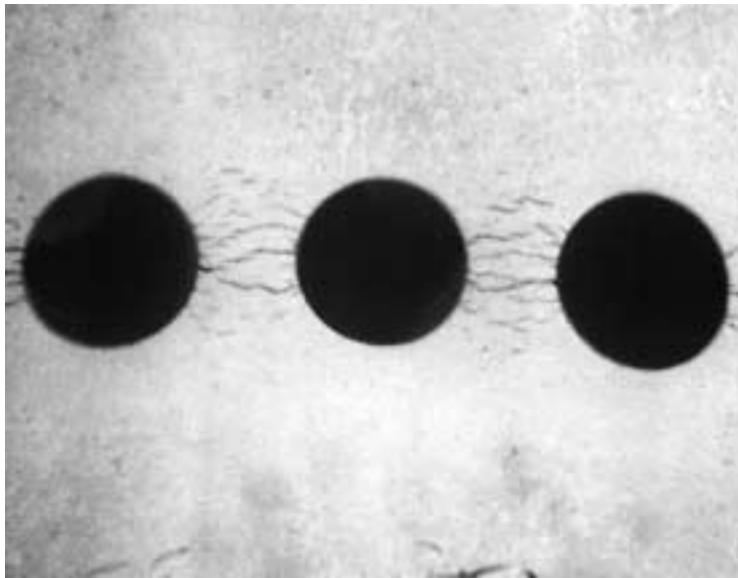
The more serious internal header bore hole and ligament cracking is a result of thermal shocking due to cycling type duty. Common types of operation are overnight reduction in load or boiler shut off. For the latter case, a daily morning boiler re-start will introduce colder feedwater into a warmer header with resultant thermal shocking. This temperature difference can be as high as 3000°F. After several thousand of these events, internal fatigue cracking will initiate and propagate in the higher stress ligament fields of the header wall between bore holes, and also longitudinally along the bore hole surfaces. Figures 1 and 2 depict this type of cracking. Periodic internal inspection of an economizer inlet header should be performed by use of fiberoptic or video probes as a check on this internal cracking. Again, the regions of the inlet nozzles should be inspected first. Headers with an underdrilled design are not as susceptible to the cracking, since their ligament efficiency is much higher.

*Figure 1 Inside Surface of Economizer Inlet Header  
Showing Circumferential Ligament Cracking*

Recommendations to alleviate this cracking condition include a review of boiler operating practices, incorporation of a continuous trickle feed during shut off periods, and installation of a downcomer recirculation system.

Once this type of internal cracking is found, the header has a finite life, since repair of internal originating cracks is not possible due to lack of access. An accurate determination of the crack depths should be made, using ultrasonic shear wave techniques. The crack depth information should then be input to stress analysis and fracture mechanics calculations for a definitive remaining component life assessment. Based on these results, measures to alleviate the thermal shocking should be incorporated, along with scheduled monitoring of the crack depths, with an ultimate component replacement date established. A part of the recommended actions may be a change in boiler operating conditions, such as a reduction in pressure and/or essentially base loaded duty, with a minimal number of transients allowed.

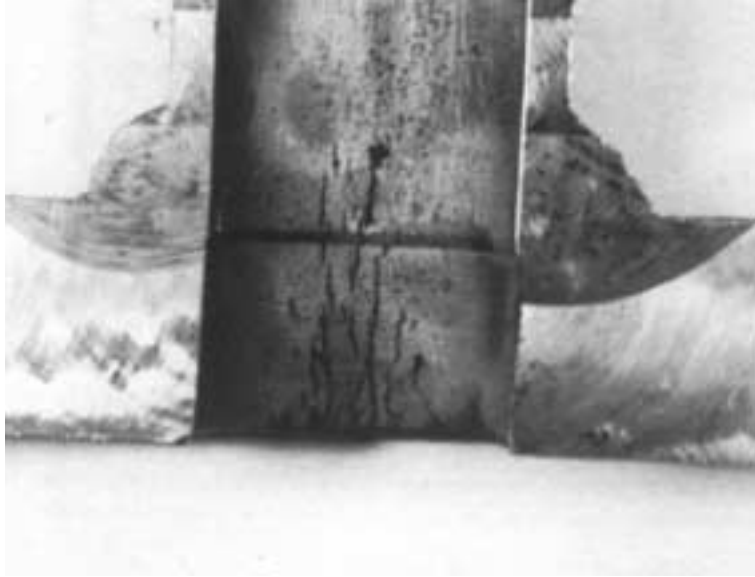
*Figure 2 Sample Piece of Economizer Inlet Header Showing Cracking in Header Bore Hole and Tube Connector*

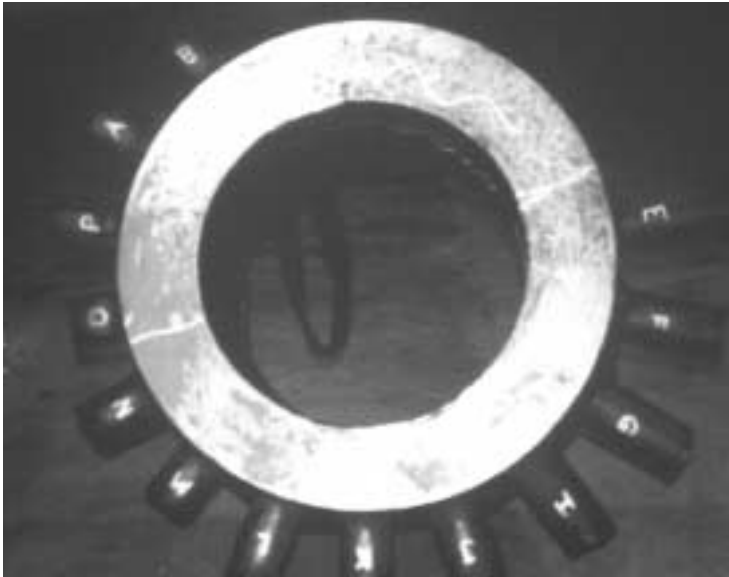
*Figure 3 Sample Piece of Radiant Superheater Outlet Header*

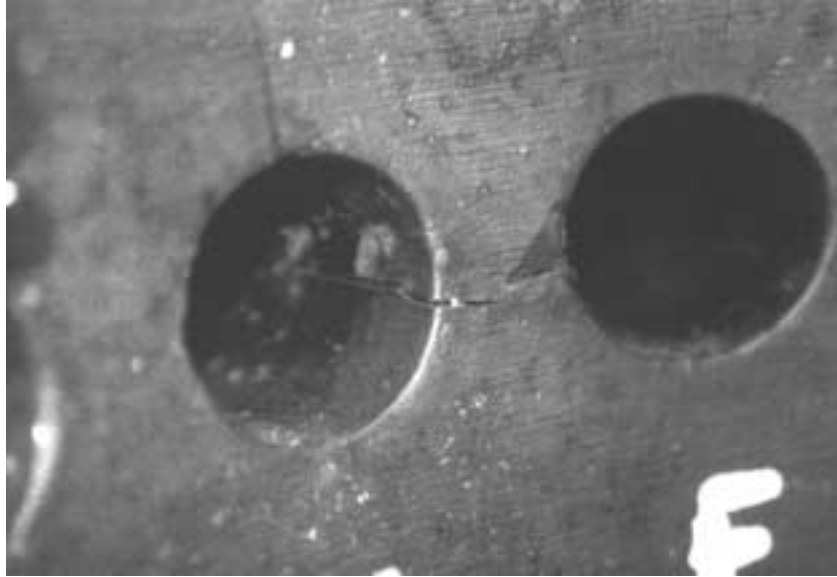
This type of internal ligament cracking, as shown in Figure 4, from the Figure 3 sample piece of header, can be easily detected by a planned fiberoptic or video probe examination. The presence of creep in header components can be ascertained by outside diameter measurements as a check on swelling, and by external metallographic replication as a check on the surface microstructure. When internal ligament cracks are found in a high temperature header, ultrasonic shear wave testing should be employed to determine the crack depths. Repairs for this cracking condition are not possible due to the lack of access to the ID surfaces. Again, a stress analysis and fracture mechanics study should be performed to determine an accurate remaining life value for the component. The Reference 5, BLESS computer program, is a powerful tool currently used to provide failure evaluations for headers with internal cracking. The BLESS code is capable of performing deterministic and probabilistic remaining life estimates for boiler header components. The Reference 6 paper presents a case history of a cracked header investigation using the BLESS program.

*Figure 4 Closeup View of Inside Surface of Header Sample Piece Showing Cracking in Circumferential Ligament Field and Bore Hole*

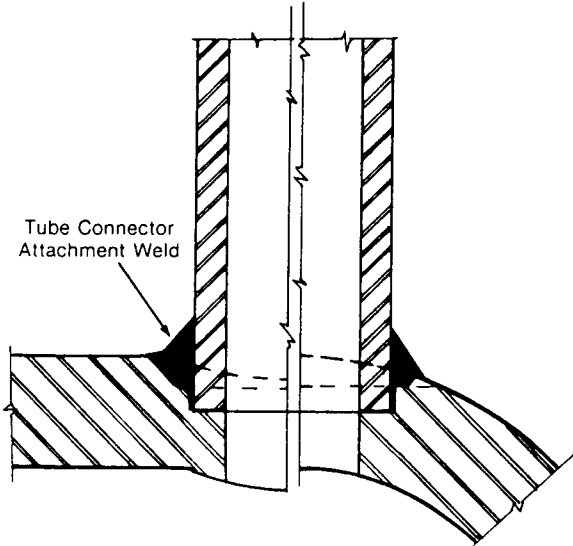
The most common external cracking is at the weld joining the inlet or outlet tube stubs to a header. Sometimes the cracking can be severe enough to cause a tube leak. A single header can have hundreds of these welded joints. The quality of the original welds can be a factor, by way of stress intensification, in the initiation of the cracking. A typical tube stub to header weld is shown in Figure 5. The relative difference in size between the two components tends to make this connection a highly stressed location. In many cases cracking has been found to have initiated in or adjacent to the weld, including locations of weld undercut. Figure 6 and 7 show a typical superheater or reheater outlet header located in the penthouse with the inlet tubing routed from the furnace, through the roof seats, to the header. Figure 7 depicts the differential thermal expansion which can occur between the header and the furnace roof tubes, which has a direct effect on the header inlet tubes. During daily load swing operation, the inlet tubes will be subject to the axial expansion/contraction of the header, in combination with the radial expansion effects imposed by the tube routing flexibility, or lack of same. After several thousand events, crack initiation will result at tube locations with the stiffest routing, highest local steam temperatures and with the poorest quality welds. As mentioned earlier, an engineering study, including a review of temperatures and tube flexibility stresses, is required to consider all of the many variables in determining

Figure 5 Typical Tube Connector to Header Junction

For the more common case of header to tube connector weld cracking, repair or replacement is much more easily accomplished due to the external access. The cracking is usually found in the toe of the weld in the tube or header metal heat affected zone. A repair method will involve grinding out the cracks, with confirmation by dye penetrant testing, and then re-welding, utilizing the appropriate pre- and post-weld heat treatment procedures. In the re-welding process, smooth, blend grinding steps should be done for the weld exterior to insure minimizing the joint stress intensification factor.

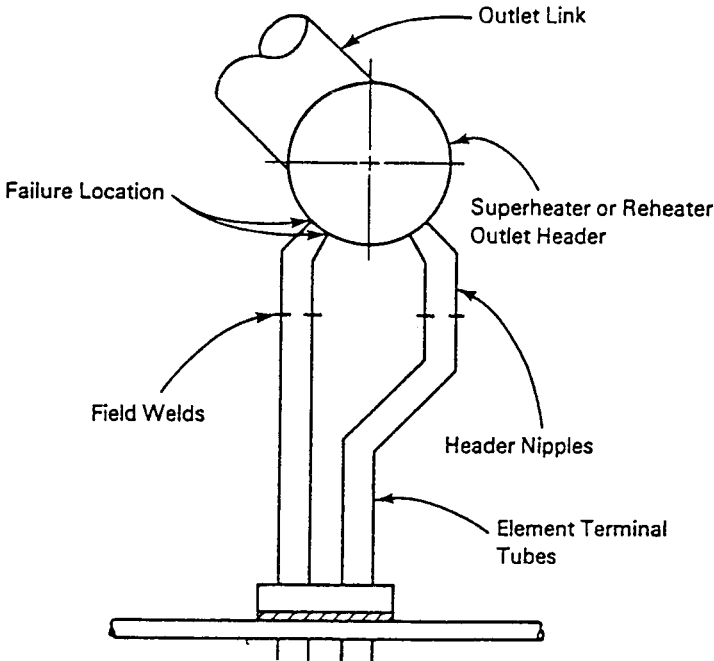
Figure 6 End View of High Temperature Header Showing Differences in Inlet Tube Routing and Flexibility

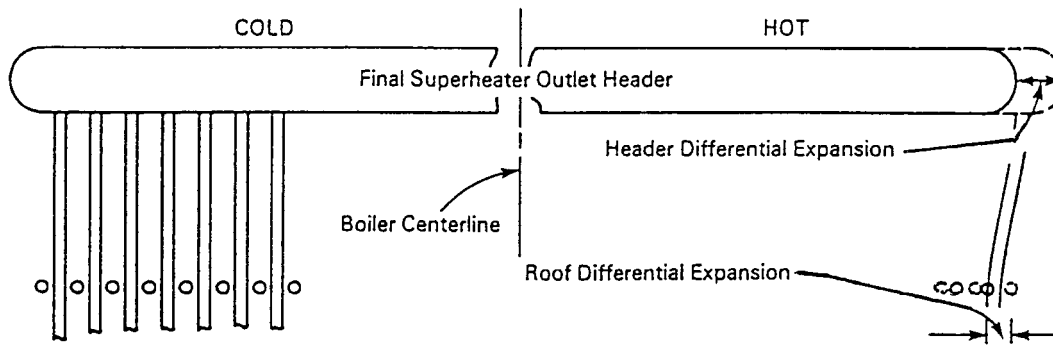
*Figure 7 Front View of Figure 6 Outlet Header Showing Differential Expansion (Axial) Between Header Tubes and Furnace Roof Tubes*
