# Recent Experience in Condition Assessment of Boiler Piping Components and Supports

James P. King  
Design Manager

RILEY POWER INC.  
a Babcock Power Inc. company  
(formerly DB Riley, Inc. )

1995 ASME Pressure Vessels and Piping Conference

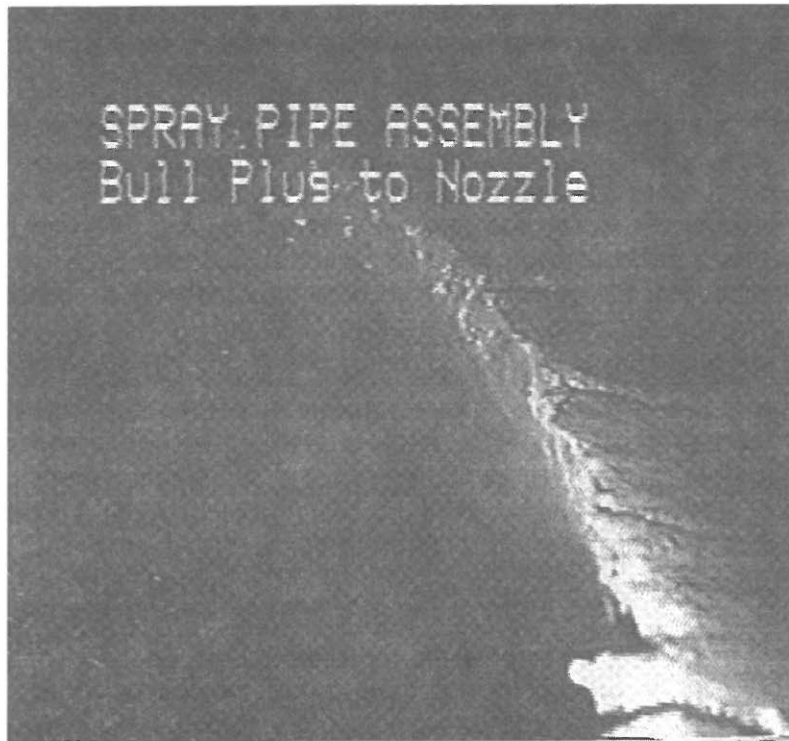
This unit had been operated in a cyclic mode for over thirty years. An internal inspection of the attemperator assembly and superheater crossover piping, both upstream and downstream, was performed with a 20 foot long video imagescope. Many cracks were found in an elbow located just downstream of the spray liner. The cracks were confined to the elbow access hole closure assembly. Around the opening in the elbow at the closure, there were many radial shallow cracks approximately " to 1" long (see Figure 2). There were also some partial circumferential cracks inside the attached bullplug nozzle. The inside surface of the closure cap was also pitted and cracked. The inside surface of the liner was found to be heavily pitted. A severe circumferential crack was also found in the attachment (fixed end) ring (see Figure 3). The removed spray nozzle was examined by dye penetrant and found to have extensive cracking and pitting on its surfaces. The cracking, approximately seven inches long, was on both sides of the spray orifice (see Figure 4), and was attributed to cyclic thermal fatigue. No other problems were found in any of the other upstream and downstream components. Recommendations were given to the client for repair or replacement of the subject attemperator and crossover piping components. The access closure was also relocated farther downstream in the piping system.

*Figure 2 Radial Cracking in Edge of  
Access Hole Closure Located in an Elbow  
Downstream of an Attenuator in Crossover Piping*

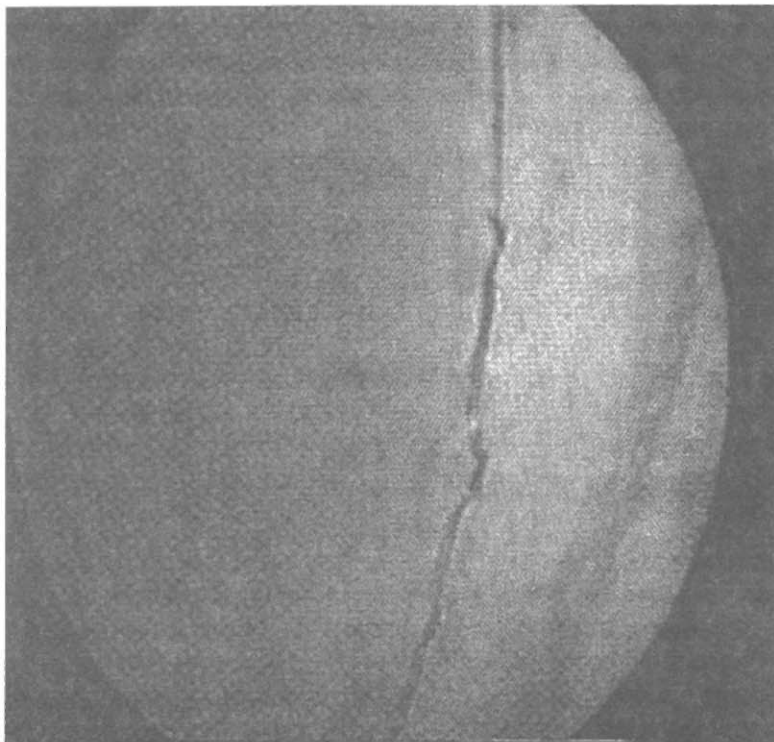
These identical large utility boilers are equipped with twin radiant superheater outlet headers. Each of these headers has two outlet nozzles for crossover to the high temperature superheater inlet headers. Each of the four crossover pipes contains a desuperheater spray station. During a boiler condition assessment program of Unit No. 1, all four spray stations were internally inspected by video imagescope, with access through a removed radiographic plug upstream of the spray nozzle. All four of the spray assemblies were found to have crack indications in the attachment ring welds that anchor the liner to the inside of the pipe. The cracking was attributed to thermal fatigue due to water spray cycles. Also, the radiant superheater had a history of overtemperature conditions. The liners were still in position and the spray nozzles were free from surface cracks. The subject attachment welds were repaired and reinspection intervals were incorporated into the plant's maintenance planning program.

*Figure 3 Videoscope Image of Circumferential Cracking in  
Attenuator Liner Attachment Ring Weld*

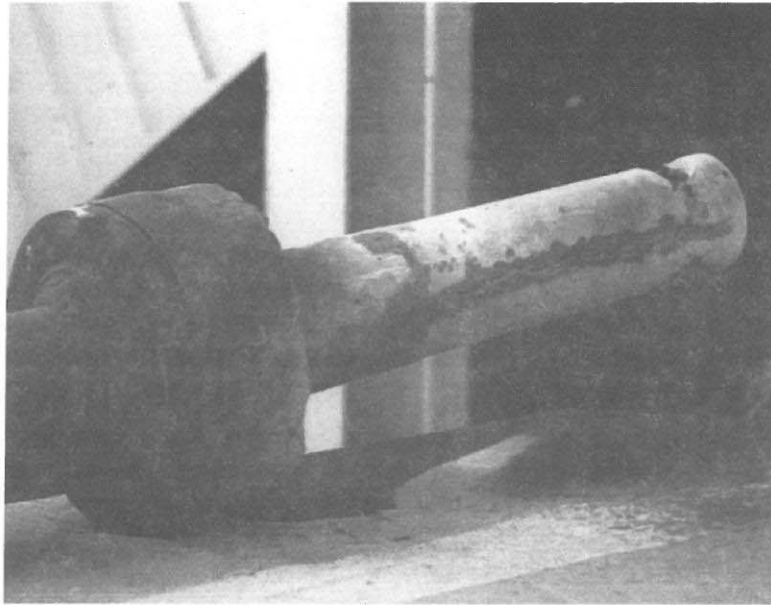
Six months later, the same components were inspected in Unit No. 2, a unit approximately five years newer than Unit 1. The results of the internal fiberoptic inspections of the Unit 2 attemperators revealed no problems with the attachment ring welds. However, one of the four spray nozzles was found to have a severe longitudinal crack on its rear face. This nozzle was recommended for replacement.

*Figure 4 Desuperheater Spray Nozzle with  
Aligned Pitting and Cracks on Each Side*

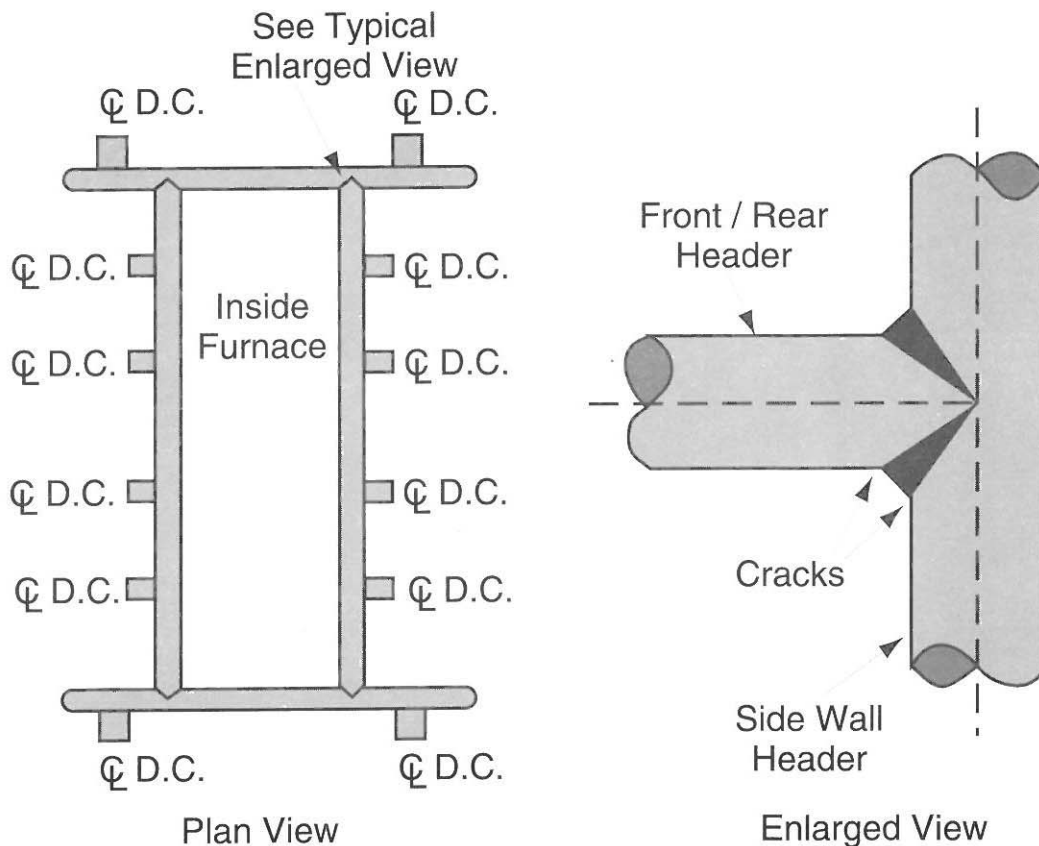
A common lower water wall header arrangement is called a “raft” design in medium- to large-size utility boilers (see Figure 9). In this header design, cracks have been discovered in the welds joining the side headers to the front and rear headers, as shown in the Figure 9 detail. This cracking has occurred in units in service for ten years or more, and is sometimes accompanied by water wall tube nipple cracking. This cracking has been attributed to a significant amount of cycling or load swings for units originally designed for base loaded operation. There have also been examples where the effects of malfunctioning supports on the attached downcomer piping lines have been found to initiate or aggravate cracking in the header joint welds.

Figure 9 “Raft” Design Lower Waterwall Headers

This cracking can be resolved by grinding and welding, together with an engineering study to determine the effects of differential temperature and stress values for the adjacent components during steady state and transient boiler conditions. In addition, the current functionality of the downcomer support system should be addressed.

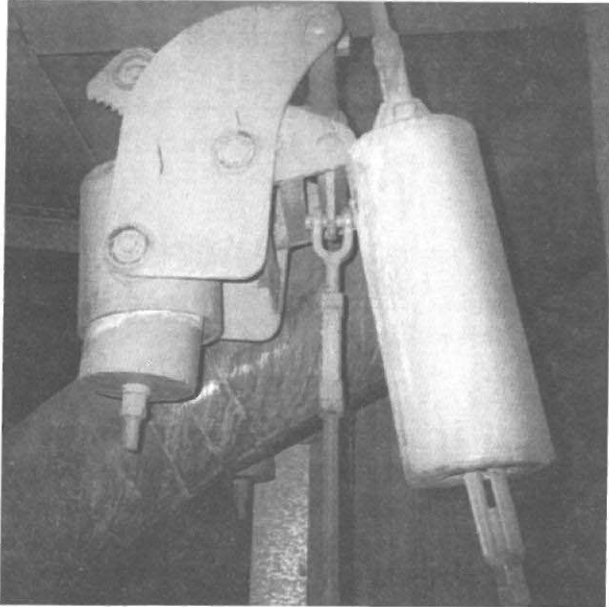
Many fossil fired units are located near the ocean. Consequently, the units experience some additional external corrosive effects. This can be reflected in the condition of the downcomer support assemblies. The major problems which can be found with the piping supports include damaged components, interferences with structures, and twisted attachment plates. These can be due to a lack of scheduled monitoring and maintenance programs for the components, and the effects of abnormal or unaccounted-for unit events such turbine trips. Examples of these problems with constant force supports and their structural attachments are shown in the Figures 5 through 8. Such problems are a result of neglect, but also show evidence of some severe unaccounted-for loadings. The constant force supports shown are obviously not functioning as designed and this can cause problems elsewhere in the piping system.

*Figure 5 Misaligned Spring Can on Constant Support Hanger on Downcomer Pipe*

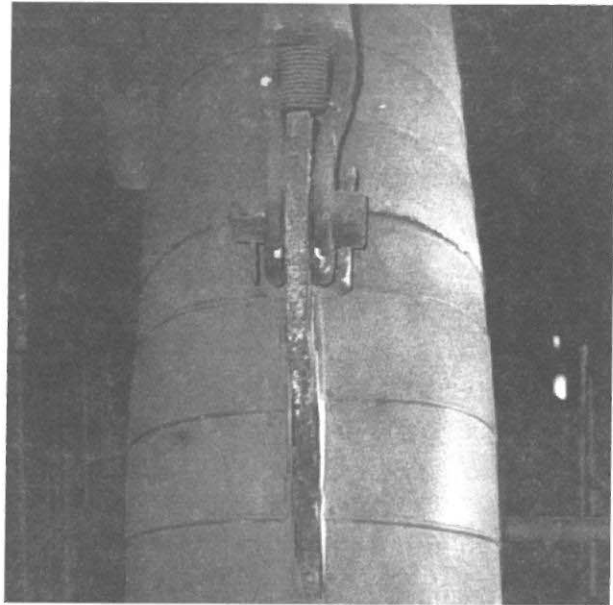
*Figure 6 Bent Downcomer Attachment Support Plate*

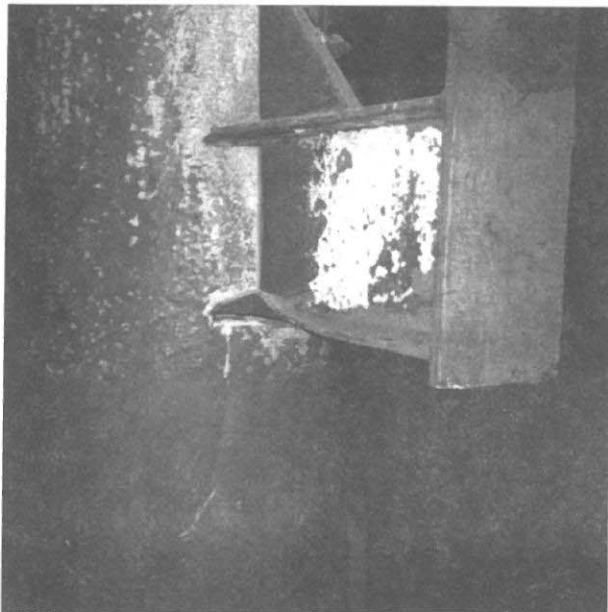
*Figure 7 Damaged Beam Support on Downcomer Pipe*

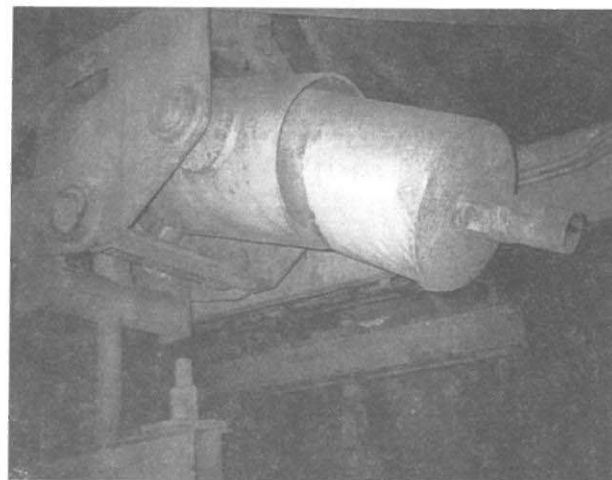
*Figure 8 Damaged Spring Can on Constant Support Hanger*

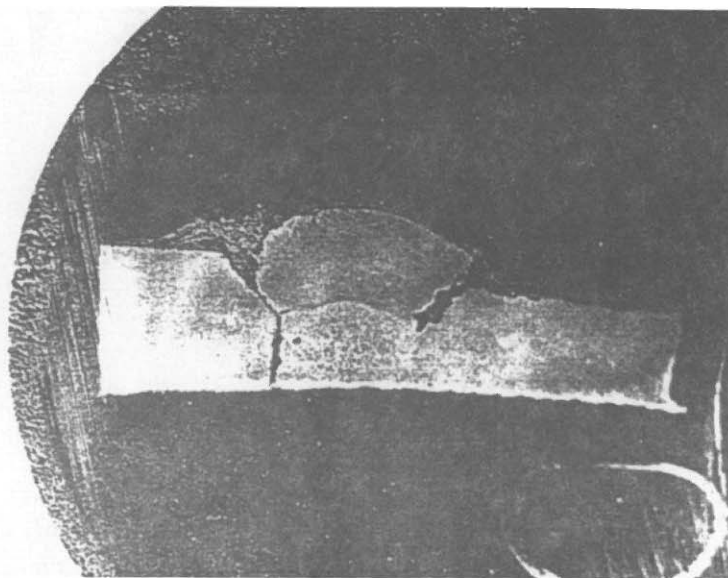
*Figure 10 Macroscopic View of  
Lower Waterwall Header Tube Stub Weld  
with Backing Ring Showing Thermal Fatigue Cracking,  
Corrosion, and Deposit Buildup*

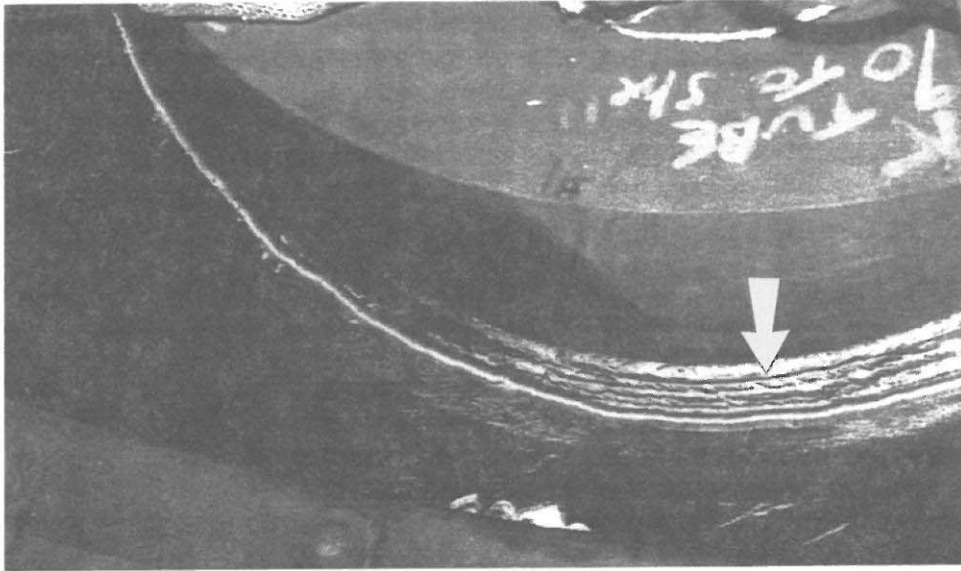
Crack indications found on the drum inside surface are typically located in the weld metal, toes of welds, and along the fusion line of the weld to shell metal. These can usually be attributed to original fabrication weld flaws such as lack of fusion or overlap. However, other cases of similar cracking were found to be caused by thermal or corrosion fatigue due to cycles of drum-related steam/water temperature and flow excursions based on the mode of boiler operation. Figures 11 and 12 show examples of internal drum nozzle cracking. Cracking in the external pipe or nozzle-to-drum shell welds are more likely caused by cyclic thermal bending moment loadings, which can be aggravated by malfunctioning supports on the downcomer piping.

*Figure 11 Downcomer Weld at Inside of Steam Drum.  
Crack Indications are Present in the Weld  
and Along the Fusion Line at Base of Weld*

Scheduled magnetic particle examination of the subject welds is the primary recommended method to determine the presence of crack indications. If indications are found, then a more detailed assessment using ultrasonic shear wave techniques and metallographic replication should be used. The results of an assessment program will provide the appropriate recommendations for monitoring and/or repair.

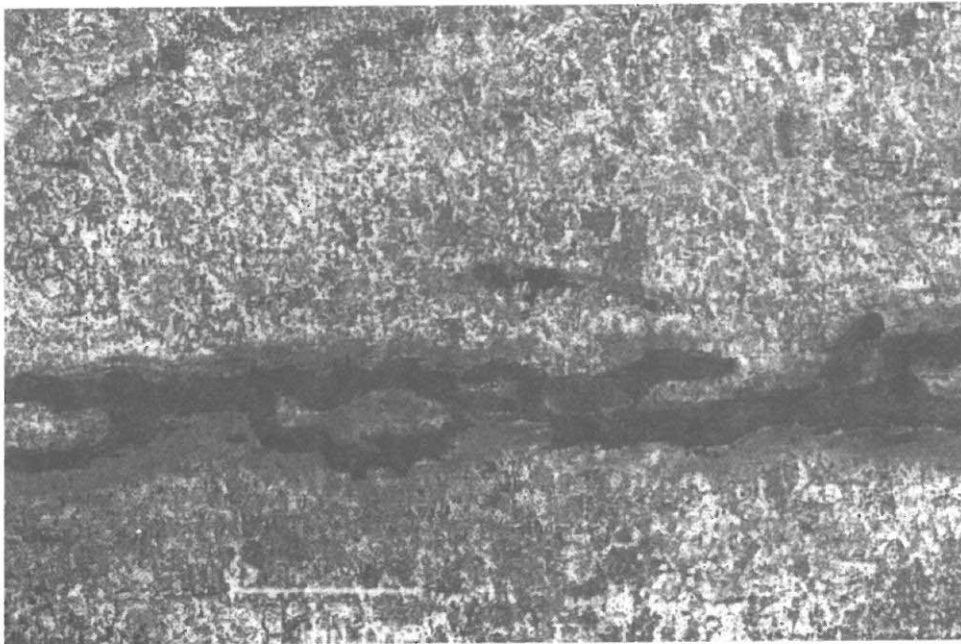
*Figure 12 50X Magnification of Replica of Crack Indication  
in the Weld Metal, as Described in Figure 11*
