Recent Experience in Dissimilar Metal Weld Failures

Gary R. Wood
Senior Metallurgical Engineer
American Electric Power

Presented at
International Conference on Boiler Tube Failures in Fossil Plants
Sponsored by EPRI and TVA
November 11-13, 1997
Nashville, Tennessee

RST-148

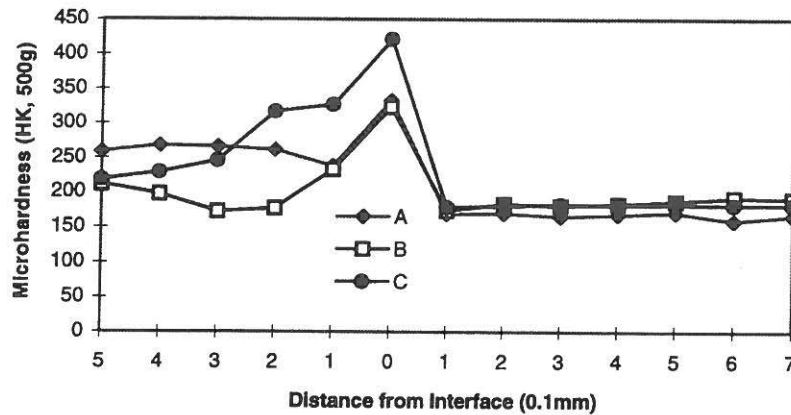
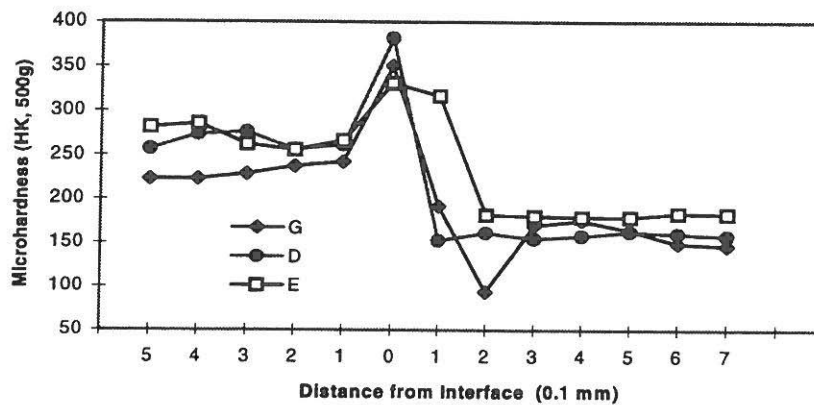
Figure 1 Typical Microhardness Profiles of DMW Joints

- (a) Variation in microhardness across the interface of the Fe-based weld metal (left) and T22 HAZ (right) of Samples A, B, and C.
- (b) Variation in microhardness across the interface of selected Ni-based joints. Sample G is from a failed tube. The trough in HAZ hardness is attributed to decarburization at the fracture surface.

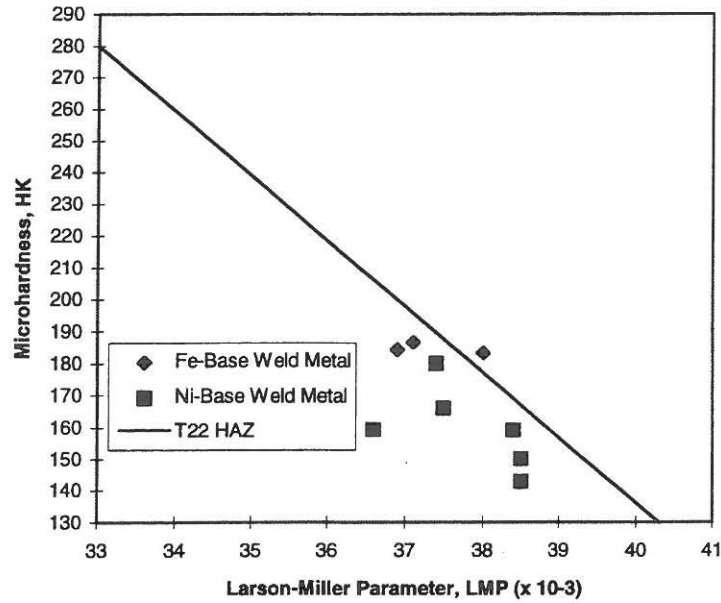
Figure 2 Microhardness of T22 HAZ vs. Larson-Miller Parameter
The T22 HAZ data generated in the current study is plotted against the best-fit line of the T22 HAZ microhardness data generated in the EPRI study⁽⁴⁾.

Larson-Miller parameter (LMP) prepared using the best-fit line of the EPRI project and the calculated LMP from this work. These tests were performed to demonstrate that the current sample population matches the characteristics of the larger population of DMWs in the EPRI study. Note that in most cases, the data generated from this work given in Table 3 closely agrees with the EPRI samples. Two examples which did not, namely samples D and H, merited closer scrutiny. It was thought that in the case of sample D, higher tube metal temperatures caused by an overtemperature excursion were responsible for the lower HAZ hardness. The lower HAZ hardness in failed sample H was caused by decarburization of the fracture surface.

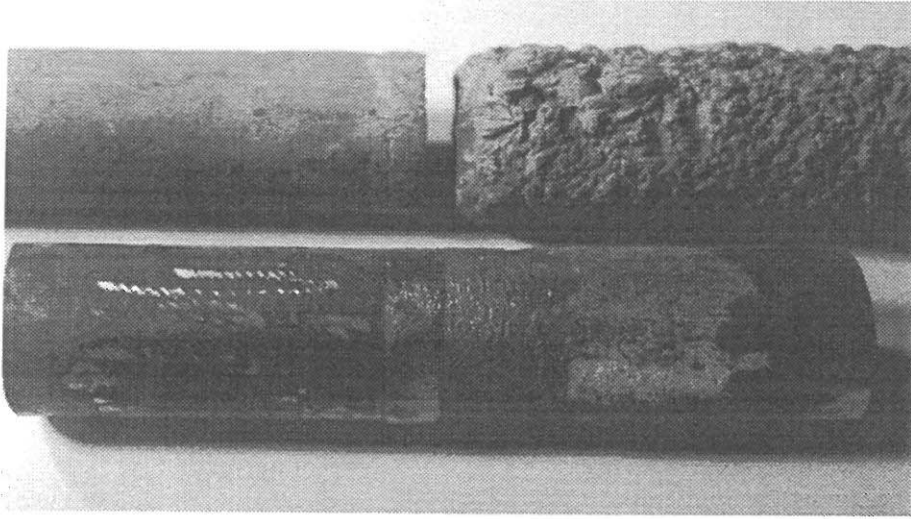
Figure 3 is a macrophotograph of a failure which prompted the removal of sample D, also shown. The damage mechanisms observed for the two types of welds were consistent with those historically experienced by iron-base and nickel-base joints. The iron-based joints experienced cracking along prior austenite grain boundaries (Figure 4) while the nickel-based joints showed microvoid formation and interfacial cracking which could be observed by light microscopy (Figure 5). In the cases of the non-standard weld chemistries, microcracking resembling creep failure occurred on crack paths angled away from the weld fusion line as well as interfacial cracking (Figure 6).

*Figure 3 Macrophotograph of DMW Samples
The top tube exhibits features typical of a DMW failure. The failure of this tube prompted examination of the bottom tube, Sample D.*

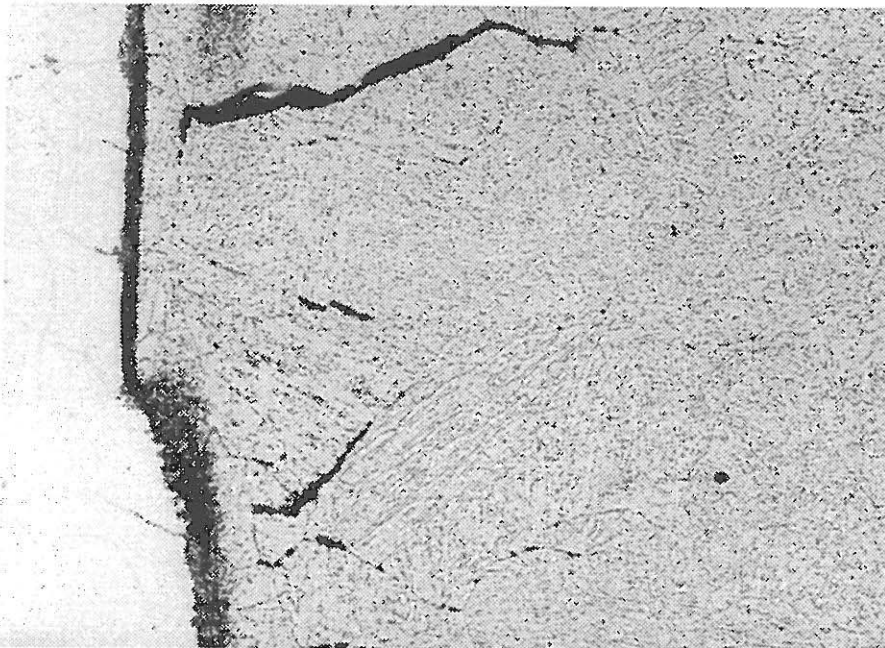
*Figure 4 Typical Cracking in an Iron-based Filler Metal DMW
Creep damage and cracking is seen along prior austenite grain boundaries.
Etched in Nital. 400X*

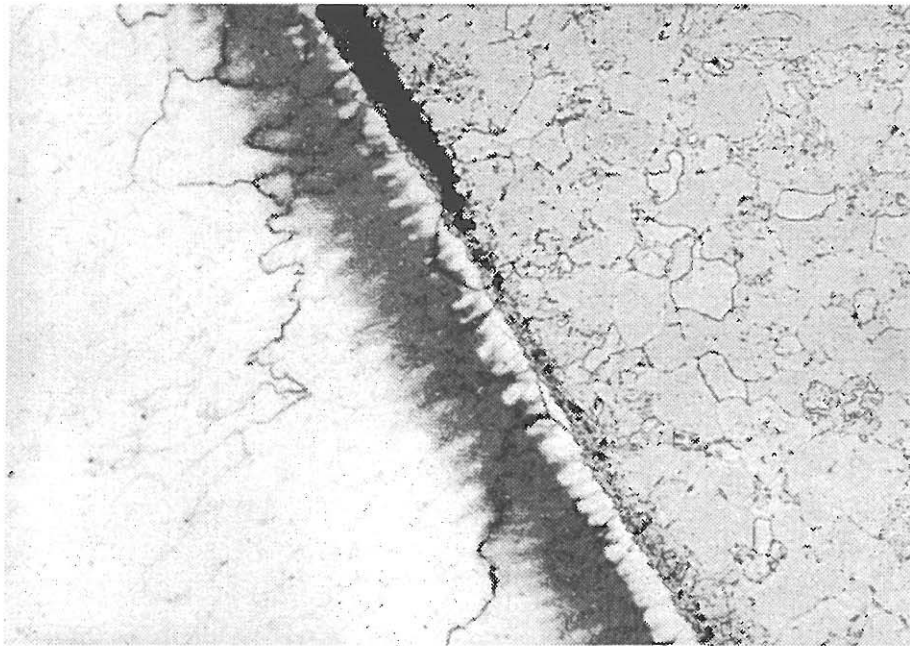
*Figure 5 Typical Cracking in a Nickel-based Filler Metal DMW
Microvoid formation and cracking is seen in association with the
interfacial carbides at the weld fusion line. Etched in Nital. 400X*

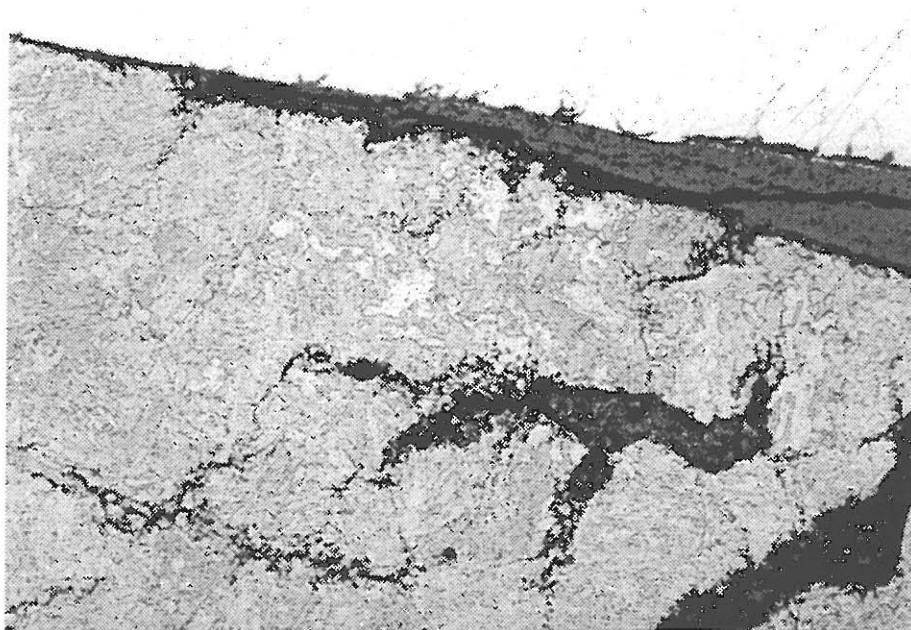
*Figure 6 Cracking in a Non-standard Alloy Filler Metal DMW
Interfacial cracking and prior austenite grain boundary creep damage is seen.
Etched in Nital. 400X*

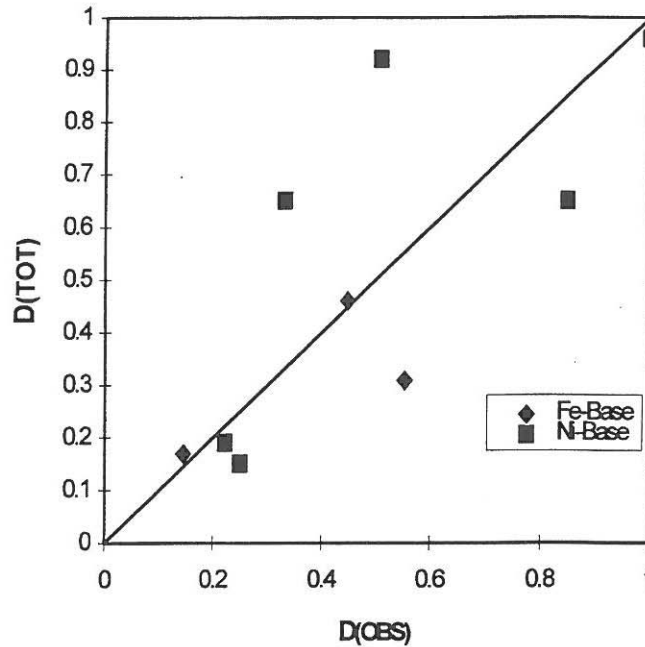
In general, the iron-based joints had the best agreement between observed and calculated damage. In the case of nickel-based joints, some improvement in the degree to which the observed damage correlated to the calculated damage was obtained by closer examination of tube metal temperatures via oxide scale estimation. An additional improvement was made in the calculation of the D_S factor by considering how the unit was operated over its life. For example several units in the study were base-loaded as new units but for a significant portion of their recent service years were used as peak load units which increases the influence of the secondary system load damage on the total life. Figure 7 is a plot of the results obtained in the damage study. The general agreement of the observed damage vs. calculated damage is a strong argument for accurate determination of critical operating variables, such as any changes in the loading and cycling of the unit. In the case of sample D, foreknowledge of an overtemperature excursion can aid in assessing system load damage.

Figure 7 Calculated Total vs. Observed Damage in DMW Samples

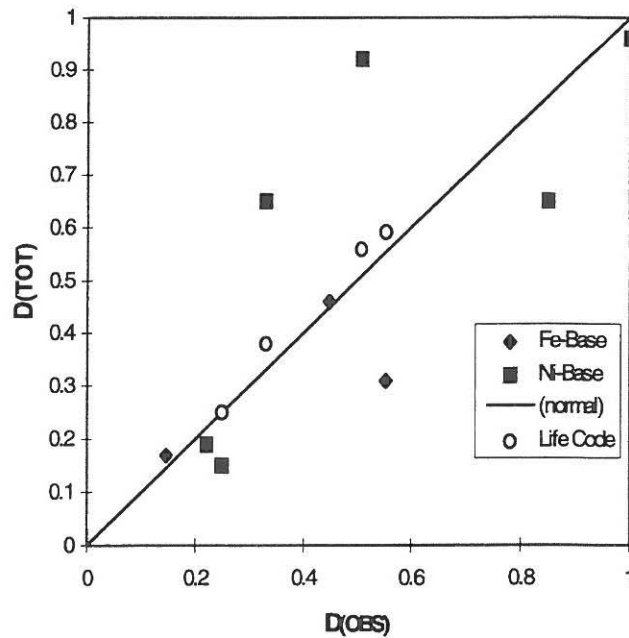
Figure 8 is a re-plot of the data used in the original PODIS code evaluation. Better agreement between the observed damage and calculated damage (Table 5) was obtained by using the DMWLIFE computer code developed by Structural Integrity⁽⁶⁾. The DMWLIFE program improves the estimated life of nickel based joints because the coefficients in the expressions for D_P and D_S were developed empirically by analyzing many samples from participating utilities.

Figure 8 Calculated Total vs. Observed Damage in DMW Samples Using DMW LIFE Code
