# Recent Experience in the Inspection and Assessment of Boiler Header and Steam Drum Cracking

Brian P. Holbrook  
Manager, Stress Analysis and Structural Steel  
RILEY POWER INC.  
a Babcock Power Inc. company  
(formerly Riley Stoker Corporation)

James P. King  
Manager, Boiler Evaluation  
RILEY POWER INC.  
a Babcock Power Inc. company  
(formerly Riley Stoker Corporation)

*Presented at*  
Third Conference on Fossil Plant Inspections  
Sponsored by  
Electric Power Research Institute  
and  
Baltimore Gas and Electric Company  
August 13-15, 1991  
Baltimore, Maryland

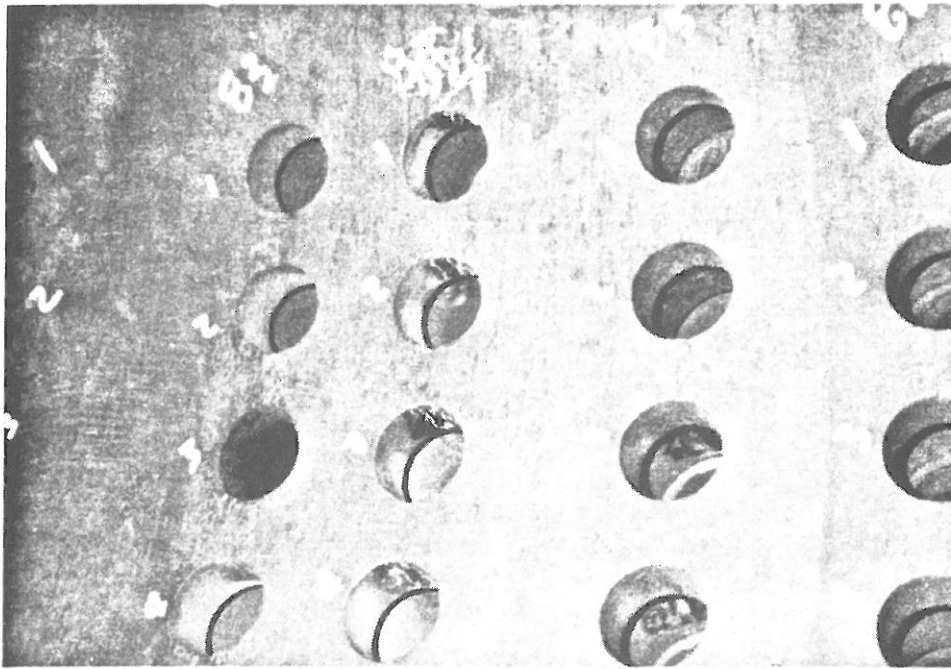
Since 1989 Riley Stoker Corporation has been involved with several cases of ligament cracking within steam drums. The cracks have been primarily located within a circumferential ligament boiler bank tube field, and have propagated down into the tube bore holes. In all cases, the discovery of the cracking has been visually established utilizing routine maintenance inspections of the inside surface of the drums. **Figure 1** illustrates the inside surface of a steam drum having bore hole cracking. Common characteristics have included units that do not have economizer systems regulating feedwater into the drum, or which have damaged feed water distribution

Figure 1 Inside surface of steam drum having bore hole cracking in the circumferential ligament

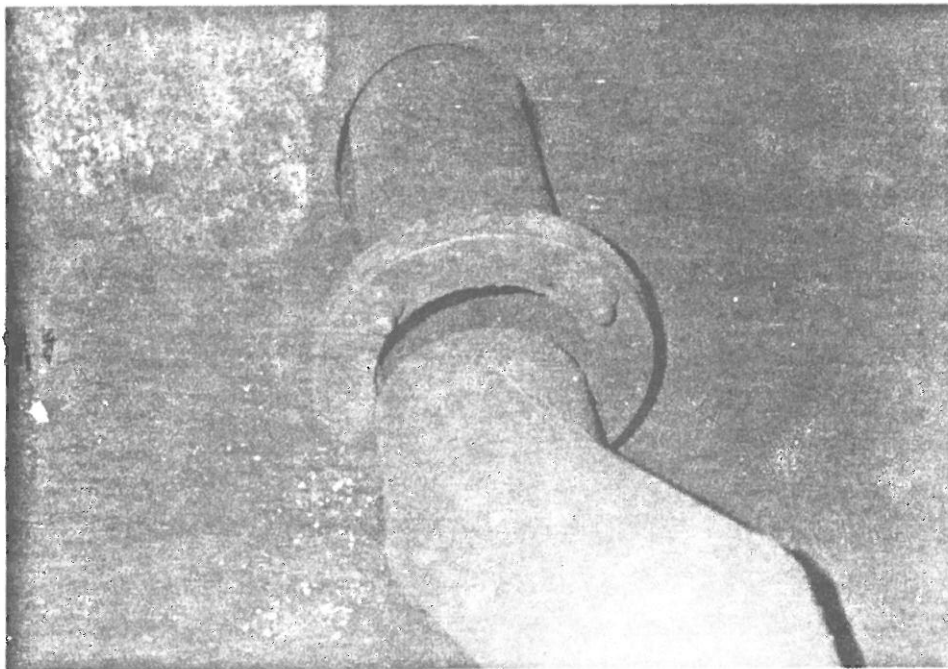
systems within the drums. **Figure 2** illustrates the case of a disconnected feedwater pipe within a steam drum.

Figure 2 Feedwater distribution pipe broken at nozzle connection inside the drum head

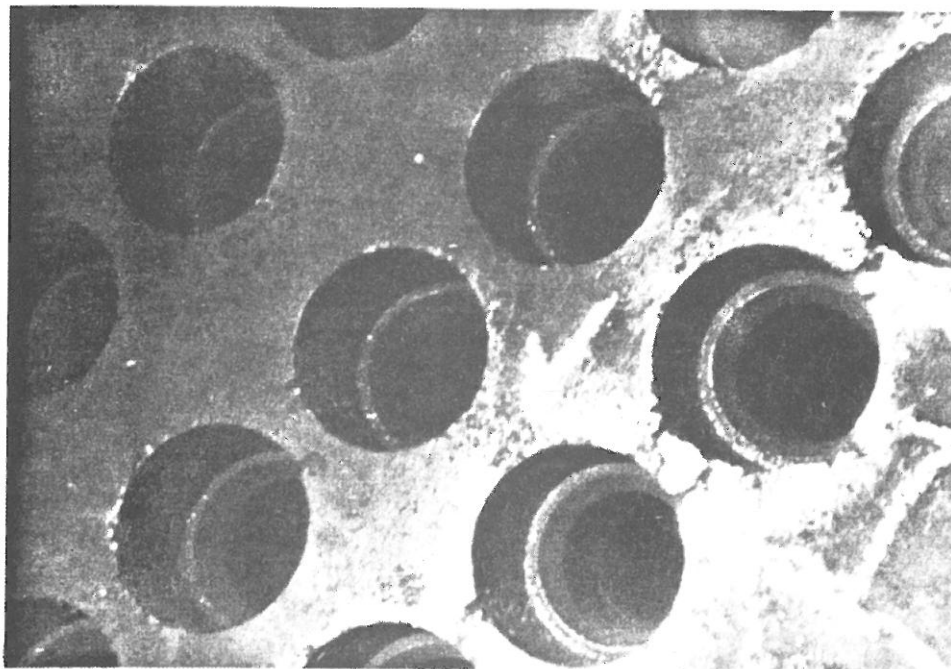
In addition to those common characteristics mentioned, variations in cyclic duty and/or the conversion of the unit to cycling or peaking service, operation of the unit exceeding specified heat up or shut down rates and extensive pitting or corrosion on the inside surface of the drums have also been found to be contributory. **Figure 3** illustrates the corrosion and pitting present in a circumferential ligament field where cracks have occurred.

Figure 3      Pitting on inside surface of drum & circumferential link-up of bore hole cracks

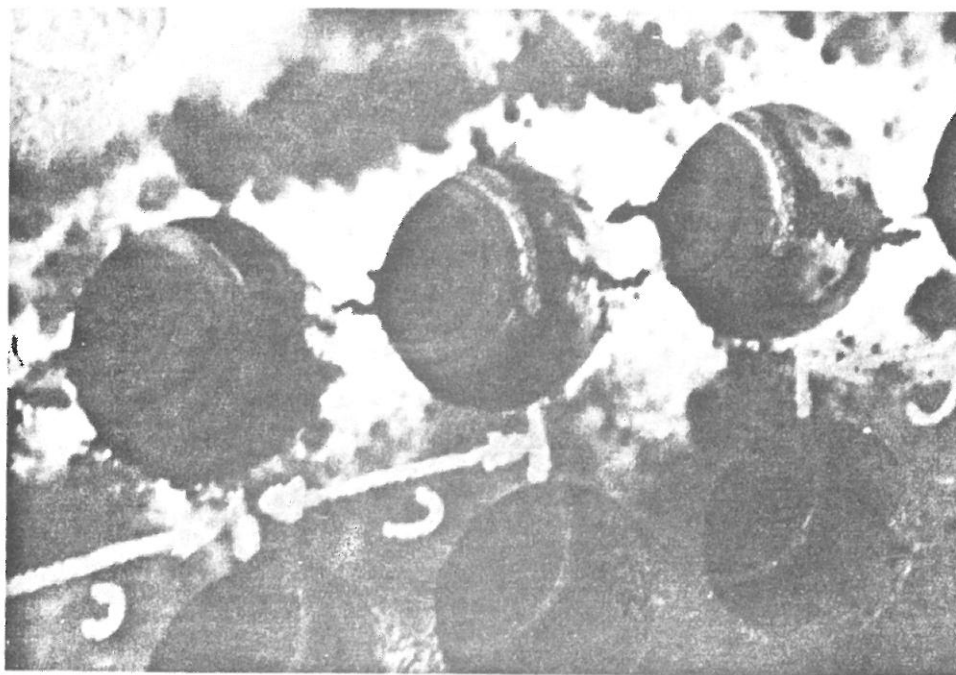
For those specific cases considered, the acquisition of the crack data is particularly significant. As will be explained in the analytical section, the evaluations have only been undertaken when the cracking has been limited to the circumferential area between tube bore holes. In general, the method used to evaluate the effects of the circumferential cracking is a comparison of the area replacement and ligament efficiency techniques as established within ASME Boiler and Pressure Vessel Code, Section I (1). Therefore, the evaluations were undertaken only when a specific cracking pattern within the circumferential ligament was evident. **Figure 4** illustrates the bore hole cracking in the circumferential ligament direction after dye penetrant examination. The cracking is often

Figure 4      Circumferential steam drum bore hole arrangement. The photograph illustrates the appearance of cracks after dye checking.

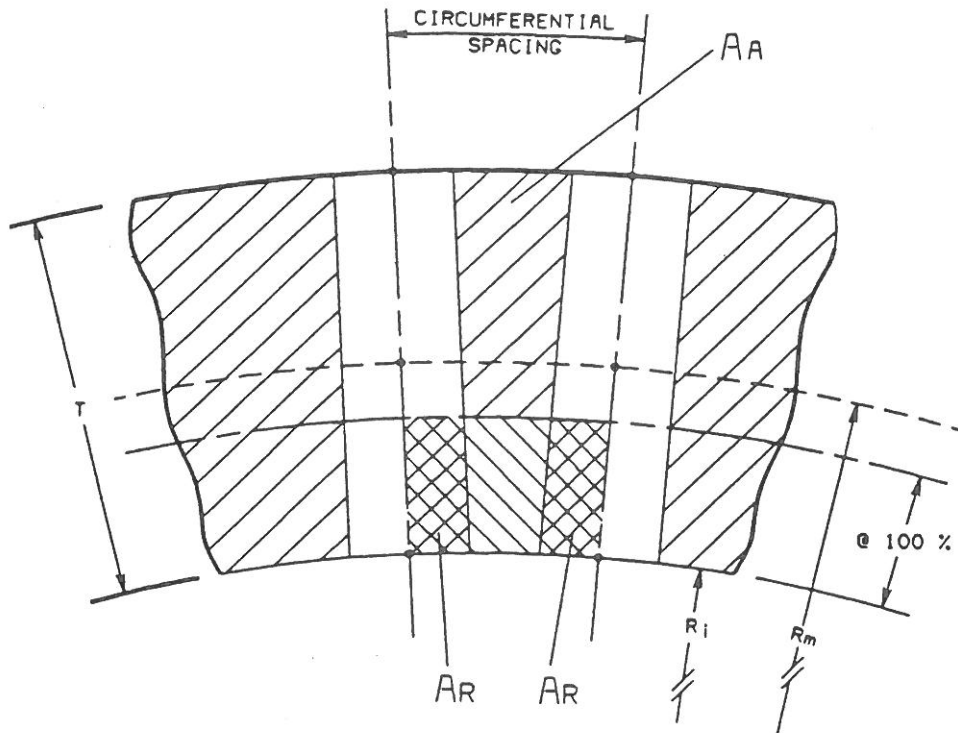
pressure. Assuming an equal distribution of metal area on both sides of the bore hole in question, the area replacement rules require that an equal amount of metal in excess of the minimum shell thickness, at 100% efficiency, be available to account for that area which has been removed by the bore hole. The area available is subsequently modified by the subtraction of the total crack area between the two specific bore holes from the area normally available. The area is further modified by the "F" factor from PG-33 (1), which basically compensates for the variation in pressure stress from the longitudinal to the circumferential direction. Thus, it is important to note the earlier specified requirement that the cracking pattern is predominantly circumferential in nature.

Figure 5 Area Replacement Technique

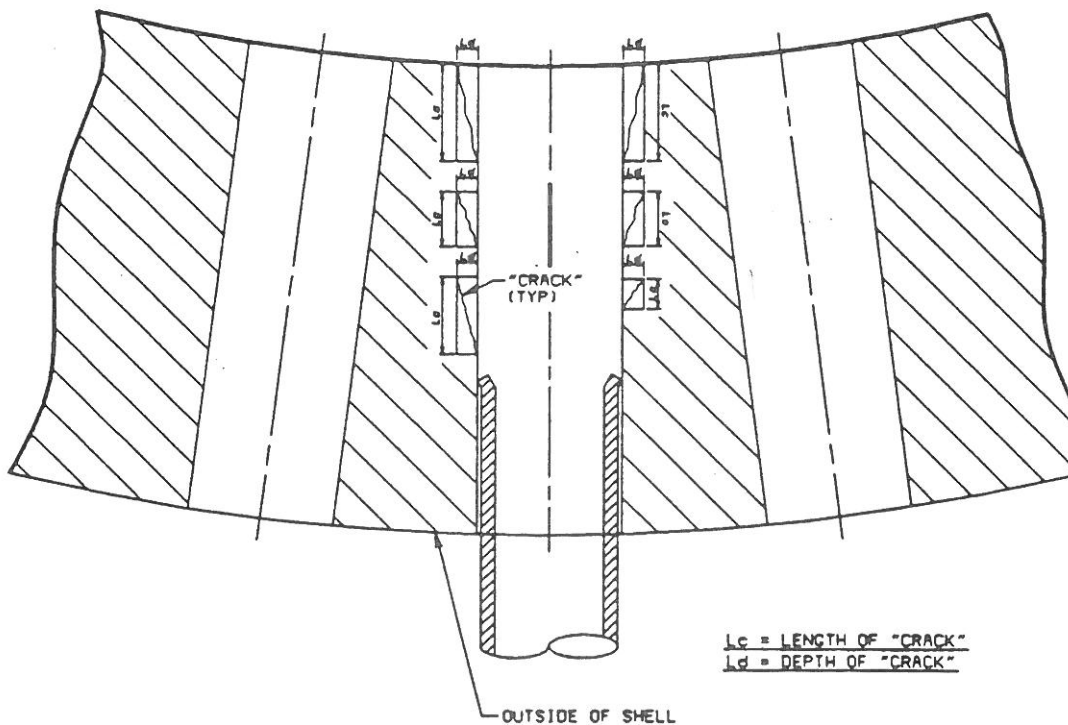
The ligament calculation is performed in accordance with PG-55 (1). The ligament calculation is based upon the average diameter of the hole and the distance between the holes considering the mean diameter of the drum shell. The ligament efficiency is then calculated as the ratio of the hole diameter minus the spacing between the holes divided by the hole diameter. In calculating the average hole diameter, the area of the tube bore hole is again modified by the addition of the cracked areas in a particular ligament and dividing by the actual thickness of the drum shell. **Figure 6** illustrates the technique involved in the development of the crack areas. The modified drum efficiency is then

Figure 6 Example of the development of areas for the circumferential bore hole cracking

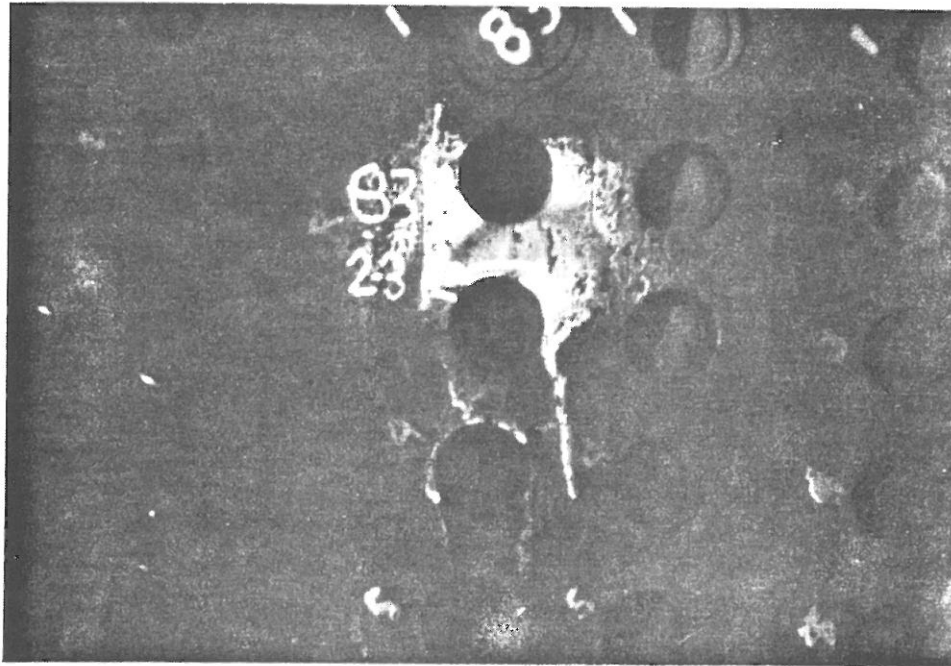
The replication technique is used to substantiate, record and reproduce crack data. **Figure 7** illustrates a circumferential drum ligament which has been polished in preparation for a surface replica. This technique has been used by Riley to monitor selective cracks in specific ligaments. The cracks are identified and a replica is taken for specific crack locations for future monitoring purposes.

Figure 7 Drum circumferential ligament which has been polished in preparation for replication

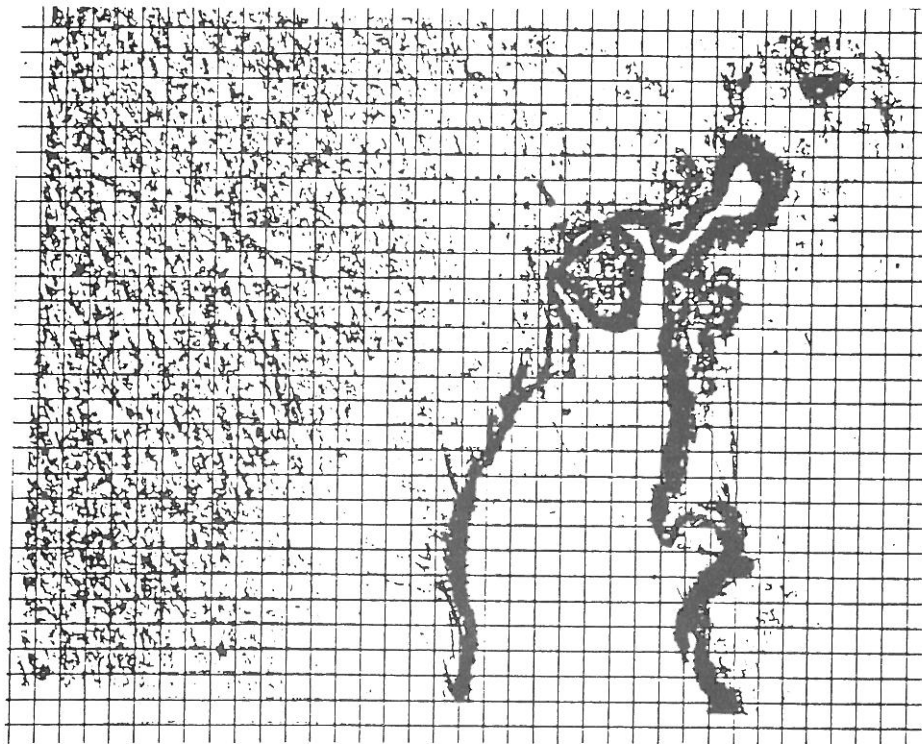
Large scale replicas are taken at ligament field locations. This provides a permanent record of the cracks and pits in each field. Subsequent replication of the same locations, at a later date, provides quantifiable measurement of changes in shape, area and number of cracks. In the laboratory, the replica is enlarged using a photo microscope and a point count of the crack area is graphically obtained. Based on a comparison of the data at two specific time intervals, a determination of crack growth can be made.

Figure 8 Example of point count technique on crack tip  
50X
