The Interactions Between Steam Piping and Boiler Outlet Headers in Fossil Power Plants

James P. King
Design Manager
RILEY POWER INC.
a Babcock Power Inc. company
(formerly Riley Stoker Corporation)

Presented at
1994 ASME Pressure Vessels & Piping Conference
June 19-23, 1994
Minneapolis, Minnesota

RST-129

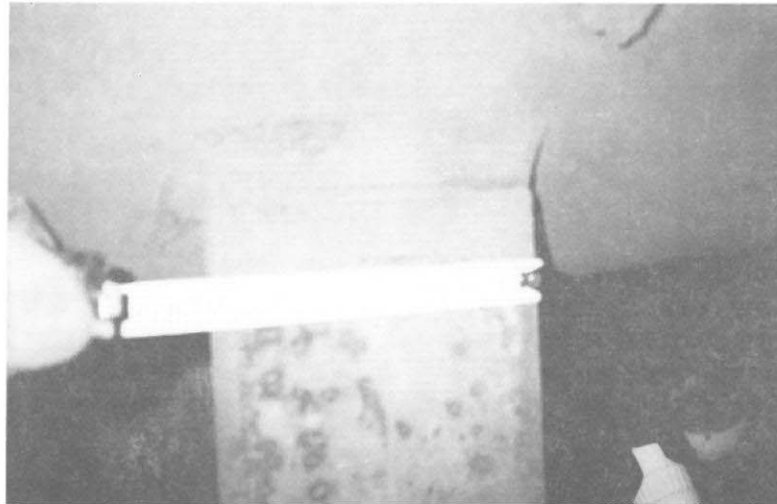
The effects of the higher loads and stresses were confirmed by visual inspection and nondestructive testing. This revealed several support locations, including header moment restraints, with deformed structural members and cracked attachment welds, as shown in Figure 1. Subsequent repairs, reinforced structural members, and added restraints were incorporated to accommodate the effects of the

*Figure 1 - Case No. 1
Reheat inlet header weld cracking on
structural member of moment restraint.*

steam hammer loads. Visual inspections showed that some supports were bottomed out. It was recommended that other supports be tested for load capacity and travel range. A methodology for the on-site load testing of constant force spring hangers on critical steam piping lines is described in the Reference 6 paper.

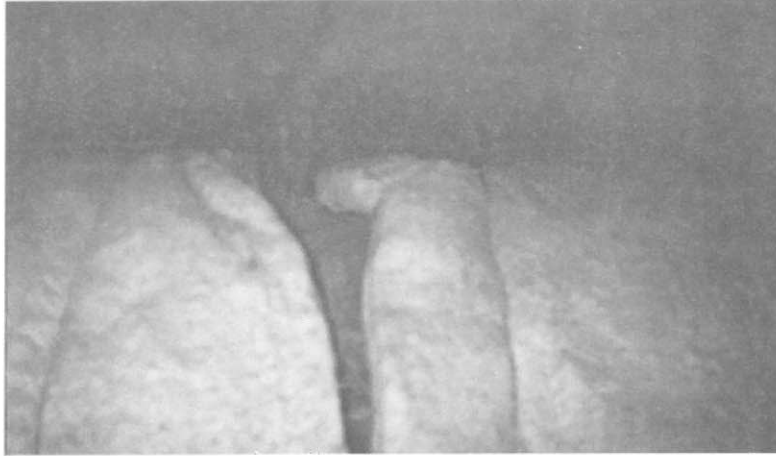
This study involved the discovery of failed hanger lugs on the high temperature superheater and reheater outlet headers on a 600,000 lbs/hr oil/gas-fired Riley combined cycle boiler which was built in 1966. The failures were discovered during an extended unit outage for the in-kind replacement of the high temperature reheater tubing. The failures included two of four superheater header solid restraint lugs and three of four reheater header lugs. The hanger lugs were completely separated from the header shells, as shown in Figures 2 and 3. Portions of the weld metal were still attached to the headers.

*Figure 2 - Case No. 2
Typical failed hanger support lug on
high temperature superheater outlet header.*

The conclusion to the investigation was that the failures of the high temperature superheater/reheater outlet header hanger lug plates were attributed to localized overheating combined with excessive tensile loading. The overheating was confirmed by the metallurgy, and could be due to leaks at the boiler furnace roof to penthouse floor seals. Excessive tensile loadings were most likely transferred from the steam piping lines to the header hanger supports. As mentioned before, the walkdown inspection of the piping lines had revealed abnormalities which indicated some of the piping supports were not carrying the loads for which they were originally designed. The results of the metallurgy confirmed the excessive loadings on the hanger lug plates by the measured thinning at the failure surface, with localized cracking, and the presence of elongated grains in the microstructure.

A comprehensive listing of detailed recommendations was presented to the client, to minimize the repetition of similar failures. Recommendations included the performance of a complete condition assessment program for the boiler header and steam piping components including supports, with subsequent scheduled monitoring of the components.

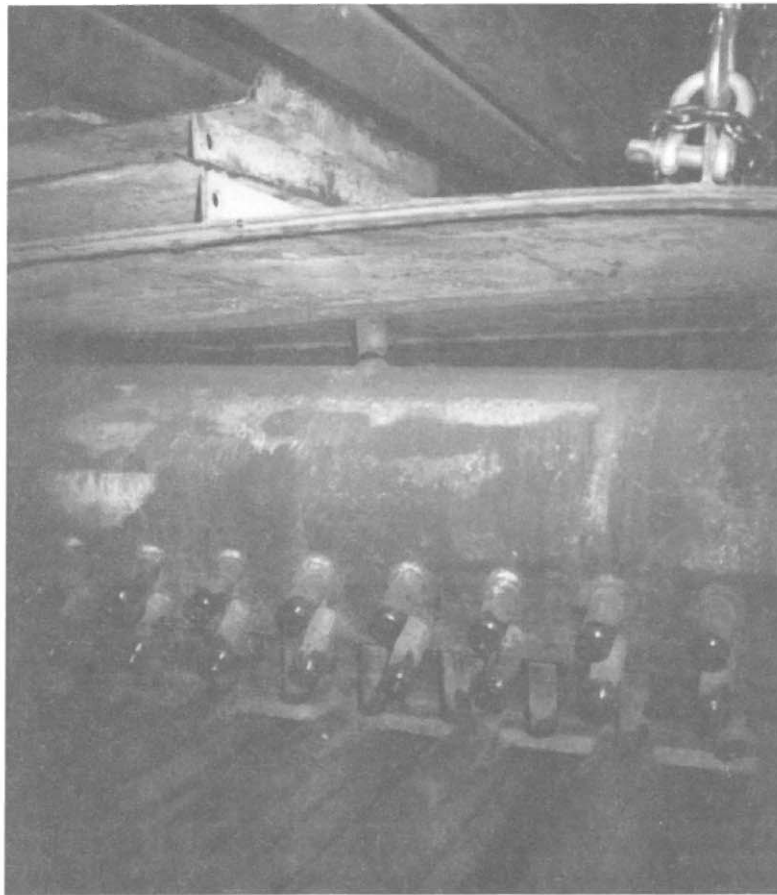
*Figure 3 - Case No. 2
Failed hanger support lug on
high temperature reheater
outlet header.*

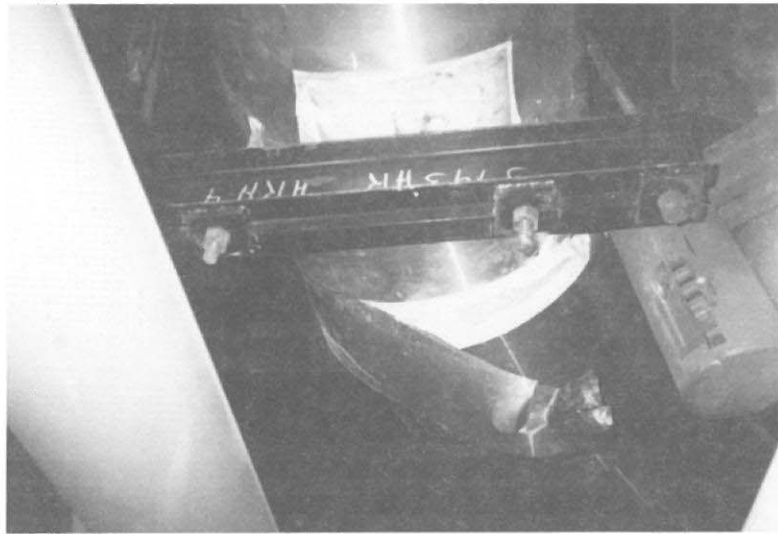
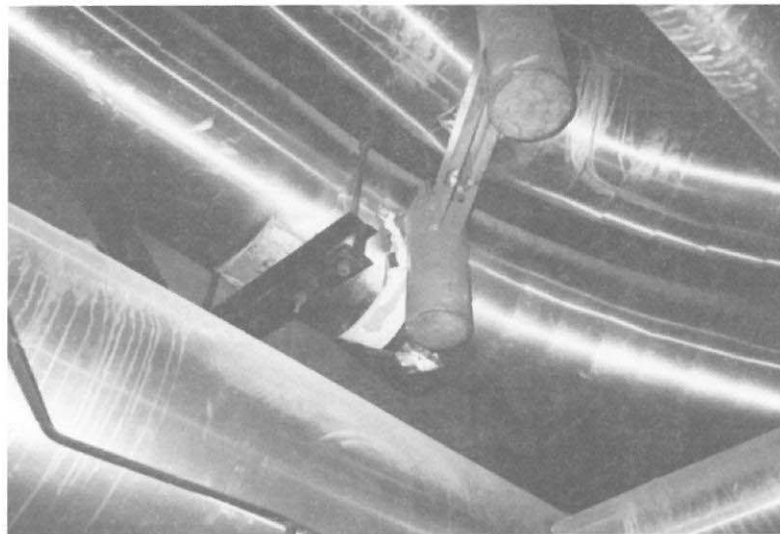
An inspection was made of the hanger support rods for the two headers, including the attachments to the structural steel. There was no evidence of damage at these locations. Riley inspectors walked down the main steam and hot reheat piping lines to check supports. There was some evidence of abnormalities at several rigid, spring, and constant force supports and their structural assemblies. Some support rods were slightly tilted, and some support indicators were not in the "cold" position. At a dual constant force support location, one support indicator was at the "cold" position, while the other indicator was mid way between the "cold" and "hot" positions. Figures 4 and 5 show this pipe support location. There were also isolated regions of minor damage such as dislodged jacketing and insulation. At one location, there appeared to be an interference between the piping and an adjacent spring hanger.

*Figure 4 (top) and Figure 5 (bottom) - Case No. 2
Main steam piping constant force support assembly,
which appear to be slightly tilted to one side.
Also, the parallel supports show different position
indications in the cold condition.*

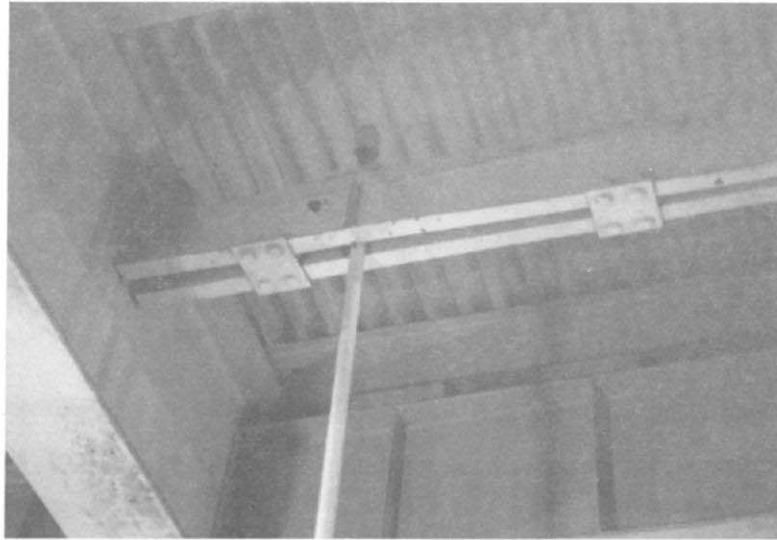
A review of records revealed that a full turbine trip event had occurred about one year previously. A complete visual inspection was made of the boiler, main steam line components, and supports. External steel for the header spring hanger supports was found to be twisted and deformed as shown in Figure 6. Additional steel was installed by the client to reinforce the structure at this location, as shown in Figure 7. A walkdown of the steam piping revealed that most of the constant force supports were bottomed out. Later, they were noted to be bottomed out while the unit was on line. The axial restraint on the main steam vertical riser was examined and the shear lugs were found to be twisted. They were subsequently replaced.

This lack of adequate support at the furnace roof seals had resulted in the entire weight of the superheater assemblies being carried by the eight spring hanger header supports, causing subsequent distress to the main steam piping supports. These supports were designed only to support the headers and that portion of the superheater tubing located within the penthouse. A complete retrofit program was subsequently completed, with appropriate integral superheater supports installed at the furnace roof locations.

*Figure 6 - Case No. 3
Twisted and deformed structural steel members due to overload at support location for high temperature superheater outlet header spring hanger.*

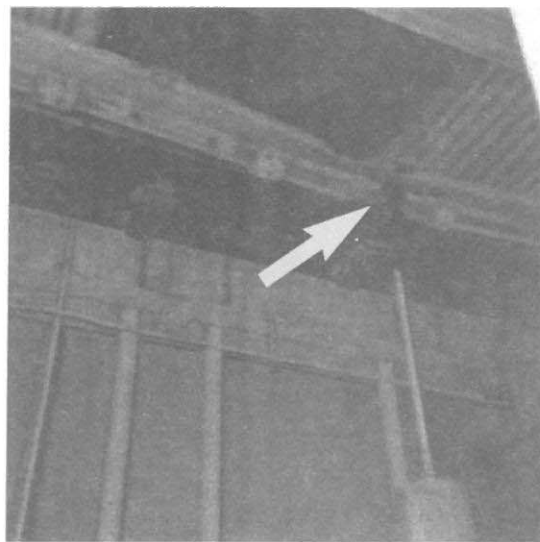
*Figure 7 - Case No. 3
Location of added structural steel installed to reinforce the deformed steel members shown in Figure 6.*
