BOILER CONDITION ASSESSMENT PROGRAM AT PSI ENERGY'S WABASH RIVER GENERATING STATION UNIT 5

William J. Boyle P.E. Project Manager Power Services Division Riley Stoker Corp.

Dennis A. Tebbe Senior Engineer Plant Engineering Department PSI Energy, Inc.

RST-98

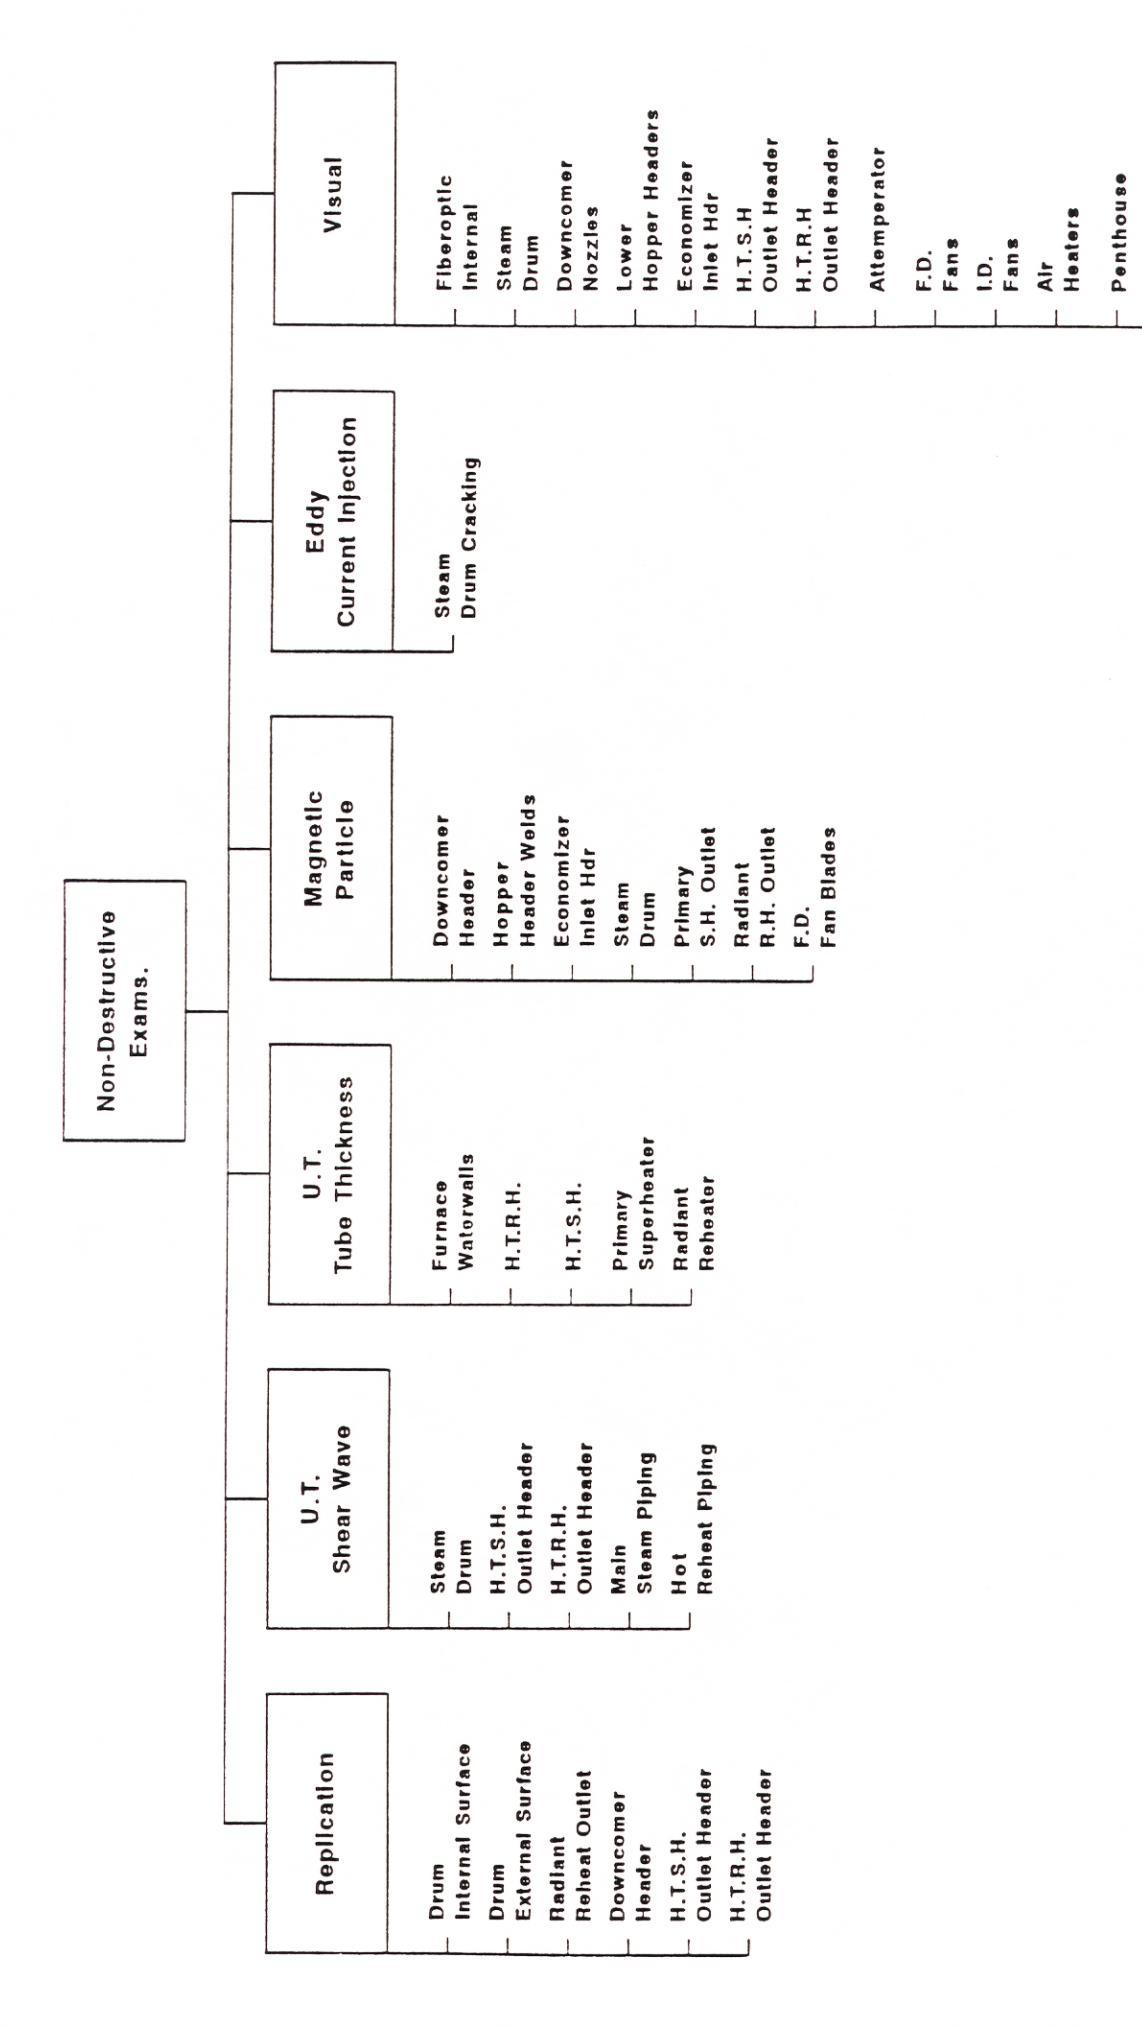
Inspection Activities Figure 3

A variety of nondestructive testing, as shown in Figure 3, were utilized to gather information on the condition of the pressure parts. The following is a brief discussion of each method and how the results were incorporated into the condition assessment.

Thirteen (13) surface replicas were used to examine the microstructure of selected pressure parts for graphitization, spheroidization, creep voids and microcracks. Ultrasonic shear wave examinations were performed to locate and measure lamination in component walls and welds. Ultrasonic tube thickness measurements were performed at selected locations in the furnace, superheater and reheater to check the integrity of the pressure boundary and obtain data for input to remaining life calculations. Magnetic particle examinations were performed to determine the presence of any indications or cracking on the external surfaces of selected pressure parts. Eddy current injection technique was used to quantify the depth of the cracks found in the steam drum.

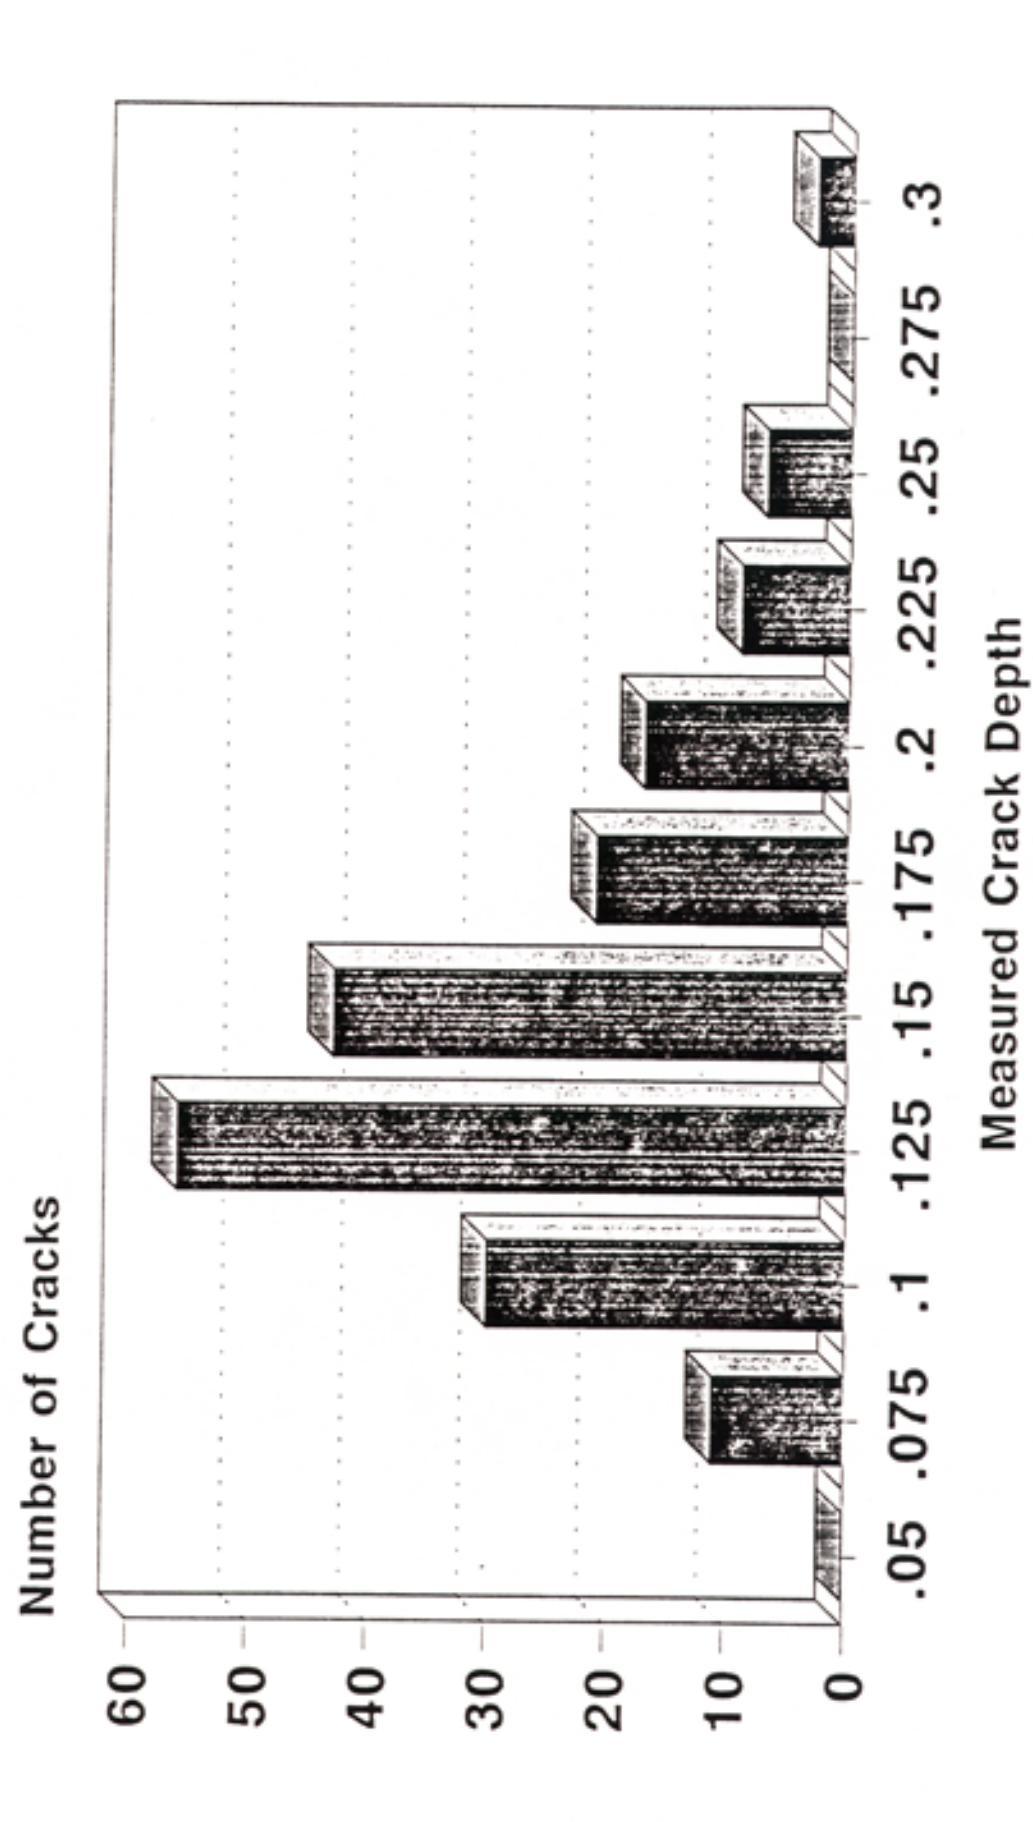
Crack Depth Distribution Figure 4

Tube bore hole cracking was noted in the steam drum and the intermediate economizer header, most likely the result of the thermal transient described above. The cracks in the steam drum were easily visible to the naked eye and located directly beneath the feedwater inlet nozzles.

A commercially available eddy current inspection technique was used to quantify sizes and depths of selected cracks. The selected cracks had to be of adequate size for the eddy current technique to yield accurate results. Figure 4 shows the distribution of the measured crack depths. Figure 5 shows the distribution of the cracks along the bore holes in the steam drum.

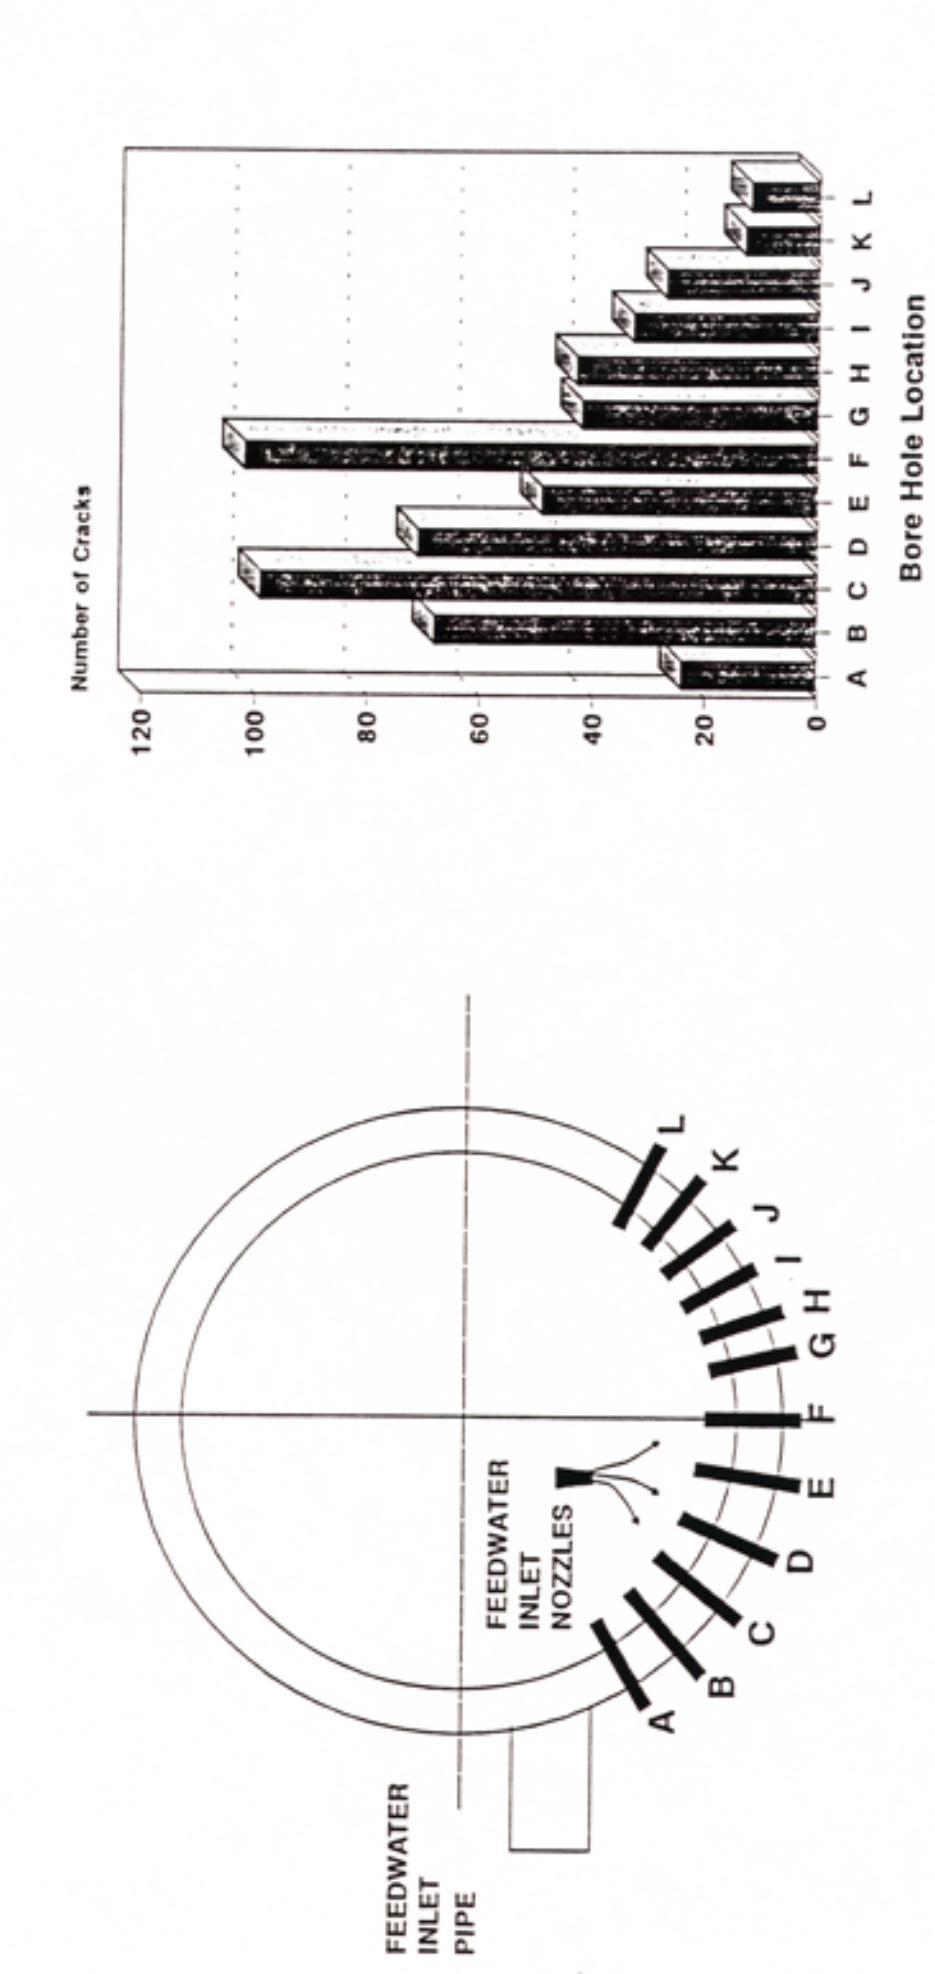
Crack Location Figure 5

The cause of the steam drum cracking was most likely thermal fatigue due to the severe temperature transients during unit startup and shutdown. Exacerbating the problem may be the relatively short length of tubing between the steam drum and downcomer header and the boiler division wall header, which results in inadequate tube flexibility, see Figure 6. As evidence, the bore holes which contain the most cracks are those attached to the straight piece of tubing extending from the steam drum to the boiler division wall header. Future inspection activities should include an internal inspection of the downcomer header and the division wall header for ligament cracking.
