**DB Riley, Inc. is now Babcock Power Services Inc., a  
Babcock Power Inc. company.**

**[www.babcockpower.com](http://www.babcockpower.com)**

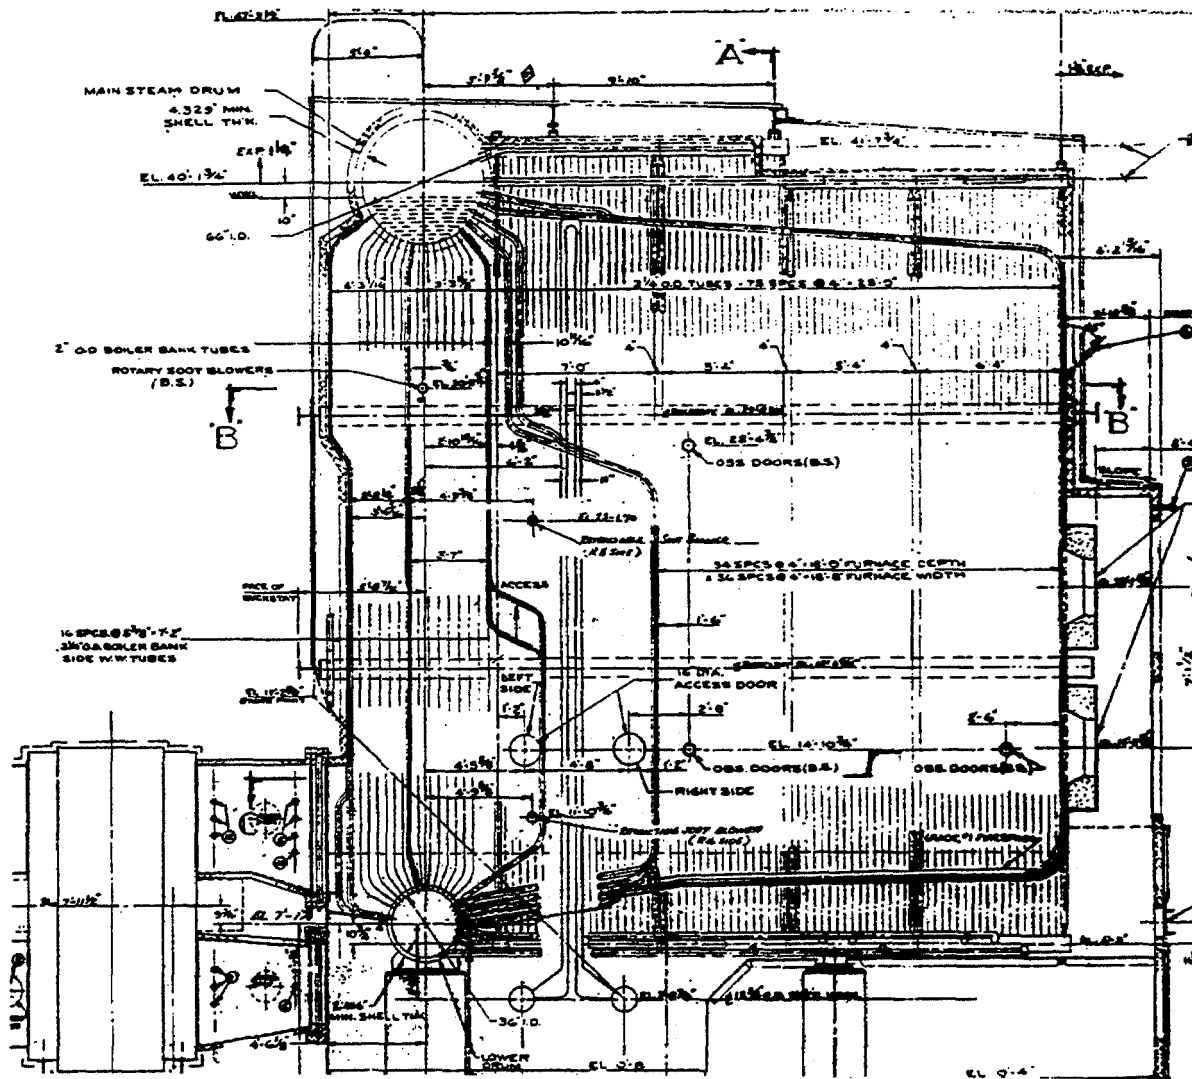
lbs/hr at superheater outlet conditions of 520 psig and 600°F. The boiler has four burners and its primary fuel is No. 6 fuel oil, with 0.3% sulfur content.

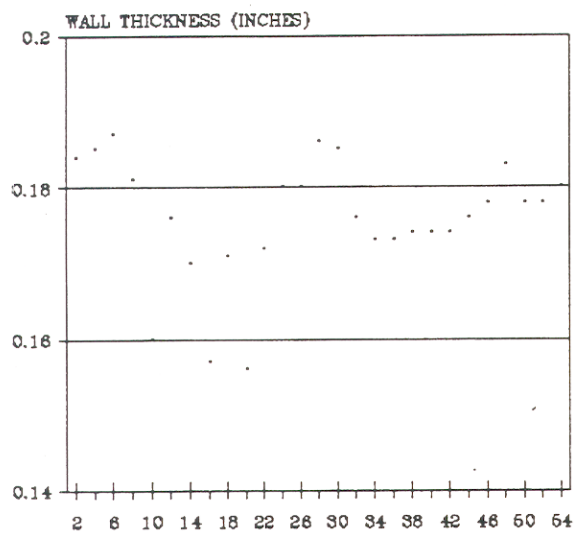
The next step in the program was to use the data obtained from the inspection in calculations to determine the remaining life of various boiler components. Inputs to the stress calculations consisted

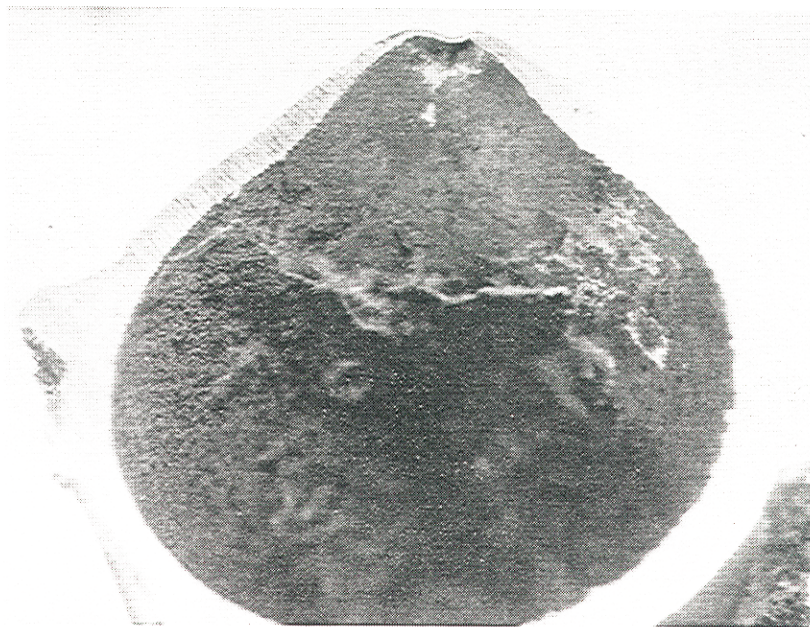
FIGURE 5. Cross Section of Blistered Tube
