Upper Rear Steam Drum Replacement

Wisconsin Electric Power Company's Port Washington Station Units 2, 3, & 4

RST-101

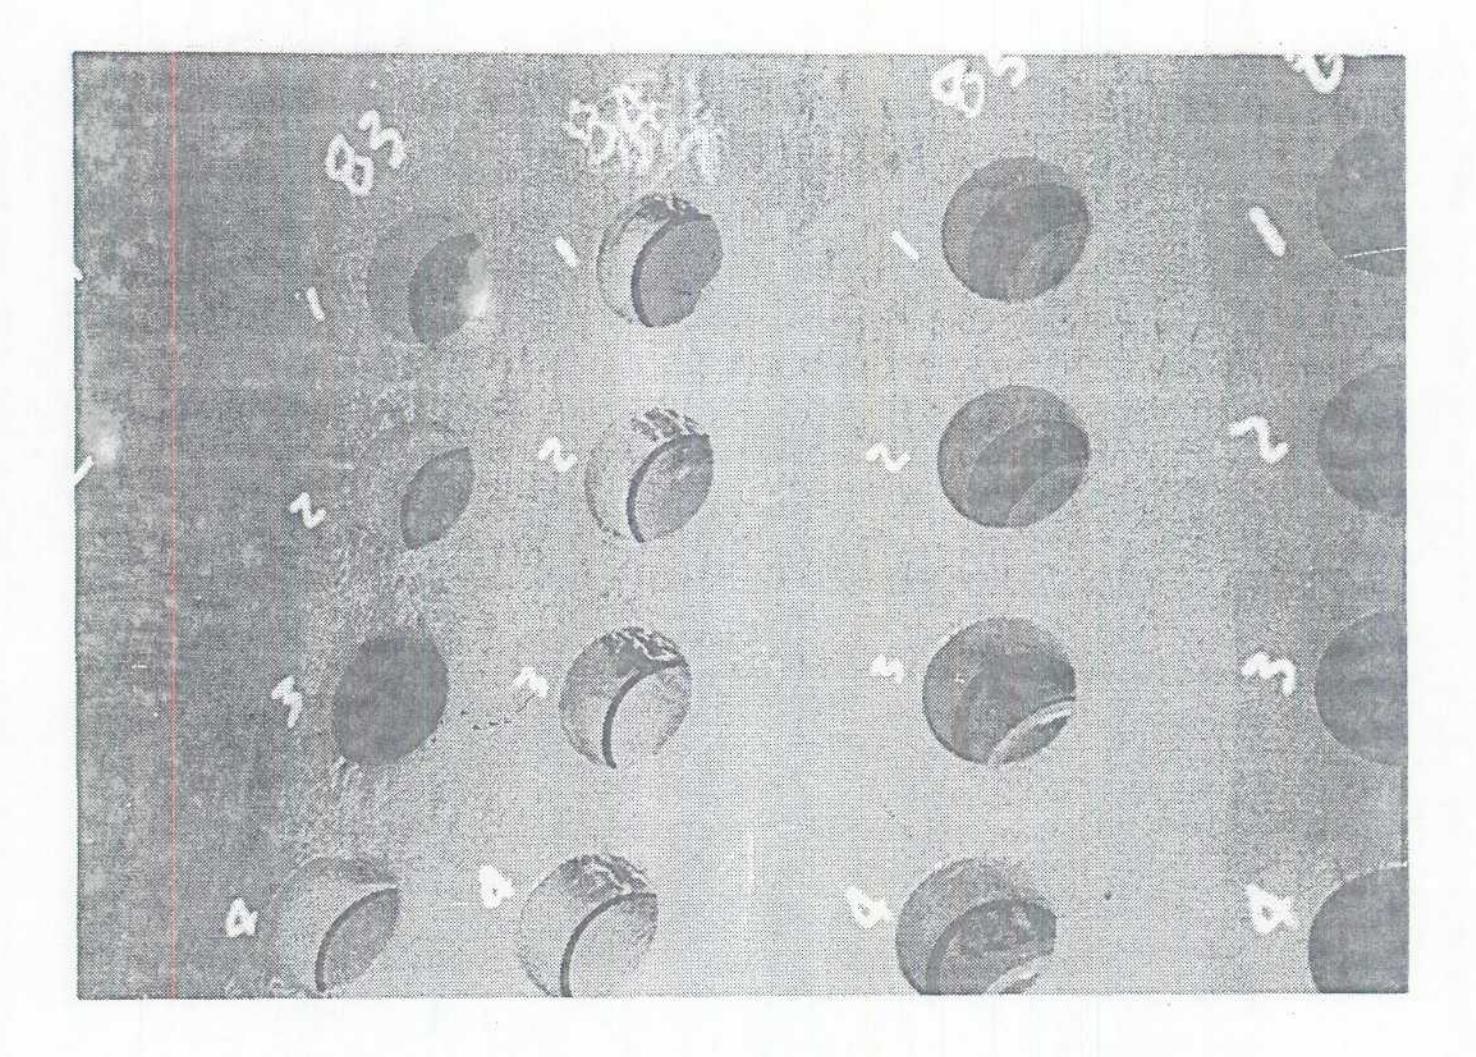
Figure 1

First evidence of bore hole and ligament cracking in the drum shell was discovered during a routine plant availability study inspection. Visual examination revealed the cracks. Dye penetrant, radiographic, and magnetic particle examination confirmed them. The most significant cracking appeared in the upper rear steam drum of Unit #5. However, examination confirmed cracking existed within the drums of Units #2, #3 and #4 as well.

Since discovery of the cracking in 1984, routine examinations of the upper rear steam drums have been conducted by WE personnel, the OEM, consultants, and other boiler manufacturers. The cracks are predominantly oriented in the circumferential direction between tube bore holes. The cracks originate on the internal surface of the upper rear steam drum within the boiler bank ligament field, as shown in Figures 1 and 2. This cracking has propagated into the thickness of the drum and/or into the tube bore holes. The drums are made of SA-204 GR. B carbon steel.

Upper rear steam drum circumferential bore hole arrangement. Photograph illustrates the tube bore hole cracking.

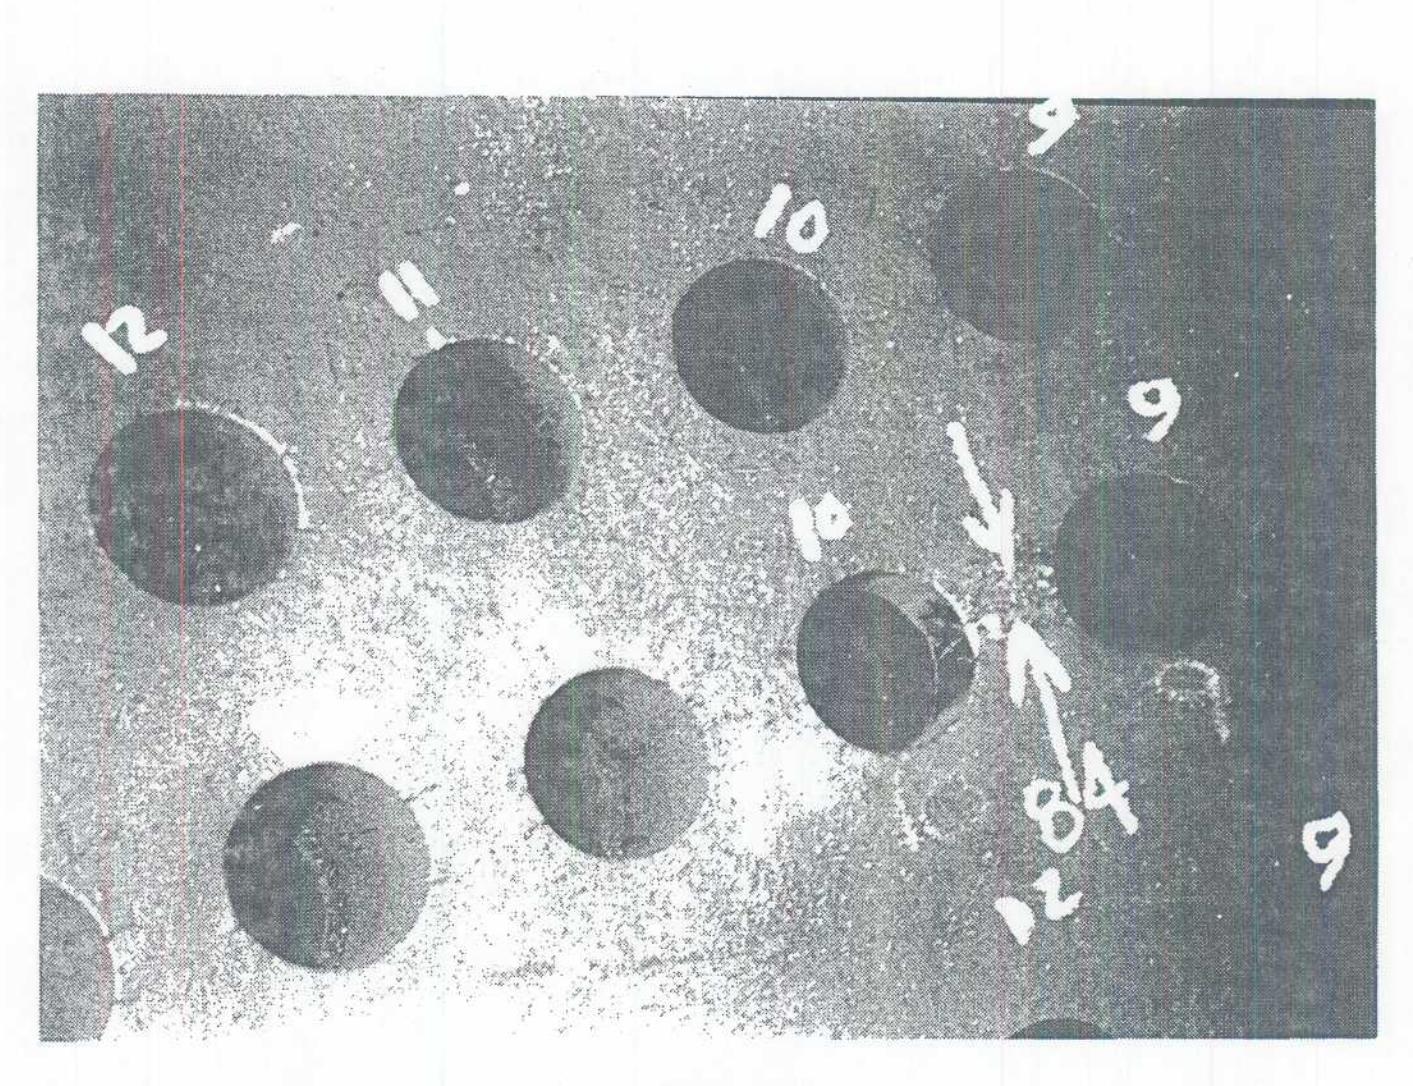
Figure 2

Introduction of feedwater supply to the boilers is through nozzles located at quarter points along the upper rear steam drums. Drum inspections continue to verify that most cracking is contained within the tube ligament field between the feedwater nozzles. This is a significant point. Units #2, #3, and #4, which do not have economizers, all exhibit drum cracking. Unit #1, which has an economizer, does not have drum cracking. A considerable amount of data with respect to the extent and propagation of drum cracking has been collected during scheduled drum inspections. In many instances, the cracks originating from the boiler bank tube bore holes extend down the bore holes from the internal drum surface before disappearing behind the flared tube roll, see Figure 3. Drum inspections over the past several years and subsequent evaluations have generally led to the conclusion that the cracking is a result of thermal fatigue which is coupled with corrosion and exacerbated by the cycling of the unit with introduction of feedwater. It has also been agreed that the growth rate of the cracking in the upper rear steam drums has slowed to a very low or negligible growth rate.

Ligament cracking between tube bore holes and propagation of cracking into shell
