Freeze Protecting Your Power Generation Assets

By: Jeff Daiber – Vogt Power International

Al Hughes – O'Brien Corporation

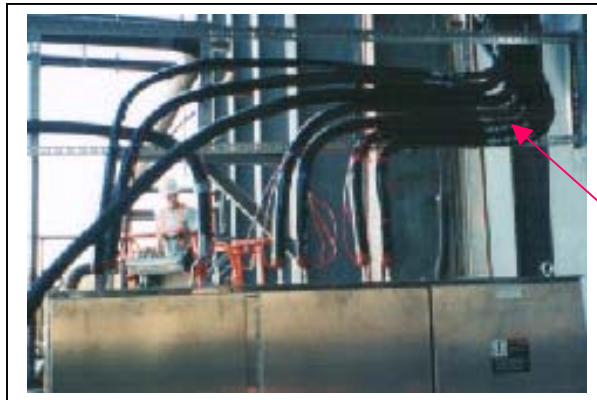
Tubing bundles used for process temperatures of 1,200 deg. F often require a bend radius of 14" to 48", depending on manufacturer. Care must be made not to exceed the manufacturers minimum bend radius. If the radius is made too tight, the insulation is compressed locally and may cause failure or the tracer may be shifted from it's designed location and not be able to provide adequate heat. If the bend radius is exceeded, especially on the larger diameter tubing bundles, the tubing inside the bundle may wander, allowing for a wide variance of heat transfer and eventual failure.

INSIDE RADIUS TOO TIGHT

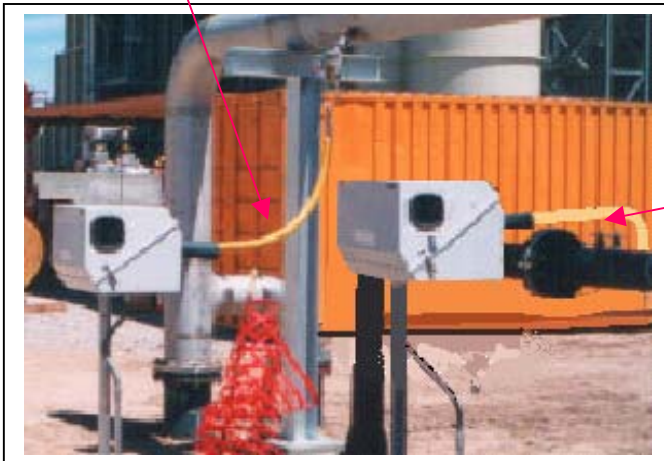
Slope the lines and the root valves so they are self-draining during a shut down period. If the valves are not self-draining, then Mineral Insulated (MI) tracing can

CORRECT

INCORRECT

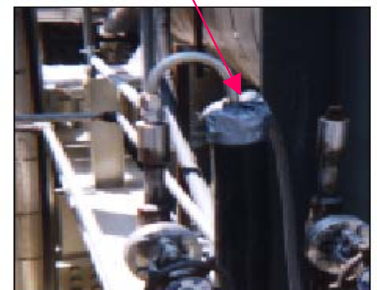
DUCT TAPE
