How to Avoid Problems with Superheaters and Reheaters

D. N. French
Director
Corporate Quality Assurance
RILEY POWER INC.
a Babcock Power Inc. company
(formerly Riley Stoker Corporation)

Presented at
Florida Municipal Utilities Association
November 6, 1980

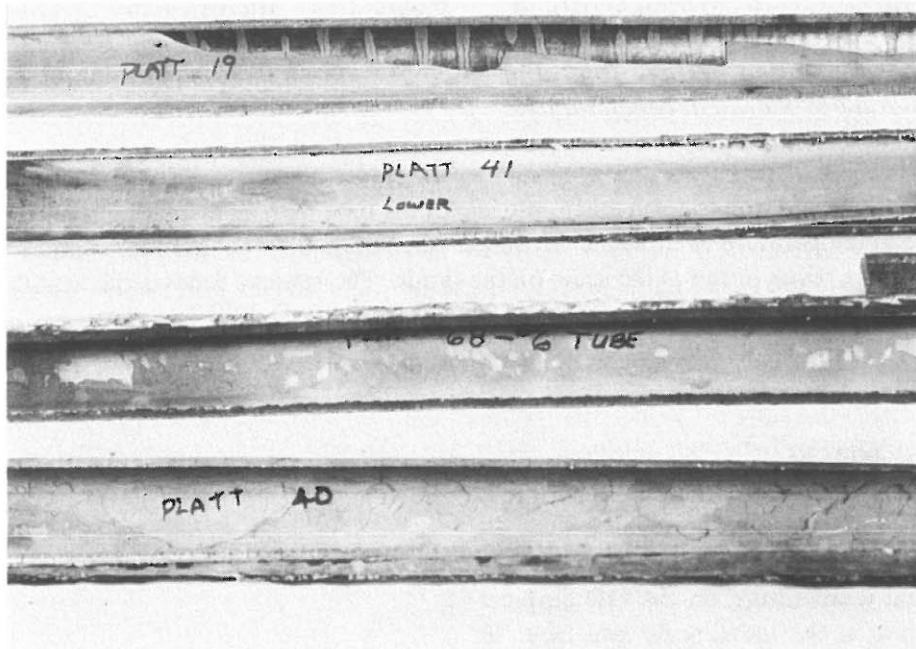
Figure 1.2 As-received Reheater Tubes. Note the Heavy Internal Oxide Scale.

- A. The rupture was a wide open burst with the tube wall drawn to a knife edge at the failure.
- B. The OD scale measured 0.011" thick and the deposit from the products of combustion was 0.04" thick.
- C. The internal scale measured from 0.015" to 0.026" thick.
- D. The tube wall thickness 12" away from the failure and in the same plane, measured 0.127". The tube wall thickness 180° from this point measured 0.171".
- E. The remaining reheater tube sections showed ID scale varying from 0.018" to 0.021" thick and OD scale and deposit up to 0.040" thick.
- F. Wall thickness measurements on these unfailed tubes varied 0.170" to 0.127".

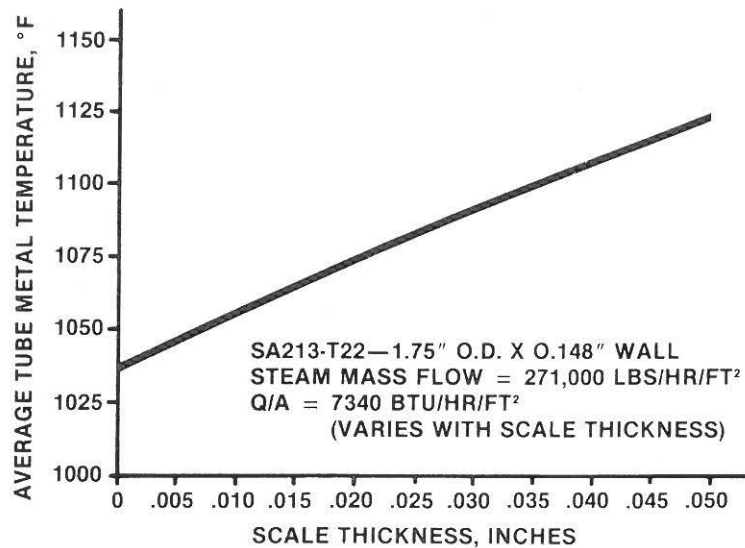
Scale affects the tube metal temperature; Figure 1.4 plots the calculated temperature as a function of scale thickness for the present reheater tube study. Figure 1.5 shows the stress for the 1% creep in 10,000 and 100,000 for T22 material. Two things are evident from the samples:

Figure 1.4 Tube Metal Temperatures as a Function of Scale Thickness of Reheater Tube Samples.

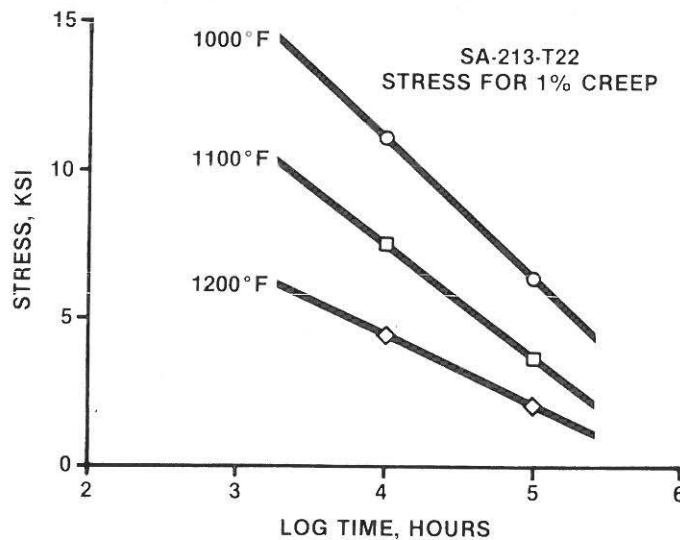
Figure 1.5 Stress for 1% Creep in SA 213-T22 Alloys.

Since the design stress for T22 per the ASME Code is 5800 psi at 1050°F, the actual operating conditions will be over 1100°F with a stress of 6700 psi. As can be estimated from figure 1.5, the time required to give a 1% creep deformation falls from about 100,000 hours for the design condition to about 10,000 hours for 1100°F and 6700 psi.

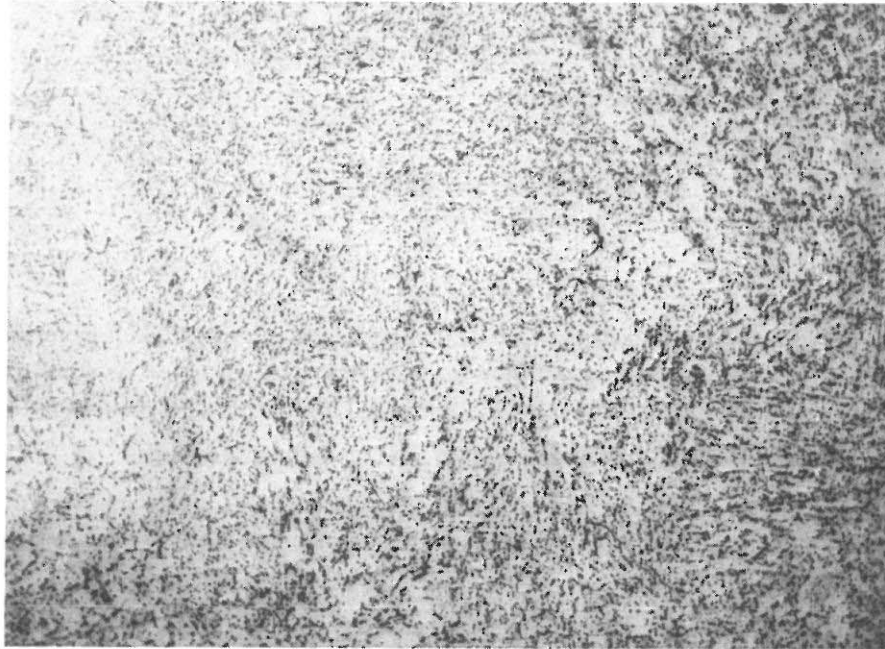
The microstructures of all samples revealed complete spheroidization of the carbides in ferrite indicating exposure to high metal temperatures for prolonged periods of time, Figure 2.2. The microstructure can be attributed to nearly 15 years of service and the pearlite would be expected to have completely spheroidized. However, there is further danger in the insulating effect of the nearly 20 mils of scale observed on the ID surface. The thermal conductivity of magnetite is about 2 percent of that of steel.

Figure 2.2 Microstructure of As-received T-22 Tubes; the Carbides are Completely Spheroidized. (500 \times , Nital Etch)

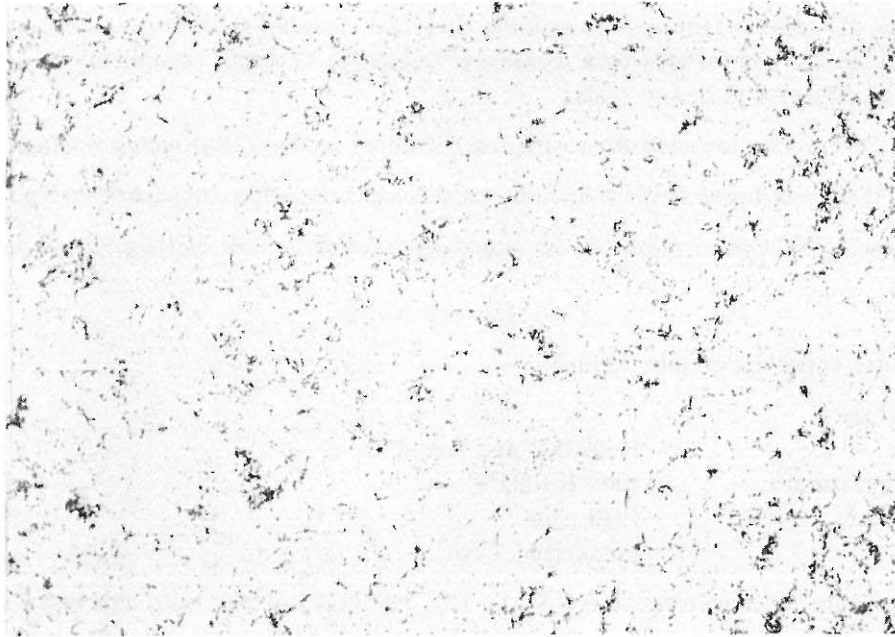
The microstructure of the failed area showed a complete spheroidized structure; see Figure 3.2. The surface of the tube shows an intergranular penetration of the OD oxide; see Figure 3.3. Figure 3.4 shows creep voids in the vicinity of the failure.

*Figure 3.2 Microstructure Shows Spheroidized Carbides and Ferrite.
(500×, Nital Etch)*

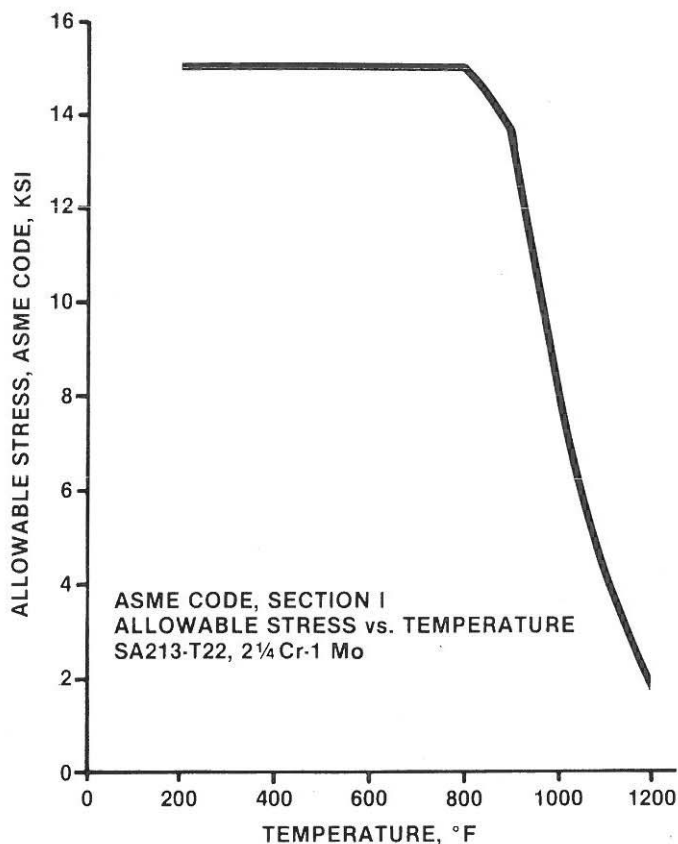
1. Increase the creep rate, or reduce the creep life. Figure 1 plots the ASME Code Section I allowable stress for T-22 as a function of temperature. Note the sharp drop off in allowable stress above about 1000°F; this stress drops from 5,800 psi at 1050°F to 4200 psi at 1100°F. Relatively small temperature increases will sharply reduce the time to reach a 1% expansion caused by creep.

Figure 1 A Plot of the Allowable Stress Per ASME Code Section I Versus Temperature for SA 213-T22. Note the Sharp Drop in Allowable Stress Above 1000°F.

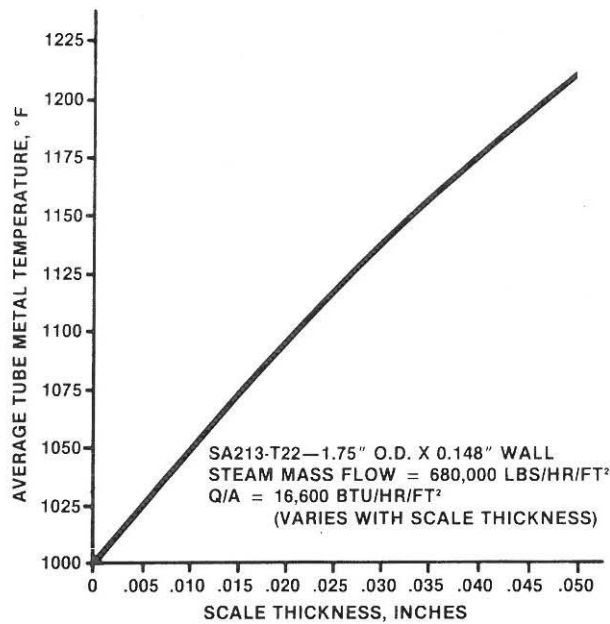
Figure 3 Tube Metal Temperature as a Function of ID Scale Thickness. 2" OD \times 0.300" Wall, T-22.

Chemically clean when scale buildup raises operating metal temperature by 15-20°F above the safe design limit. At the annual outage, the high temperature portion of the superheater and reheater should be checked for scale buildup. The thickness of scale that will be required to increase the tube metal temperature by 15-20°F above the safe design limit depends on the design parameters. Figures 3, 4 and 5 show the calculated wall temperatures as a function of scale thickness for several cases. Note the wide variation expected. However, even this modest 15-20°F increase in tube metal temperature will reduce the time for 1% creep expansion by almost a factor of 2.

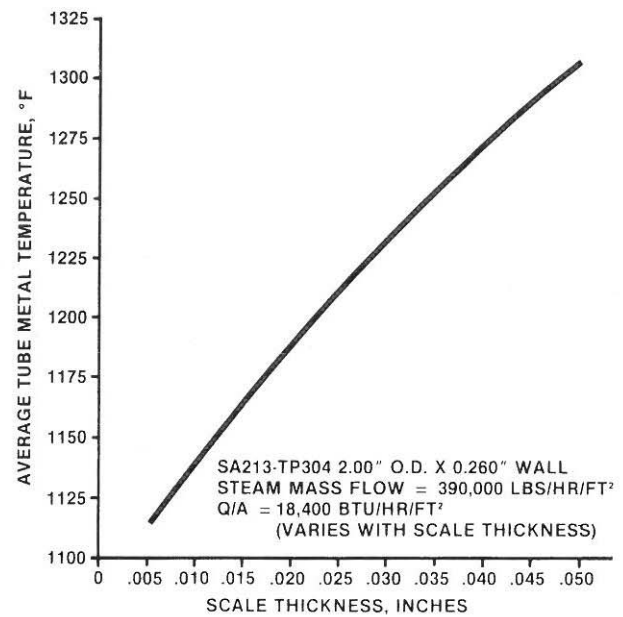
Figure 4 Tube Metal Temperature as a Function of ID Scale Thickness. 2" OD \times 0.260" Wall, 304.

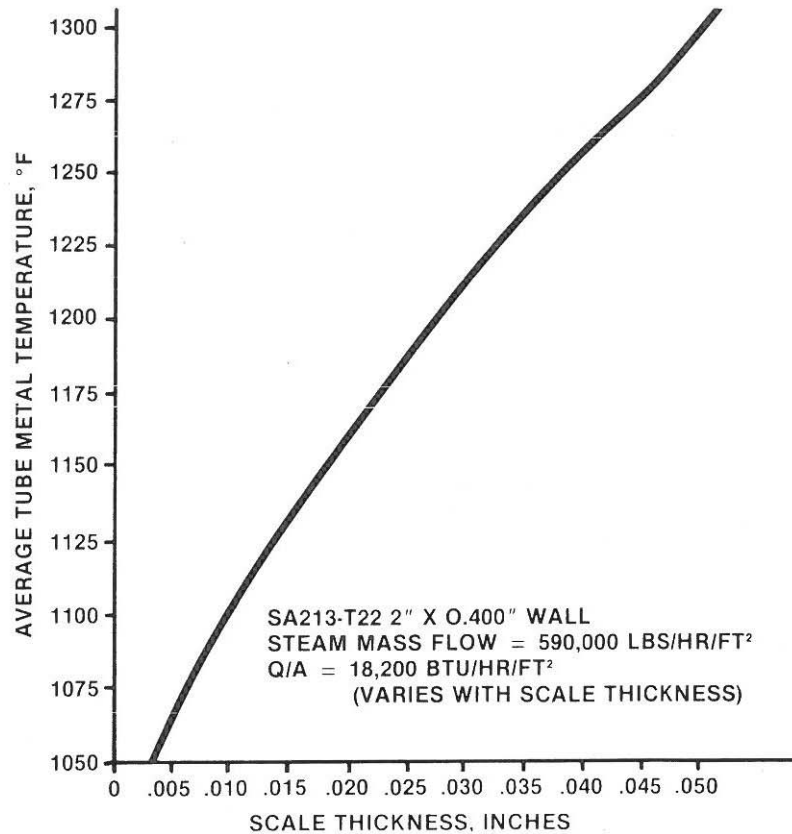
Figure 5 Tube Metal Temperature as a Function of ID Scale Thickness. 2" OD \times 0.400" Wall, T-22.
