# Thermal Considerations in Boiler Tube Failures

C. W. Arcari  
Boiler Design Engineer  
RILEY POWER INC.  
a Babcock Power Inc. company  
(formerly Riley Stoker Corporation)

D. N. French  
Director, Corporate Quality Assurance  
RILEY POWER INC.  
a Babcock Power Inc. company  
(formerly Riley Stoker Corporation)

*Presented at*  
1982 Joint Power Generation Conference  
Denver, Colorado  
October 17-21, 1982

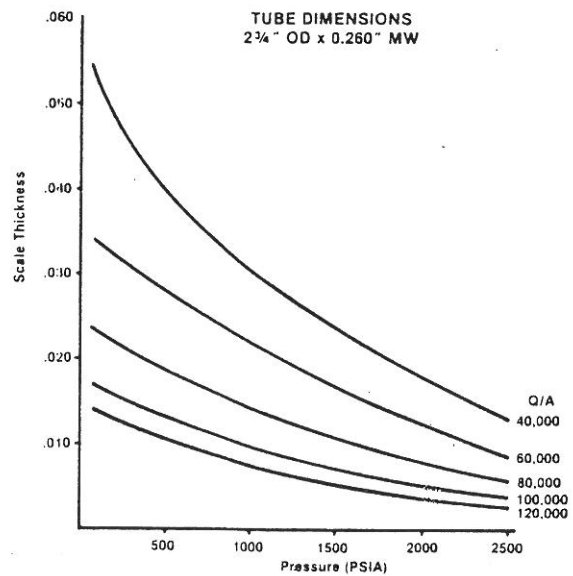
Figure 6 Scale Thickness Required To Raise Crown Temperature To 454°C (850°F) From Saturation As A Function Of Pressure For Various Q/A For Waterwall Nucleate Boiling Heat Transfer.

Steam generating units need a periodic chemical cleaning to maintain proper design metal temperatures. Figure 5 plots saturation steam temperature as a function of unit pressure. Since the maximum oxidation limit for carbon steel is 454°C (850°F) but some units use SA 209-T1 in the burner area, the figure 454°C (850°F) is chosen as the maximum safe operating temperature. The difference between 454°C (850°F) and the crown temperature of the tube is the temperature increase that a furnace wall tube may have before excessive tube failures occur. In these examples, the highest heat release areas are used, as these are the regions where internal deposits occur first, and subsequently, do the most damage. From Figure 5 and Figure 2, the amount of internal scale allowed before chemical cleaning is necessary may be determined. Figure 6 plots the amount of scale permissible as a function of pressure for several sets of furnace conditions.

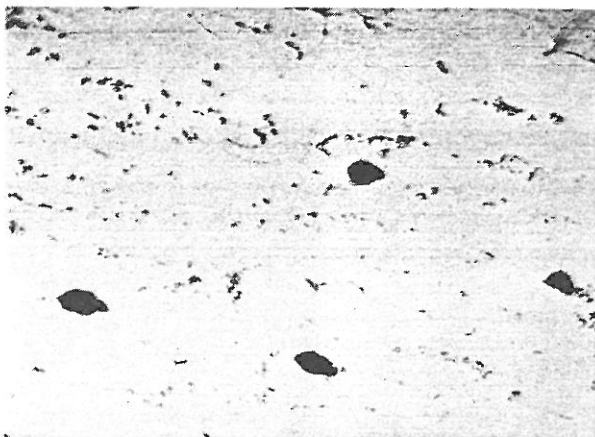
The microstructure of the fire side of all these tubes showed the effects of overheating to varying degrees. In the most severe cases of elevated temperature exposure, the iron carbide had spheroidized with some decomposition to graphite present. Toward the steam side of the fire side, the effects of thermal distress are less evident, an insitu breakdown of the carbide but the pearlite colonies are still clearly evident. Figure 1.3 shows the most severe case of degradation on the fireside, spheroidized carbides, graphite, and ferrite. Figure 1.4 shows the steam side conditions of the same tube, an in situ breakdown of the iron carbide but the shape of the pearlite colonies is still clearly discernible. The gradient in structure is caused by the temperature gradient through the tube, the fireside is about 56°C (100°F) hotter than the metal in contact with the steam. On the backside of the tube, 180° from the fireside, the microstructure shows the normal ferrite and lamellar pearlite, note Figure 1.5.

Figure 1.3 Microstructure At The OD Of The Tube. Large Black Spots Are Graphite. Nital Etch, 500x.

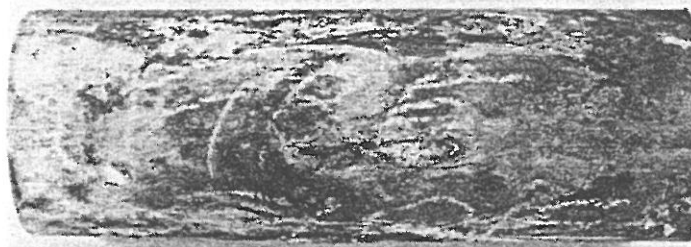
This example is of a water-wall tube failure from a small industrial packaged boiler. The tube is from the convection pass toward the rear. The tube is 5.08 cm by .241 cm (2 inch OD by 0.095 inch) minimum wall SA 178-A material. The failure is a small, narrow fissure about two inches long with very little swelling or wall thinning associated with the rupture, see Figure 3.1. Visual examination revealed the following:

Figure 3.1 As-received Waterwall Tube From An Industrial Boiler. Rupture Is A Narrow Fissure.

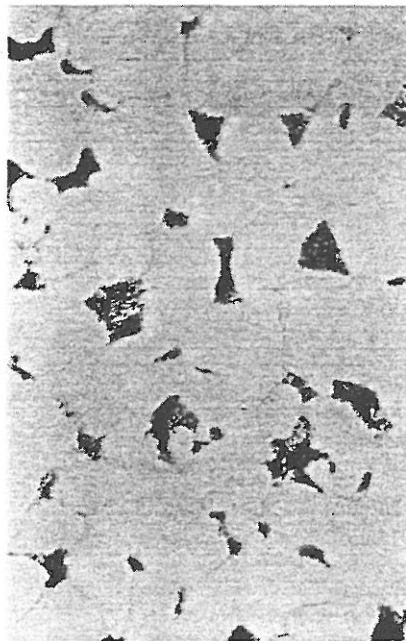
*Figure 3.4 The Microstructure Of The Same Tube Taken From The Rear Of The Tube, 180° From The Rupture, The Structure Is Pearlite With An In Situ Spheroidization Of The Carbide Phase, And Ferrite. Nital Etch, 500x.*
