# ANALYTICAL-EXPERIMENTAL DYNAMIC ANALYSIS OF THE EL CENTRO POWER PLANT UNIT NO. 4 STEAM GENERATOR UNDER THE EFFECTS OF THE OCTOBER 15, 1979 IMPERIAL VALLEY EARTHQUAKE

by
G. Lopez
Senior Engineer
B. Pankow
Manager
RILEY STOKER CORPORATION
WORCESTER, MASSACHUSETTS
and
Y. Makimoto
Research Engineer
T. Mii
General Manager
K. Mitsuhashi
Assistant Manager
MITSUI ENGINEERING & SHIPBUILDING
TAMANO, JAPAN

RST-27

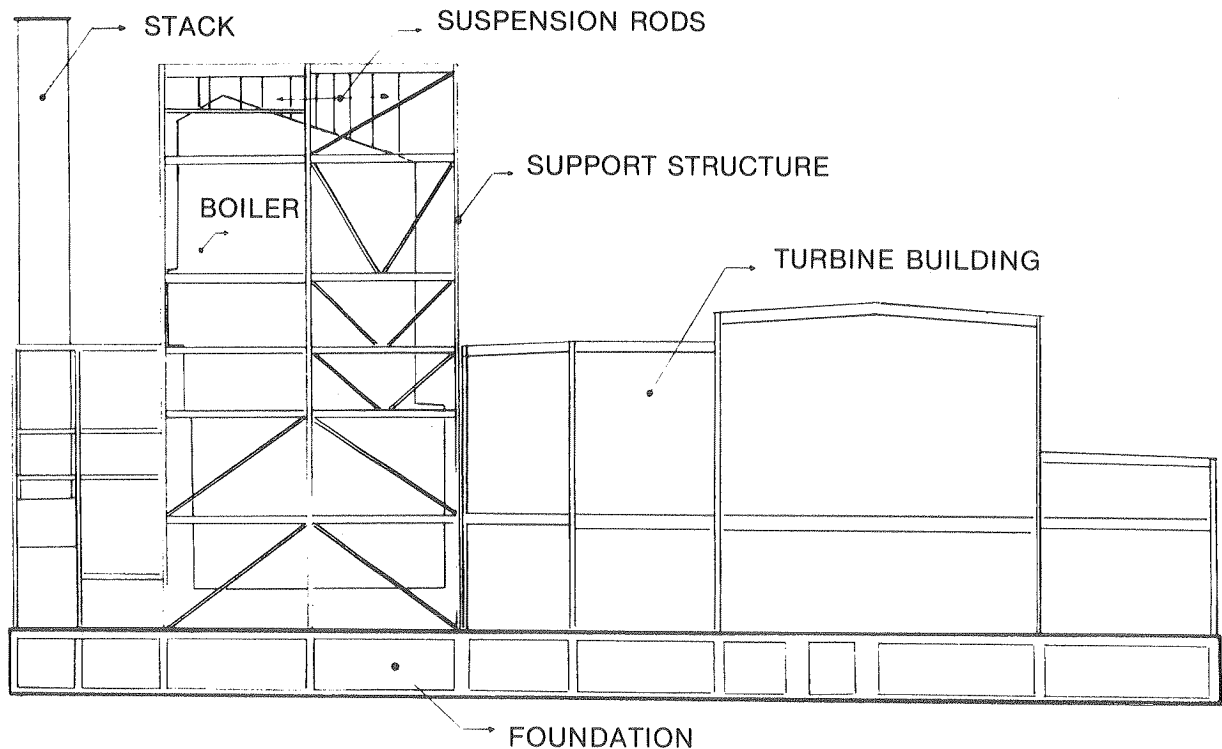
*Figure 1    Unit No. 4 General Arrangement*

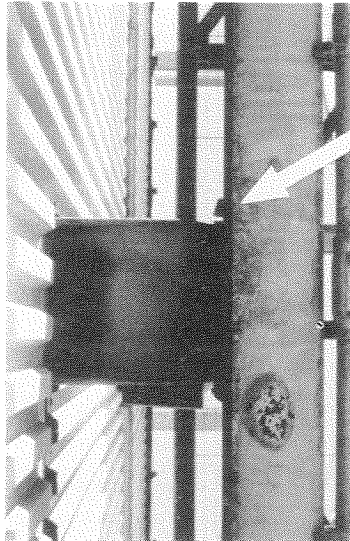
Figure 3   Damaged Seismic Guide

As a result of the earthquake, some of the bracing members of the main vertical frames and the suspension level horizonal trusswork buckled; the permanent transverse deflection in some of these members reached approximately 10 cm (3.94 in). In addition, most of the seismic guides suffered some degree of permanent deformation, either by bending or localized buckling. Dye-penetrant tests of the welds at the boiler walls showed no signs of cracks, indicating that the damage was confined to the seismic guides themselves. Figures 2 and 3 show a buckled bracing member and a bent seismic guide, respectively. Some piping and equipment damage also occurred, but their investigation was beyond the scope of this work. The equipment damage and the analytical study of the equipment response have been previously discussed[4].

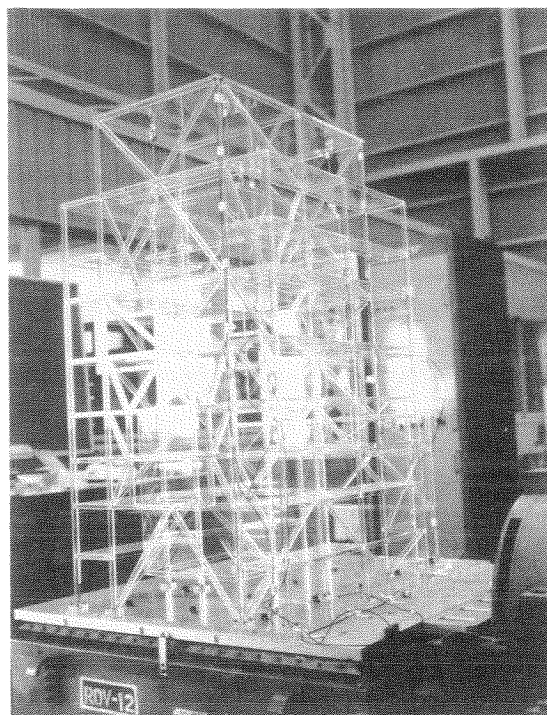
The experimental study was conducted on a scale model of the boiler and the support stucture, subjected to base excitation on a shake table. The experimental model, Figure 4, was made of acrylic resin, to a scale of approximately 1/25 of the actual structure.

*Figure 4    Test Model*

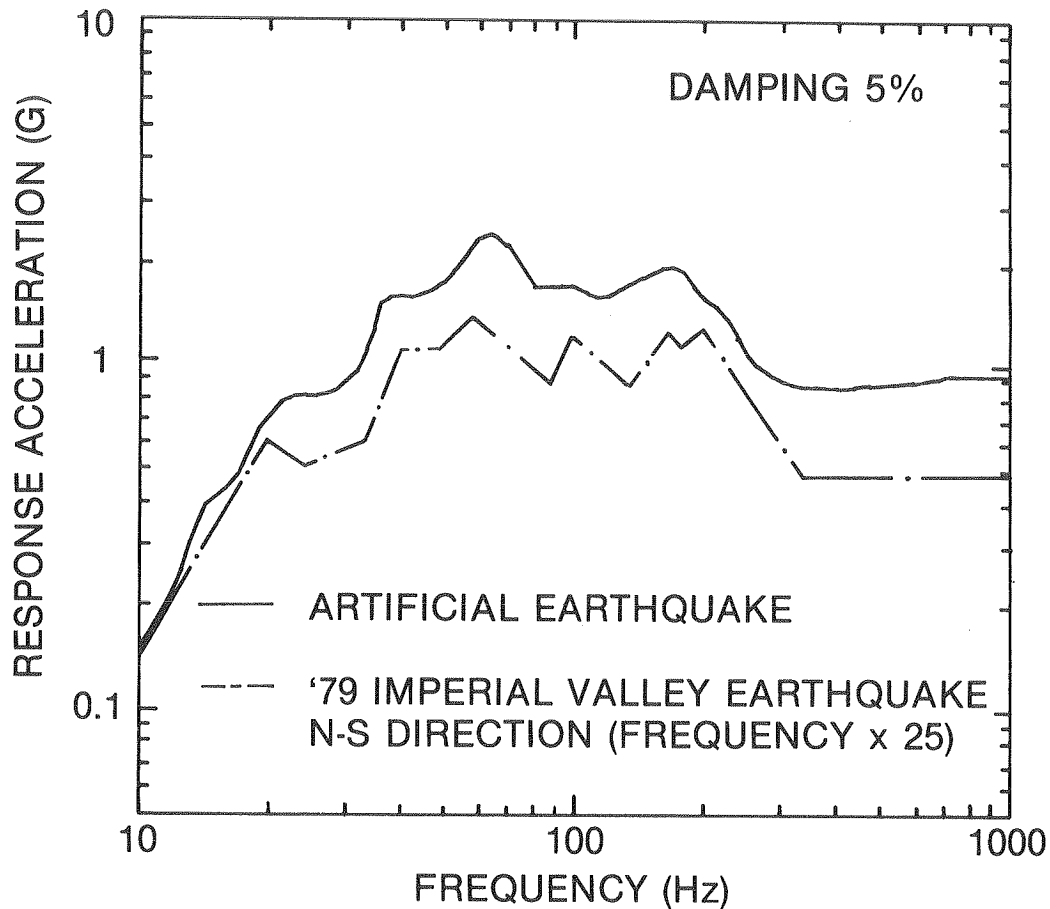
As input to the shake table, artificial waves were generated that simulated the north-south component of the ground motions. The digital-to-analog synthesis process accounted for the natual frequency scaling of the model and resulted in ten waves that had, accordingly, higher frequency and shorter duration than those of the actual earthquake. The maximum amplitude of the artificial waves was 0.9 g (0.03 oz) and their duration was approximately 3 seconds. Figure 5 shows the response spectra for both the artificial seismic waves and the actual ground motion.

*Figure 5    Response Spectra of Seismic Inputs*

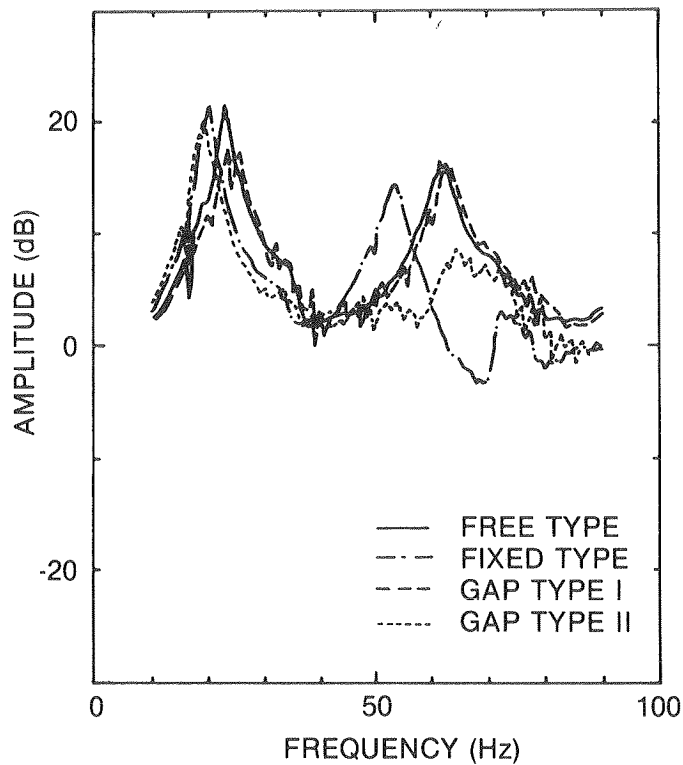
The response accelerations of the test model to the seismic wave input were recorded at various locations. From these, the model acceleration transfer functions were calculated and compared for the four different seismic guide conditions listed above. Figures 6 and 7 show the transfer functions at the top of the structure and top of the boiler, respectively. It can be seen from these curves that, for the range of frequencies of interest, below 30 Hz., the response for GAP TYPE I approximates that of the free type. Also, for the same frequency range, the response for GAP TYPE II is equal to or lower than that of the fixed type.

*Figure 6    Transfer Functions of Support Structure*
