BOILER CONDITION ASSESSMENT PROGRAM AT PSI ENERGY'S WABASH RIVER GENERATING STATION UNIT 5

William J. Boyle P.E. Project Manager Power Services Division Riley Stoker Corp.

Dennis A. Tebbe Senior Engineer Plant Engineering Department PSI Energy, Inc.

RST-98

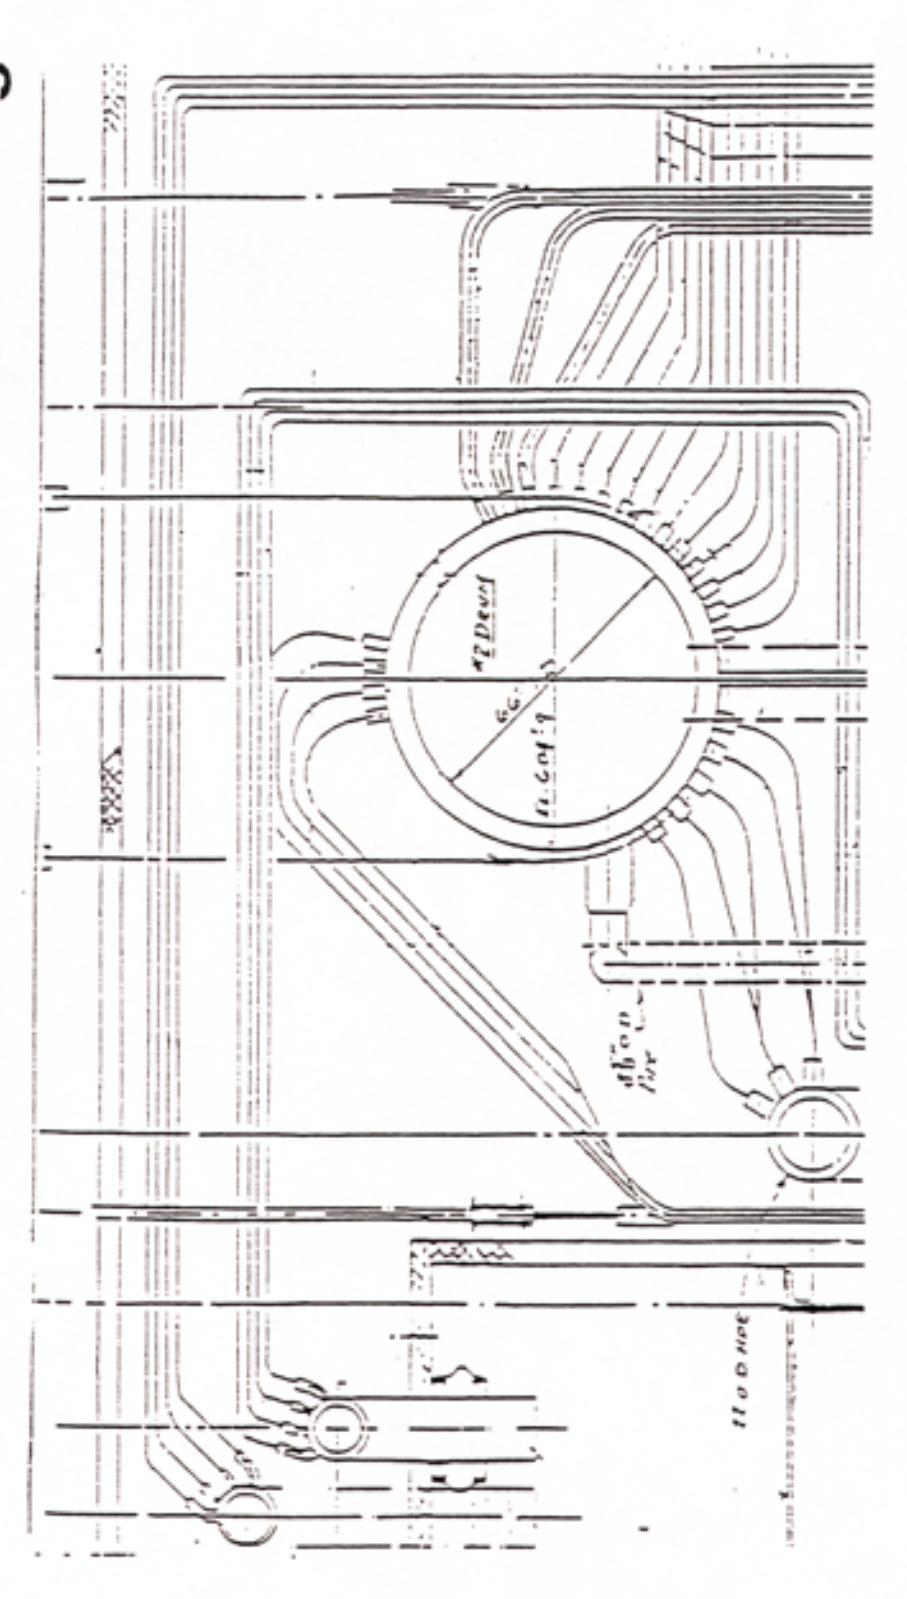
Steam Drum Arrangement Figure 6

The cause of the steam drum cracking was most likely thermal fatigue due to the severe temperature transients during unit startup and shutdown. Exacerbating the problem may be the relatively short length of tubing between the steam drum and downcomer header and the boiler division wall header, which results in inadequate tube flexibility, see Figure 6. As evidence, the bore holes which contain the most cracks are those attached to the straight piece of tubing extending from the steam drum to the boiler division wall header. Future inspection activities should include an internal inspection of the downcomer header and the division wall header for ligament cracking.
