**CONDITION ASSESSMENT PROGRAMS FOR
BOILER AND PIPING COMPONENTS AT THE
BIG CAJUN II POWER STATION**

Presented at the
POWER-GEN '97 International Conference
November 9-11, 1997
Dallas, Texas

RST-149

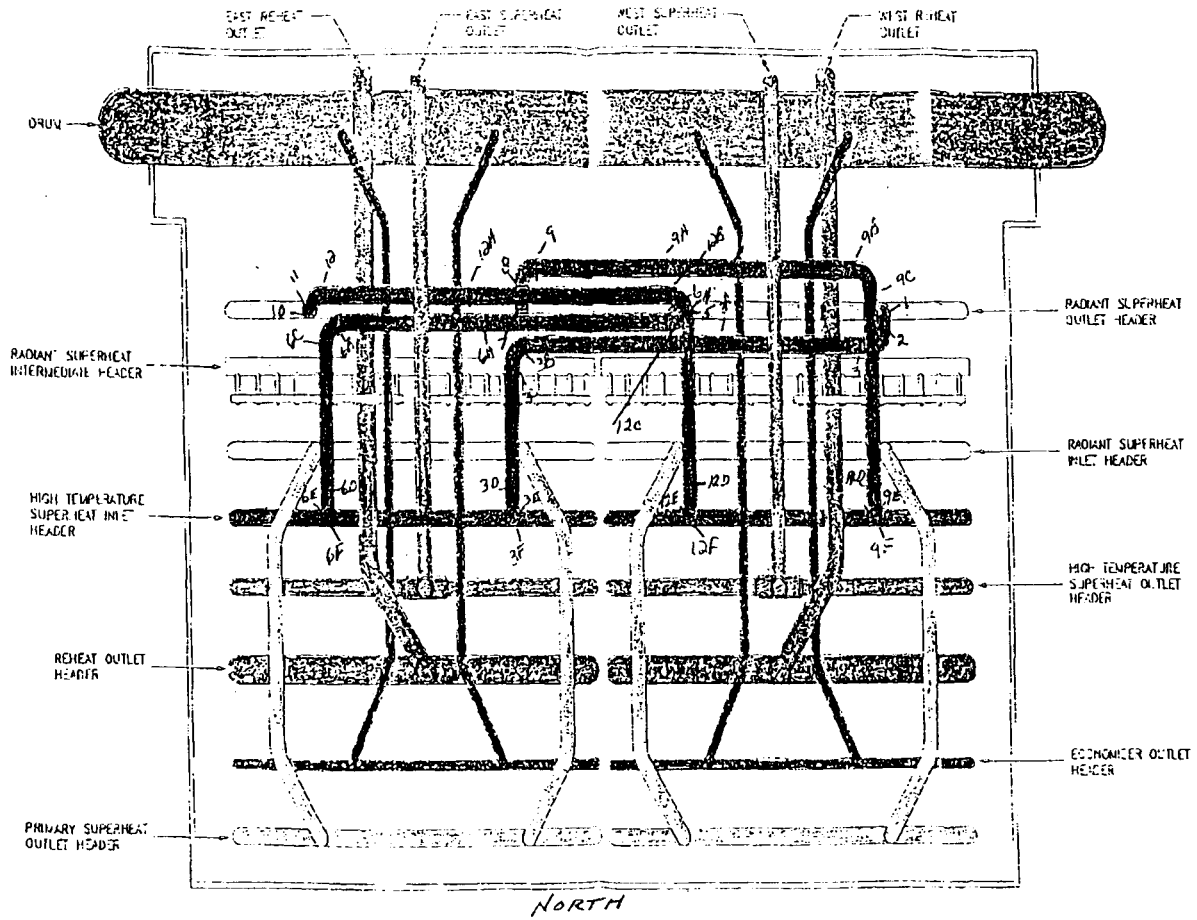
Figure 3 Plan view of the penthouse headers and crossover piping system

During the spring 1993 condition assessment program on the Unit No. 1 boiler, additional problems were found in the radiant superheater crossover piping components. These included visible crack indications in the existing weld prep regions of the four crossover piping lines at the new radiant superheater outlet header nozzles. In addition, radial crack indications were found in the internal bore holes of the four pipes at threaded locations for radiographic plugs. Figure 3 depicts a plan view of the crossover system, and Figure 4 shows the cracking in a pipe weld.

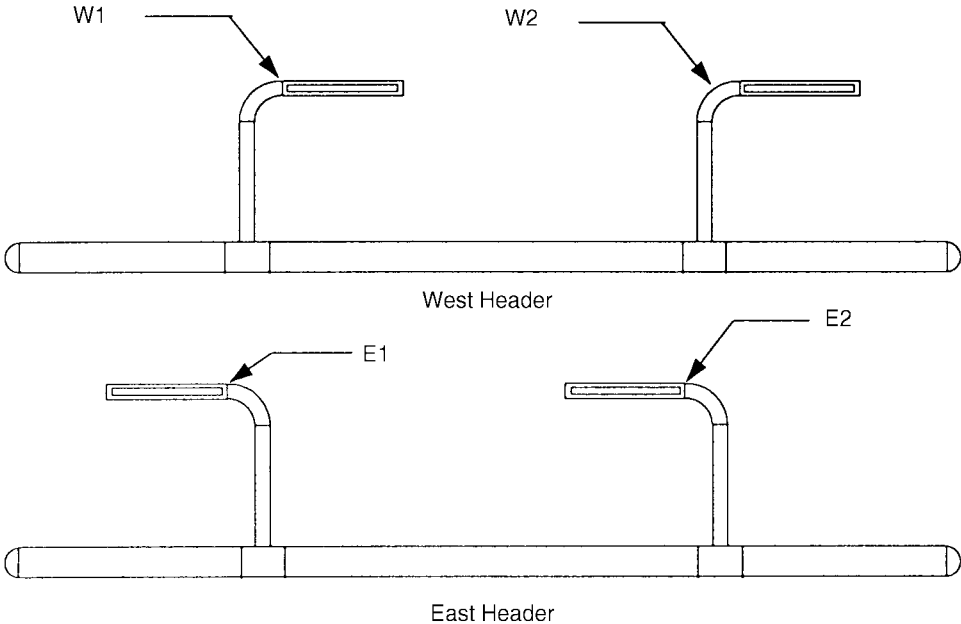
*Figure 5 Spray piping, front view
Radiant superheater outlet headers, terminal piping, and spray assemblies*

lining anchor welds, and in the high temperature superheater inlet headers. These indications were all designated for monitoring. A schematic sketch of the crossover piping to the attemperators is shown in Figure 5.

All of these instances of cracking were attributed to thermal fatigue and over temperature conditions experienced by the components early in the life of the boiler. Because of the higher temperatures experienced by the radiant superheater components, spray stations were added to the primary superheater systems soon after the boilers first went into service.

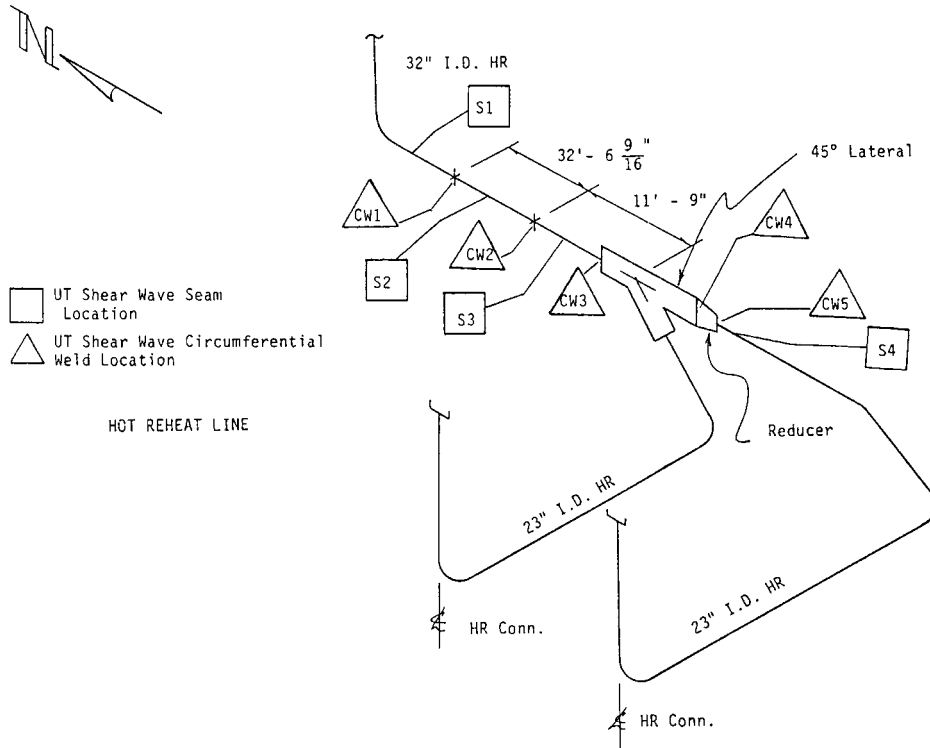
The condition assessment of the steam piping was begun on the Unit 1 lines during the 1993 spring outage. During the Unit No. 1 1995 fall outage, some indications were identified by ultrasonic shear wave testing, and surface creep damage was observed by metallographic replication, in portions of the long seam and girth welds of the hot reheat piping in the turbine building. These findings resulted in the removal of plug samples for metallurgical evaluation. In lieu of performing weld repairs to the piping, a three foot long piece of the hot reheat piping was removed for a comprehensive analytical testing program. The spool piece was cut eighteen inches on each side of a circumferential weld, and contained two offset portions of long seam weld. See Figure 11. The results of this program are presented in detail in the Reference (6) and (7) documents, and are summarized herein, as follows.

Figure 9 Typical hot reheat piping isometric drawing identifying the piping to be examined during condition assessment program

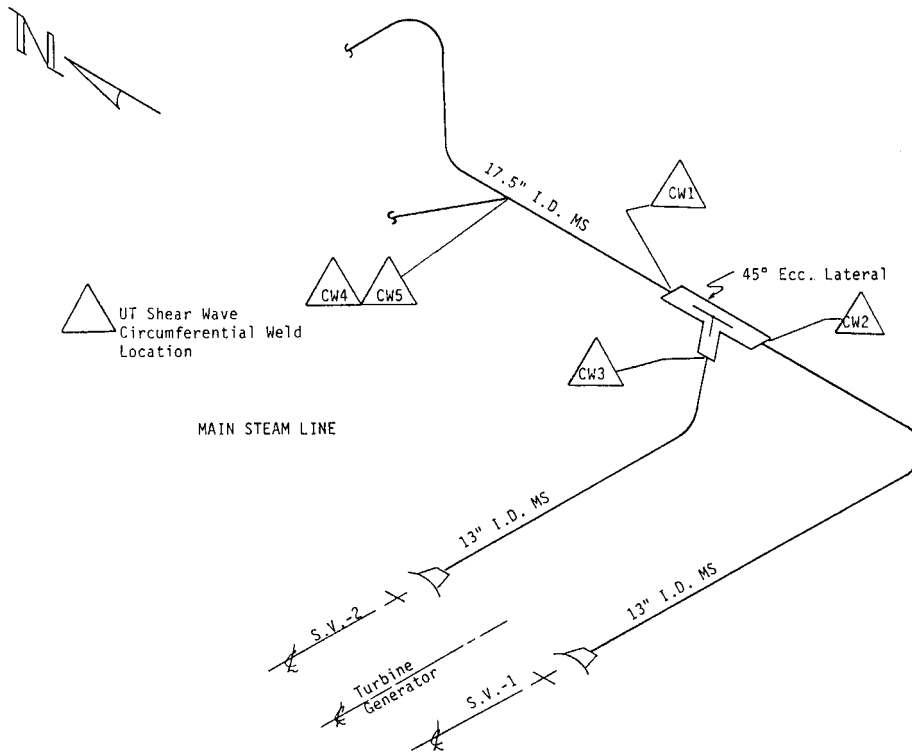
Figure 10 Typical main steam piping isometric drawing identifying the piping to be examined during condition assessment program
