**CURRENT EXPERIENCE IN  
TYPICAL PROBLEMS AND FAILURES WITH  
BOILER PIPING COMPONENTS AND SUPPORTS**

James P. King, Design Manager  
DB Riley, Inc.

Presented at the  
1998 ASME Pressure Vessels and Piping Conference  
San Diego, California  
July 26-30, 1998

RST-152

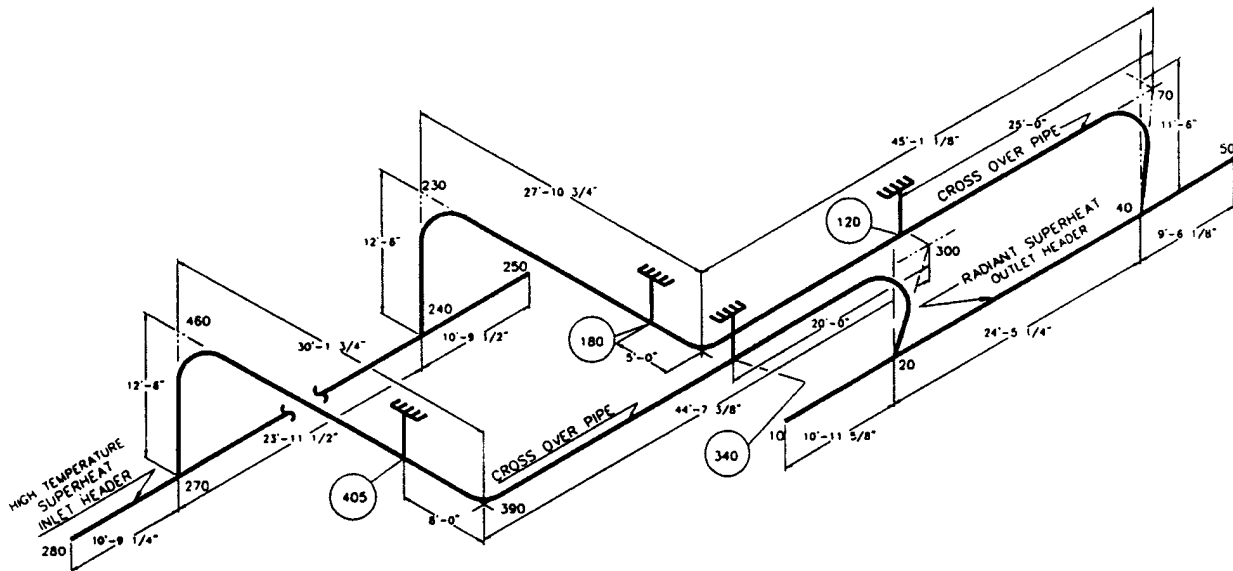
Figure 5 A typical radiant superheater crossover piping system

The condition of crossover piping supports should also be documented on a scheduled basis, since such hangers have been found to be non-functioning or inadequate, resulting in over stress conditions on the piping components. A case study of crossover piping problems is described in the Reference 4 paper. A typical radiant superheater crossover piping system is shown in Figure 5.

For such condition assessment programs, the following crossover superheater piping components should be evaluated.
