**EVALUATION OF  
HOT REHEAT STEAM PIPING,  
INCLUDING A TEST SPOOL PIECE,  
AT THE BIG CAJUN II STATION**

Presented at the  
POWER-GEN'96 International  
December 4-6, 1996  
Orlando, Florida

RST-144

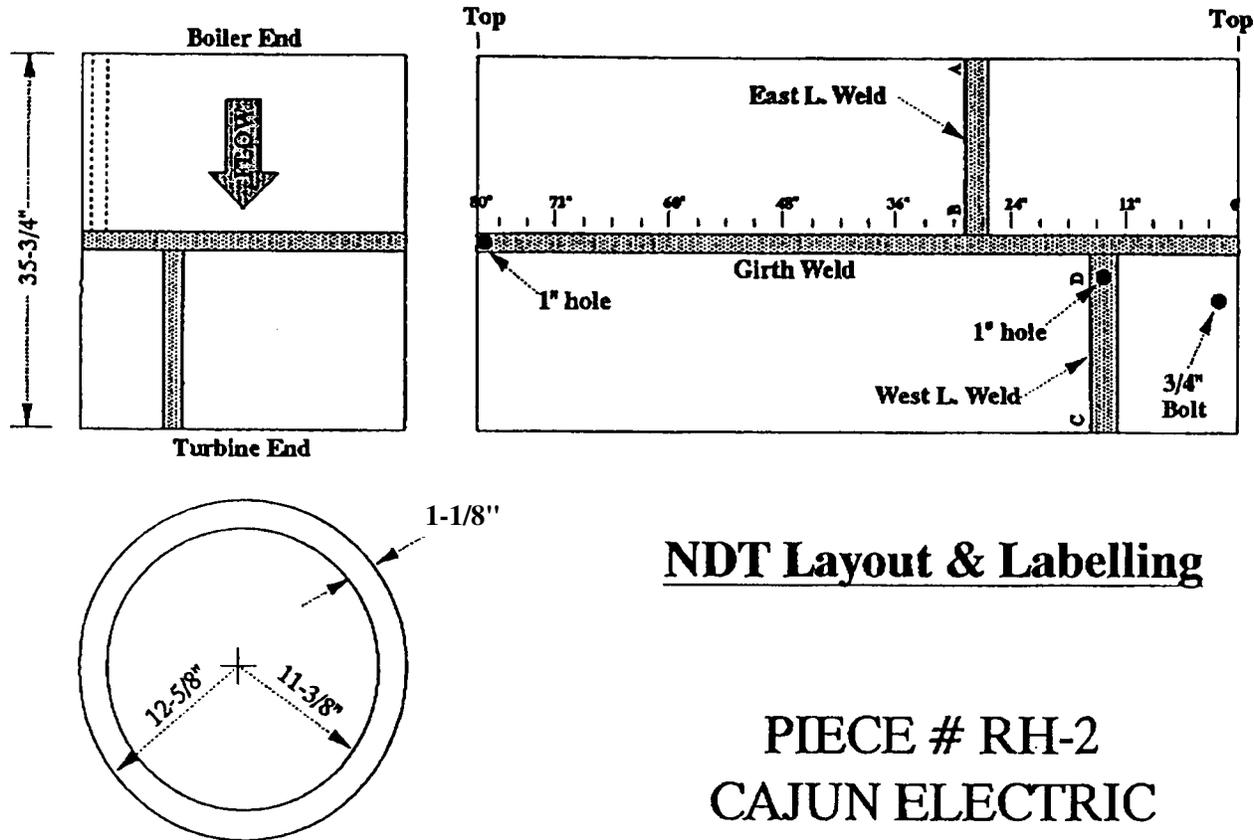
### PIECE # RH-2 CAJUN ELECTRIC Big Cajun II, Unit 1

The spool piece, having nominal measured dimensions of 25-1/4" O.D. by 1-1/8" wall and 22-7/8" I.D., had been cut from the hot reheat line at a location downstream from a "Y" connection, which is inside the turbine building (Figure 1). The spool piece had been cut eighteen inches on each side of a circumferential (girth) weld and contained two offset portions of longitudinal seam weld (upstream [Figure 1b] and downstream [Figure 1a] from the girth weld). The steam flow in the pipe is from east to west at this point in the line. A layout of the as-received spool piece is shown in Figure 2. The locations of the plug samples, which had been removed prior to removing the spool piece from the line, are indicated by the 1" radiographic holes in the girth weld and in the downstream seam.

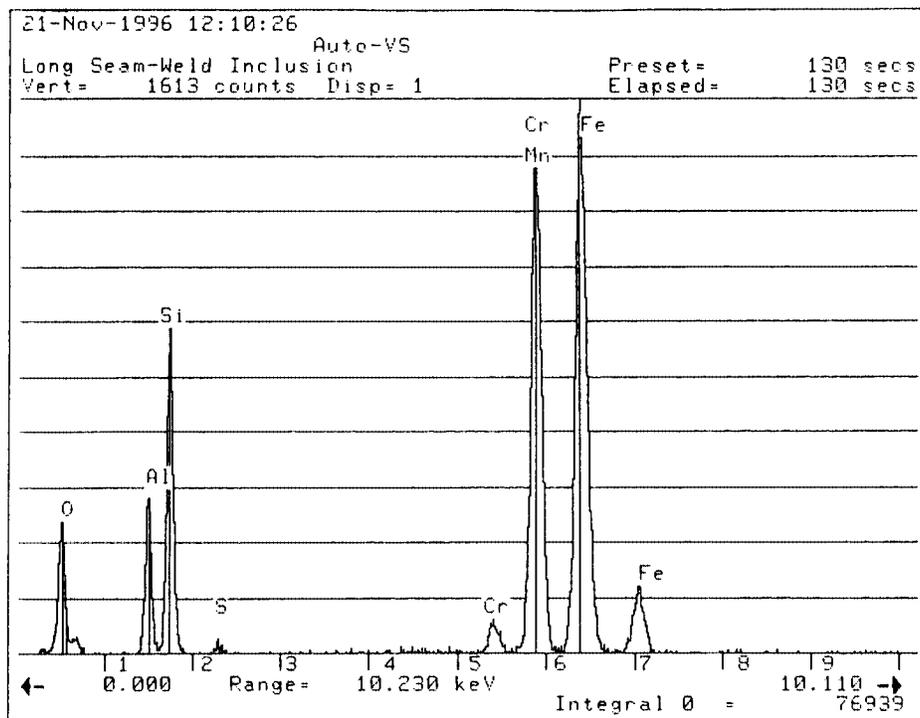
The weld metal inclusions of the longitudinal seam weld were found to be composed largely of manganese, silicon, aluminum, oxygen and sulfur (Figure 10).

Figure 10 EDS Spectrum of Representative Long Seam Weld Metal Inclusion.

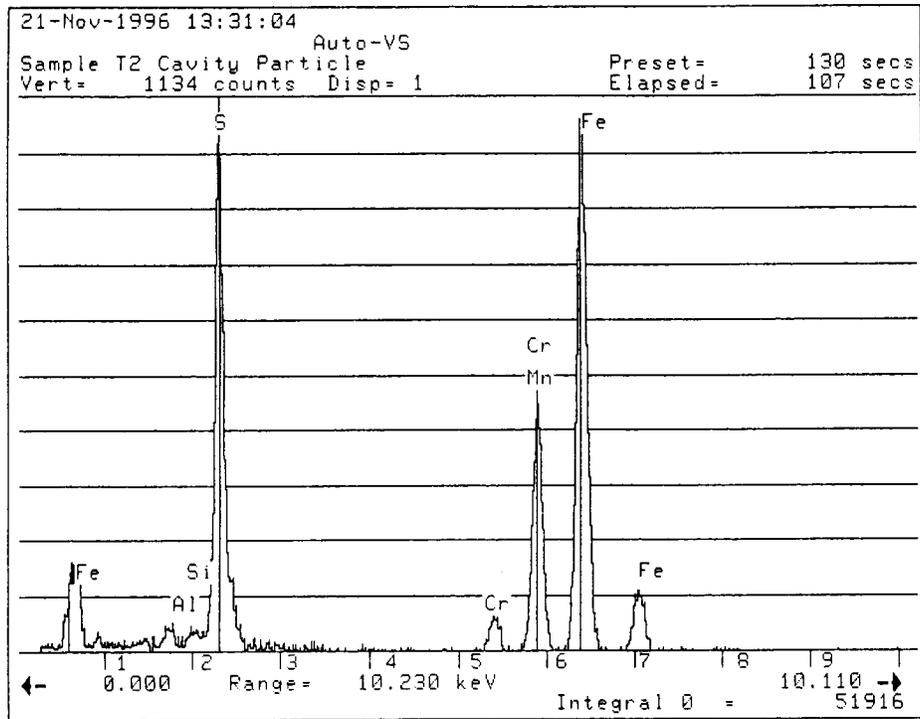
Examination of the stress-rupture specimens showed that cavity nucleation in the HAZ of the longitudinal seam weld was generally associated with an inclusion (Figure 11). EDS analyses of these inclusions showed that they are largely manganese and sulfur-rich (Figure 12).

Figure 11 EDS spectrum of a Representative Particle Associated with a Cavity in the Stress-Rupture Sample, T2. Particle Seen in Figure 12.

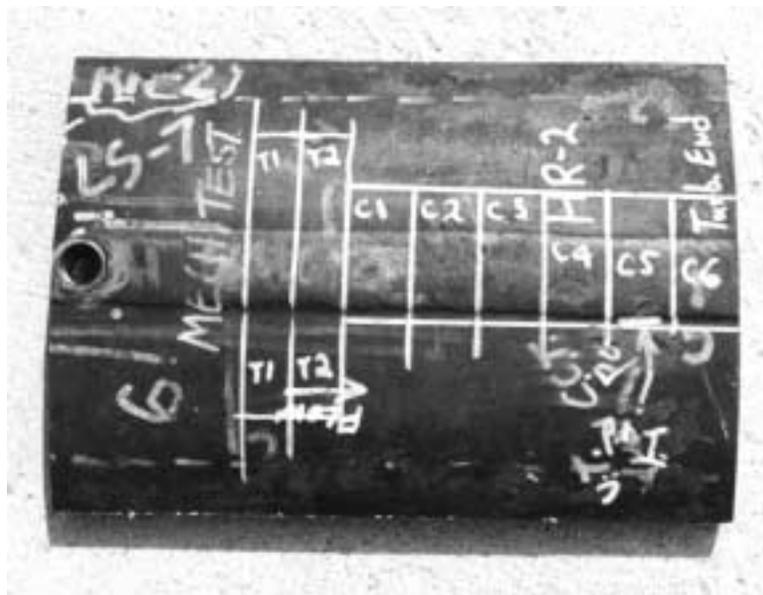
The location of the mechanical test specimens are shown in Figure 13a, oriented perpendicular to the downstream leg of the longitudinal weld. Specimens T1 and T2 are the stress-rupture samples. Four of the six specimens designated C1 through C4 are used for testing elevated temperature toughness and creep-crack-growth. Figure 13b shows the macroetched blanks prior to preparation of the cross-weld specimens.

Figure 13a Orientation of the Stress-Rupture (T1 and T2), and Creep-Crack-Growth and J<sub>IC</sub> Specimens (C1 through C6) on the Downstream Leg of the Long Seam.

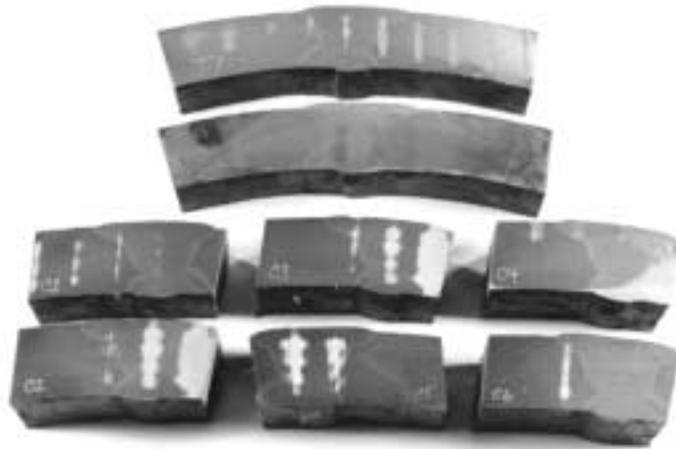
Figure 13b The Macroetched Faces of the Specimens, Showing the Location of the Double-V weld.

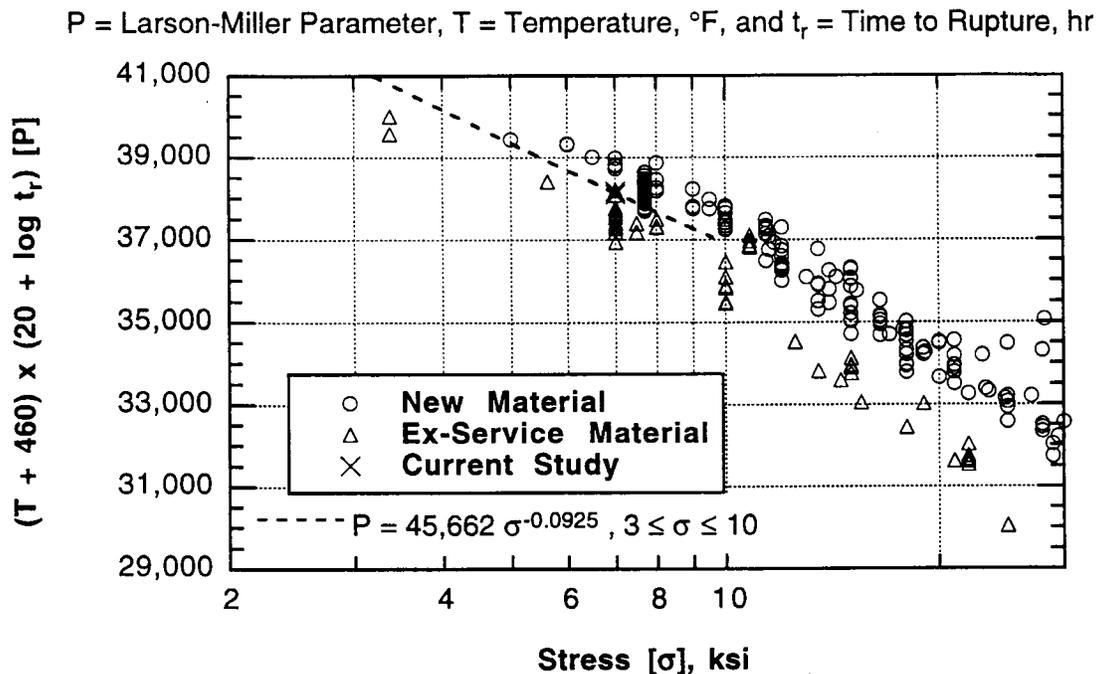
Two blanks, oriented across the downstream leg of longitudinal weld, were machined into tensile specimens with a 1/4" diameter by 2" long gage section. The specimens, designated T1 and T2, were located so that the welds and heat-affected zones were in the gage section. The specimens were dead-weight loaded in tension in standard creep test frames and heated in air using a standard laboratory test furnace. The tests were accelerated by using 1225°F and 1250°F test temperatures, which are well above maximum service temperatures, and a stress of 7 ksi. A value of 7 ksi was chosen so that the results could be compared directly with those of a past study conducted for the Electric Power Research Institute (See Ref. 4), as may be seen in Figure 14.

Figure 14 Results of the Stress-Rupture Tests Compared With Data From EPRI-TR-101835

Sample T1 failed after 213.9 hours at 1250°F and Sample T2 failed after 409.0 hours at 1225F. The calculated Larson-Miller parameters are given in Table 2. A substantial amount of ductility is seen in both samples. Optical metallography of the stress rupture test specimens showed that the fracture occurred through the HAZ (Figure 15). In addition, aligned cavities were observed in the weld metal at prior austenite grain boundaries.

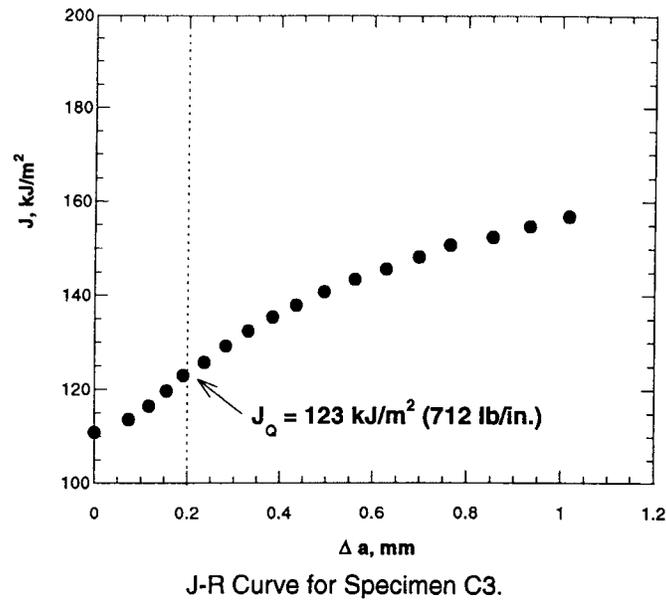
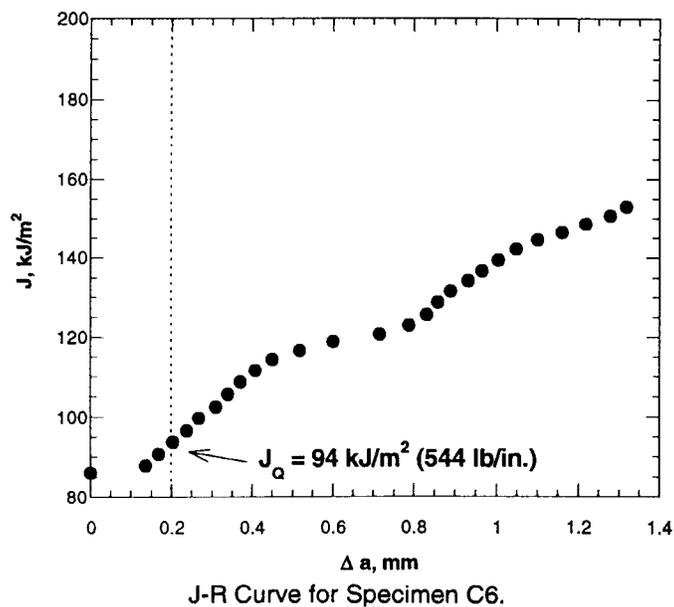
The results compare well with other  $J_Q$  values for 2-1/4 Cr - 1 Mo steel at temperatures near 1000°F as reported in the literature (See Ref. 4). As may be seen in Figure 16, the  $J_Q$  value for specimen C6 is lower than that for Specimen C3, which is attributed to a variation in microstructure and not to the slight difference in test temperatures. The crack path of

the Specimen C6 appears to follow the fusion line of the long seam weld, and that of Specimen C3 does not.

Figure 16 The J-R curves (plots of J versus  $\Delta a$ ) were developed from the measured data and used to determine  $J_Q$  fracture toughness at  $\Delta a=0.2$  mm.

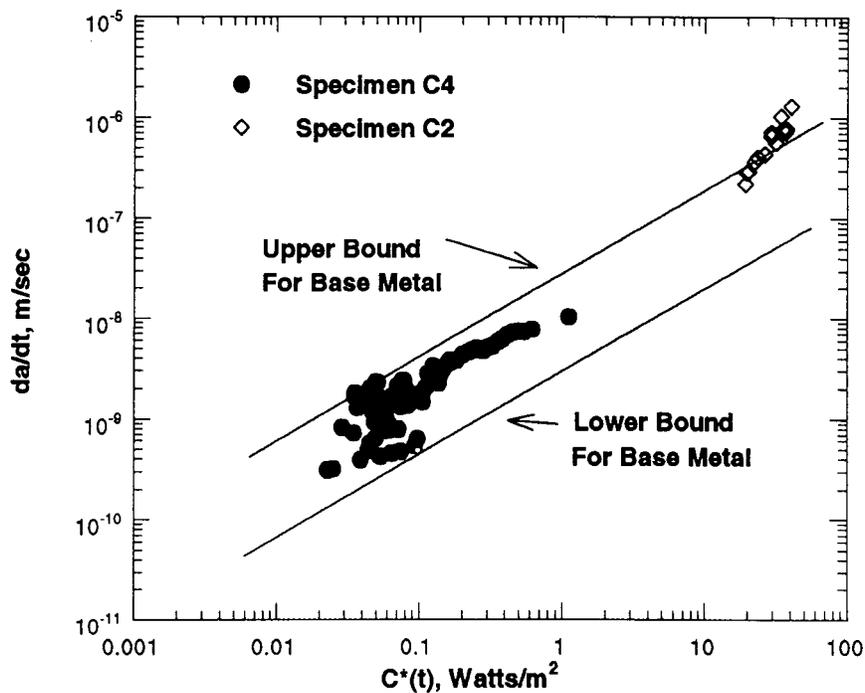
The creep-crack-growth data for Specimens C2 and C4 are presented in Figure 17. High crack growth rates ( $da/dt$ ) were obtained for Specimen C2 under these test conditions, which failed in only one hour. In contrast, much lower crack growth rates were measured for Specimen C4, which failed in 527 hours. The accelerated fracture of Specimen C2 compared with that of Specimen C4 is most likely a result of differences in material microstructure, since there were no significant differences in the original conditions of the test specimens. The creep-crack-growth data for both specimens falls within the lower and upper bound for data for 2-1/4-1 Mo base metal tested under similar conditions. Since the crack path for the test specimens was through the weld metal, the results indicate that creep-crack-growth resistance of the weldment specimens has not been significantly affected by service exposure.

Tested In Air at 1015°F and 1200 lbs.

Figure 17 Creep-crack-growth data for Specimens C2 and C4
