Upper Rear Steam Drum Replacement

Wisconsin Electric Power Company's Port Washington Station Units 2, 3, & 4

RST-101

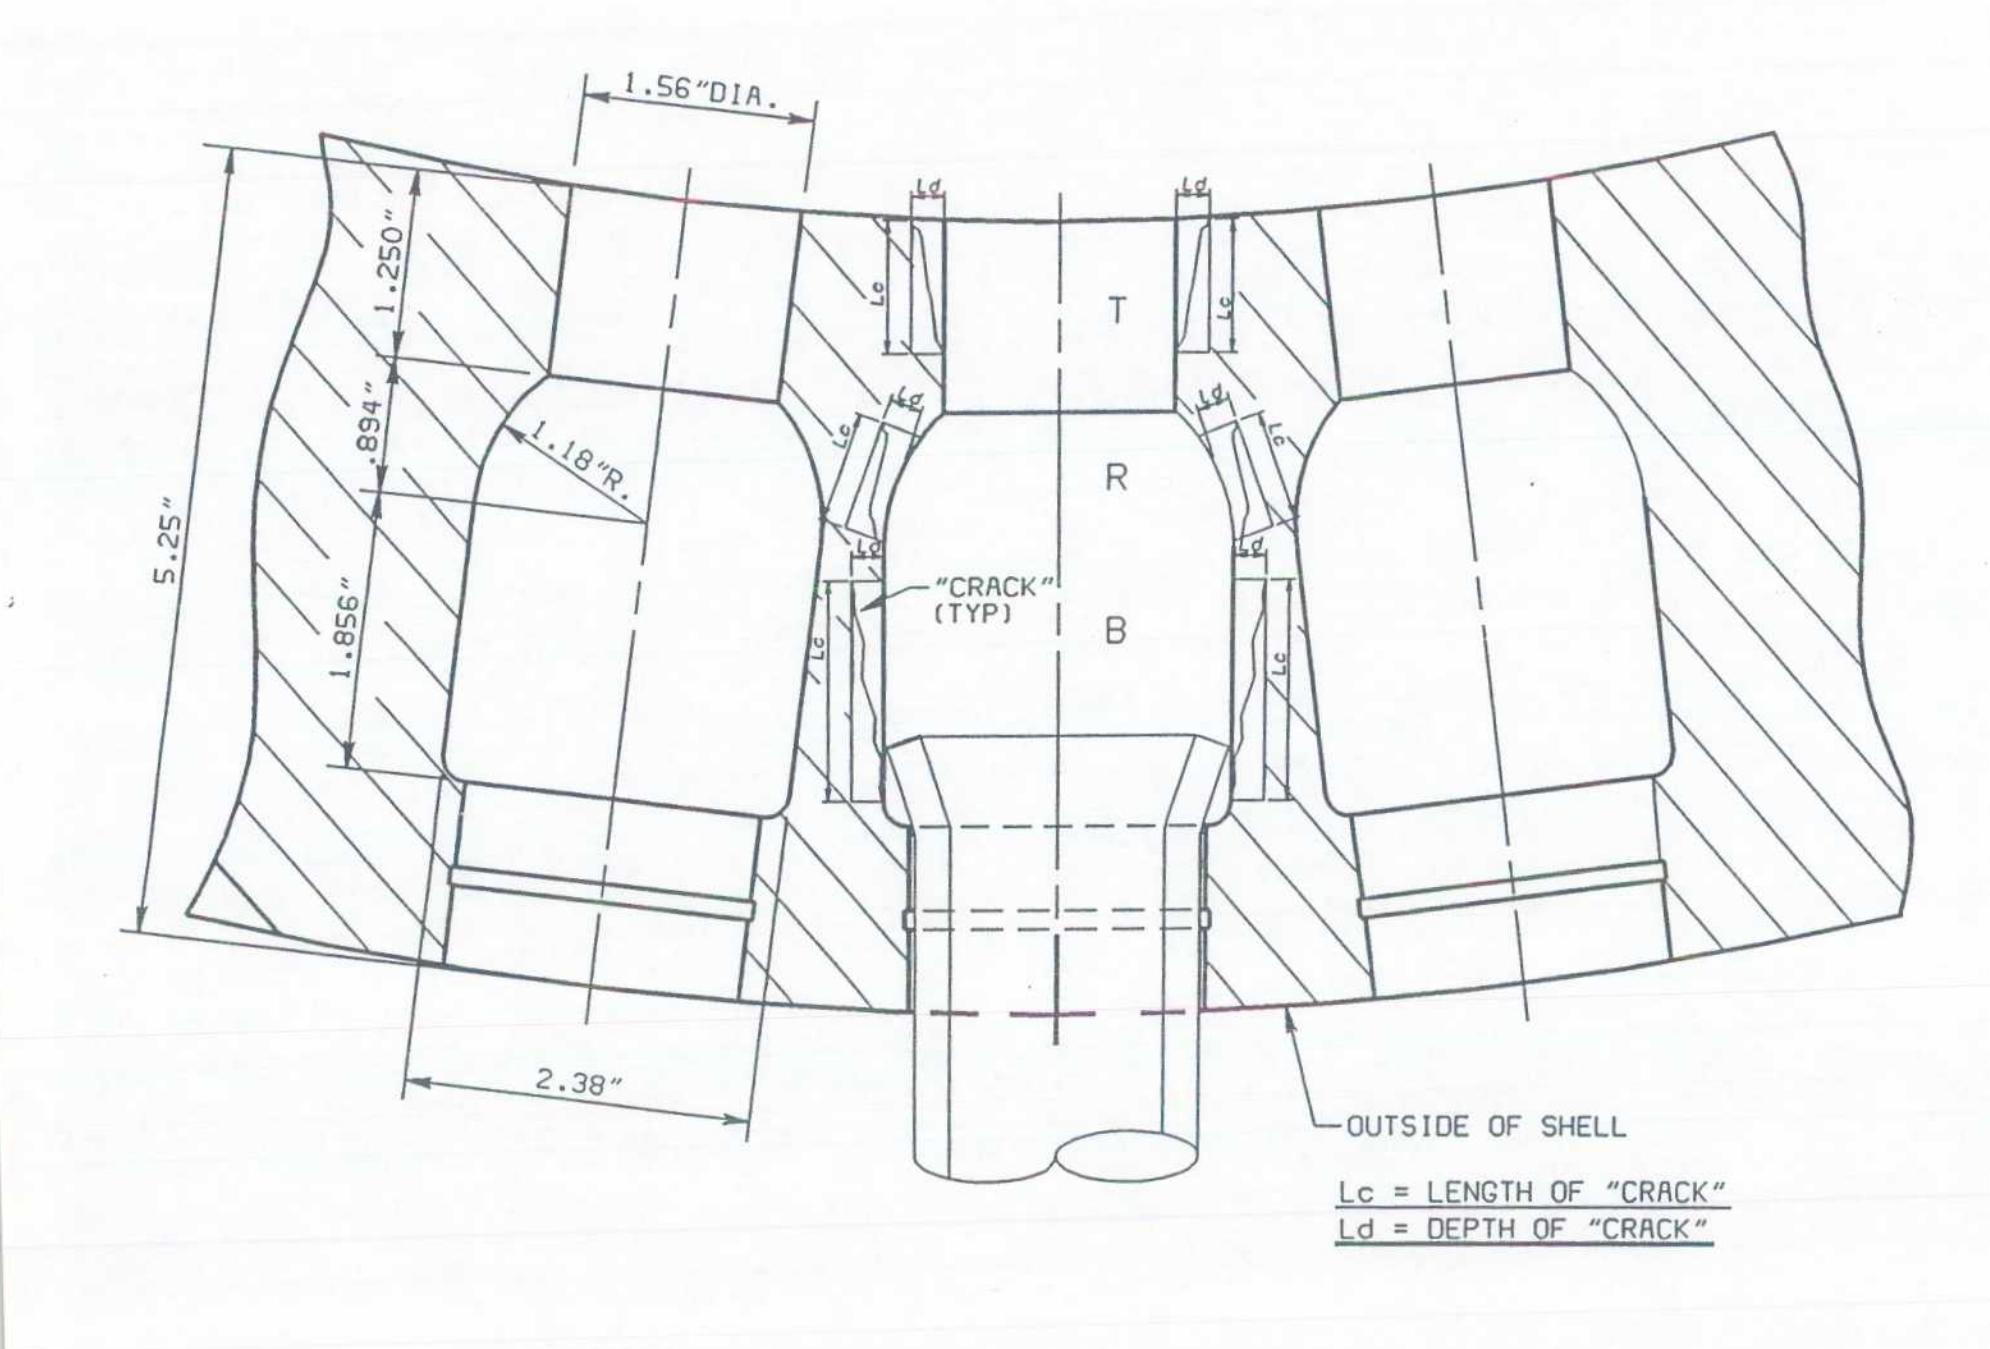
Figure 2

Since discovery of the cracking in 1984, routine examinations of the upper rear steam drums have been conducted by WE personnel, the OEM, consultants, and other boiler manufacturers. The cracks are predominantly oriented in the circumferential direction between tube bore holes. The cracks originate on the internal surface of the upper rear steam drum within the boiler bank ligament field, as shown in Figures 1 and 2. This cracking has propagated into the thickness of the drum and/or into the tube bore holes. The drums are made of SA-204 GR. B carbon steel.

Ligament cracking between tube bore holes and propagation of cracking into shell
