**BOILER ASSESSMENT AND UPGRADE STUDY**

**For  
Tennessee Valley Authority  
Allen Steam Station  
Units 1, 2 and 3  
Memphis, Tennessee**

**Presented at the  
Power Generation '93 Conference  
Dallas, Texas  
November 17-19, 1993**

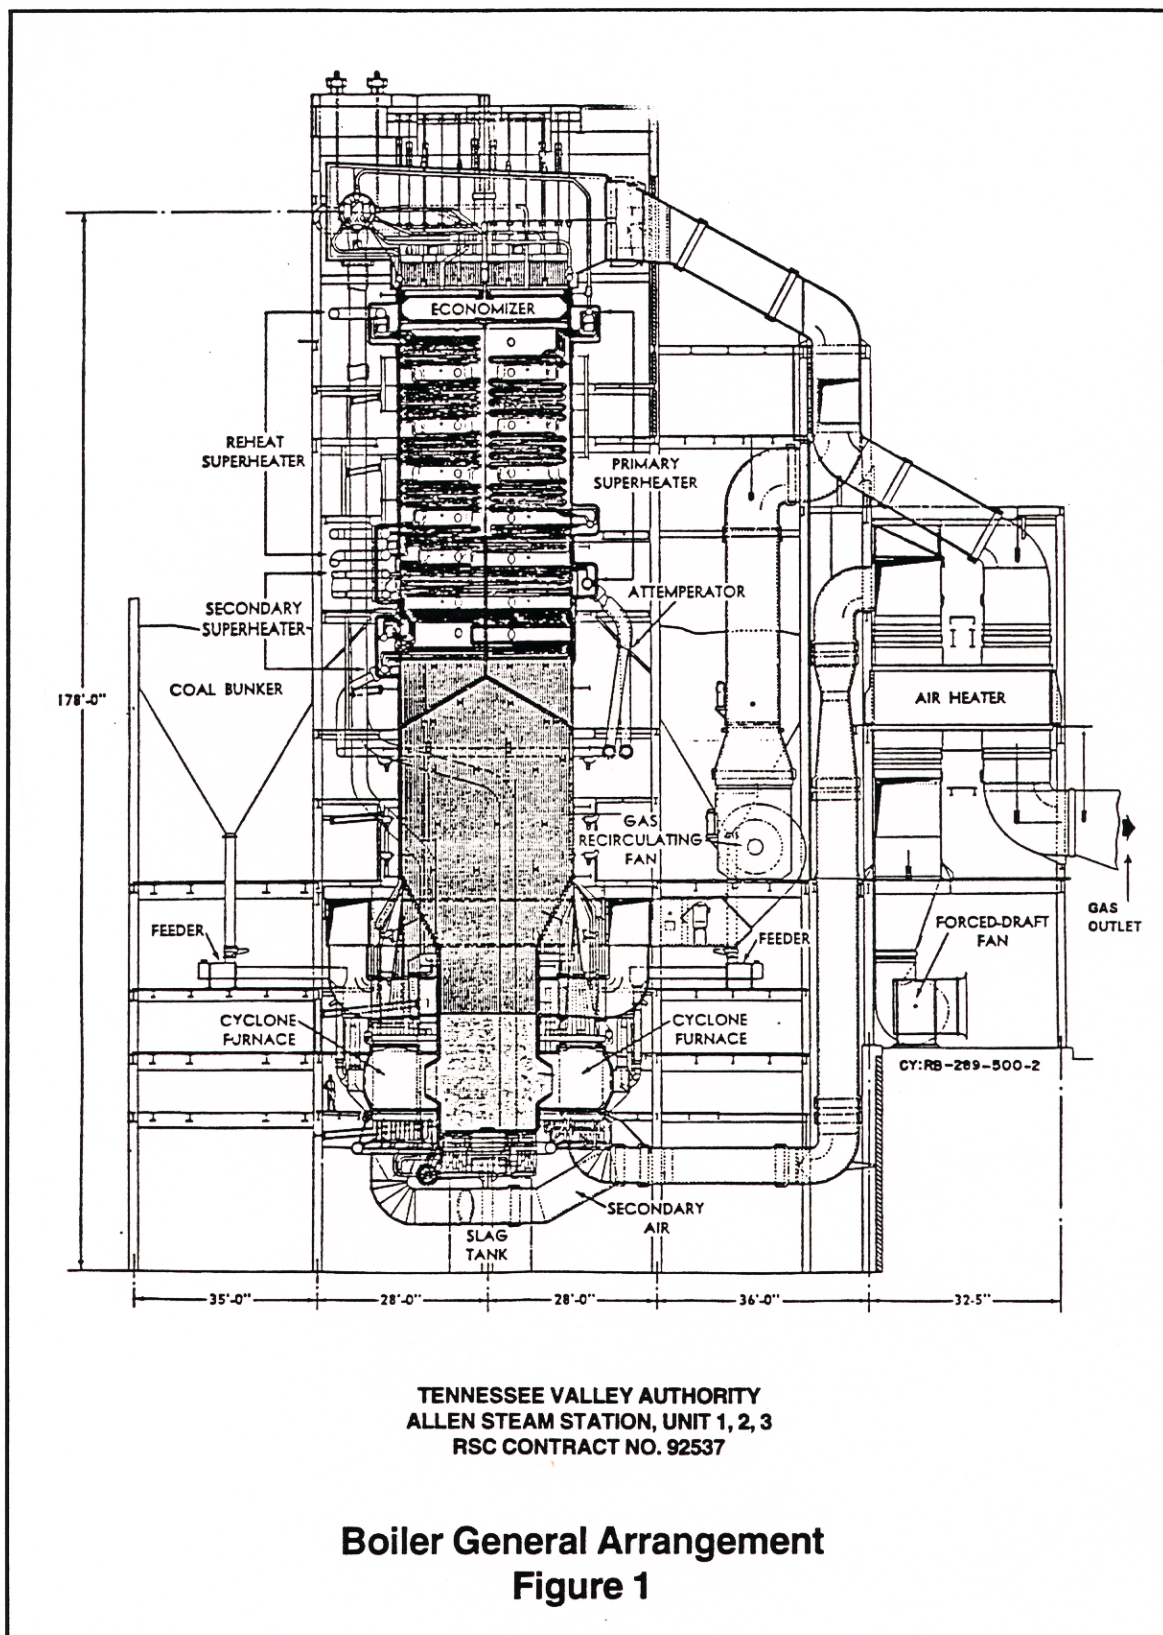
SUBPROBLEM MATRIX (Part 1 of 2)

Subproblem Number	Component I.D.	Subproblem Description	Boiler Number	Year	Number of Occurrences	Current Situation	Reference Documents
D3	AH	Air Heater leakage up to 301. Radial & sector seals worn.	1,2,3			FD fan limit reached. Load limited to 2,000,000 lbs/hr.	Int & Rep
D3(contd)	AH	Rotor shaft misaligned. Tears on T-bar. Baskets not levelled.	1,2,3			30% of T-bars need replacing. Levelled rotor on B2 Unit.	Int
D3(contd)	AH	Leakage worse on B1. Higher diff. because of bal. draft.				Furnace draft press.	Int & ER
D5	AH	High Air Heater pluggage. Originally designed for NG & intermittent coal	1,2,3			Wash AH's every 2 months.	Int
D5(contd)	AH	Popcorn carryover on hot side. Cold-side cake buildup.				Louver type cinder (slag) trap installed between the Econ and A.H. in 1972. Very little popcorn now.	Int & A.H. CA
D5(contd)	AH					Turndown limit to 1,400,000 lbs/hr. (OK below 50MM-no slag)	Int & HMP

C1	Slag	Slag cannot be tapped at low load.	1,2,3				Int
C1(contd)	Slag	Low sulfur coal required for S02 has high iron. T250 seems OK (K2600F).	1,2,3				Int
D4	GR	GR fan high maintenance, vibration, wheel erosion (retipped yearly).	1,2,3			GR ceased operation in 1980. Industry wide problem. Most have removed GR, if possible.	Int & PC
D4(contd)	GR	Overhung fan. Poor control damper design. No turning gear.	1,2,3				Int
D4(contd)	ER	Duct expansion gas leaks. Duct erosion OK.	1,2,3				Int
C2	Exiss	Opacity problems. Worse on Unit B1 because of balanced draft conversion.	1,2,3			Conversion scheduled for B2 & B3 units.	ER, Int. & FC
C2(contd)	Exiss	Precipitator is marginal. Over 20% opacity if any boiler upsel.	1,2,3			Perforated plates to be put at inlet to Precip.	ER & Int
C2(contd)	Exiss	Many deratings on Opacity.	1,2,3				ER

Pertaining to the six TVA Goals for Boiler Condition Assessments and Upgrades Programs and based on the analysis from this study, a formal summary was established. Examples of the summary which includes Findings, Conclusions, and Recommendations, are shown the following Figures.
