REFURBISHMENT OF AN EXISTING 1000 TPD MSW FACILITY USING MODERN STATE-OF-THE-ART EQUIPMENT

Craig Gillum, Staff Engineer Babcock Borsig Power, Inc.

Arthur Cole, Vice President and Roger Anderson, Director of Engineering Wheelabrator Technologies

Presented at the 10th Annual North American Waste-to-Energy Conference (NAWTEC 10) Philadelphia, Pennsylvania May 6-8, 2002

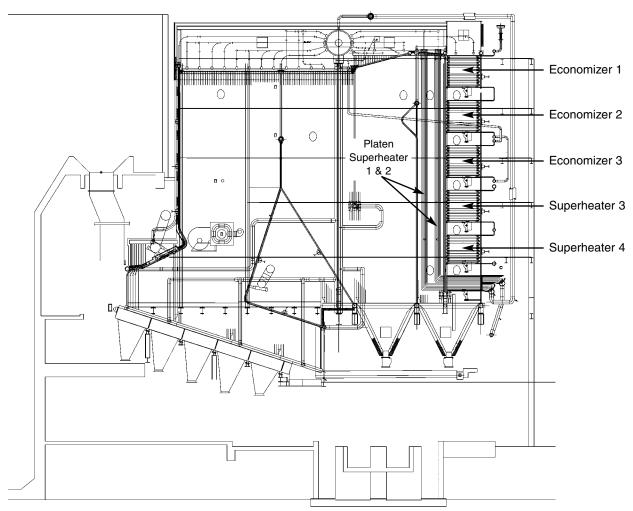
Figure 1 McKay Bay Side Elevation

The boilers are a balanced draft, naturally circulating design. A gas-tight setting is formed by welded water wall construction. The boilers are nominally rated at 250 TPD each with a maximum continuous rating of 62,186 pounds of steam per hour per unit when burning the specified 4,800 Btu/lbm MSW. Figure 1 shows a side elevation of the boiler.

The boiler is a five-pass design. The five passes are:

- Furnace
- 1st dropout pass
- 2nd dropout pass
- 4th pass
- 5th pass

The furnace dimensions accommodate several different design constraints. The lower furnace had to match the stoker dimensions. The design of the front wall nose arch was based on the recommendation of the stoker manufacturer but it had to fit within the confines dictated by the location of the existing feed chute and the refuse pit retaining wall. The overall height of the furnace was limited by the restriction on boiler penthouse height imposed by the tipping floor roof. In order to provide enough furnace radiant surface area to keep the furnace heat release rate and furnace exit gas temperature within accepted design guidelines, furnace depth had to be increased. The end result is a short, squat furnace configuration.

A notable feature of the 5th pass is that it was designed for easy removal and replacement of the tube elements. The 5th pass rear wall tubes are 2.25" OD on 5-inch centers. Starting at the elevation of superheater 4, the membrane fins have been removed. This allows the convective superheater and economizer elements to be easily inserted and removed without having to cut out any of the rear wall tubes. To replace an element, the buckstay is unbolted and the casing is removed. The element can then be cut out and a new one slipped in between the rear wall tubes.

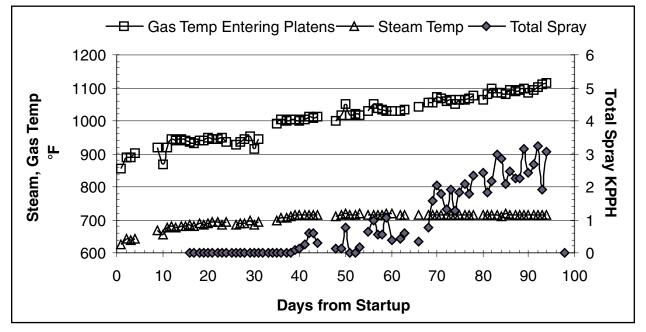
Figure 2 Spray Flow, Steam Temperature, and Platen SH Gas Inlet Temperature From Startup McKay Bay Unit 4

of surface area, the 2nd and 3rd dropout passes, were located in front of the convective section. These dropout passes took longer then expected to season. After seasoning, however, steam temperature reached its guarantee value and the boiler began to spray. Figure 2 plots steam temperature, spray flow, and the superheater platen gas inlet temperature variations from startup. Now that the boilers are seasoned, it only takes one to two days for steam temperatures to recover after the unit has been shutdown for a cleaning outage.

During the startup of Units 3 & 4, there were two performance related concerns. The first concern was that the boilers were not meeting the 725°F steam temperature guarantee. It took about three and one half weeks for the steam temperature to reach its design value once the boiler properly seasoned from new conditions. Operating and special test data collected during this period showed that the cause of the low steam temperature was low gas temperatures entering the convective section. One of the design objectives was to limit the gas temperatures entering the convective surfaces. In order to accomplish this, a large amount
